CASE STUDIES

LOGISTICS AND TRANSPORT INDUSTRY

WSHCOUNCIL

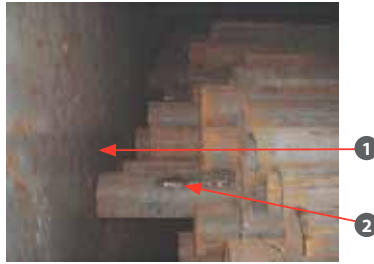
- Although work was supposed to start at about 1:00pm, the team of stevedores reported for work at about 7:00am. The stevedores stopped work at about 9:00pm and resumed at about 11:30pm. The accident occurred at about 12:30am.
- There was no risk assessment conducted before commencement of the work.
- No safe work procedures nor fall protection measures were in place.

1. The opening where the deceased fell through
2. Steel pipes

Evaluation of loss	• One worker killed.
Type of contact	• Fall from height.
Immediate cause(s)	• Improper positioning of worker.
Basic cause(s)	• Unsafe work environment; fatigue.
Failure of SMS	• Hazard analysis and risk assessment.

Identify appropriate fall prevention measures.

Recommendations

Apply proper rigging methods.

Conduct proper risk assessment prior to the commencement of any lifting operations.

Disseminate to workers, safety measures and safe work practices such as fall protection and the hazards of such lifting operations via toolbox meetings.

Closely monitor and review existing fatigue management programmes.

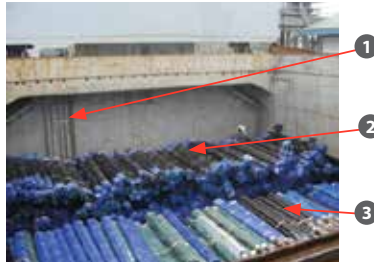
1. The ladder which was used to access the cargo hold
2. Steel pipes at the forward side
3. Steel pipes at the aft side

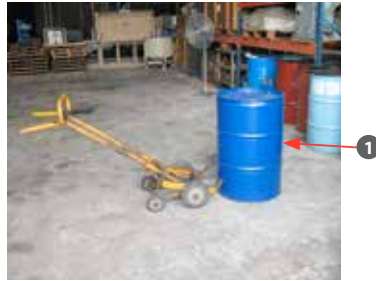
- The nose tips of the drum mover were probably not placed properly under the drum.
- When the worker tried to pull the handle towards himself to lift the drum, the nose tips slipped from underneath the drum, causing him to fall backward.

1. The drum mover which was used by the deceased

Evaluation of loss	• One worker killed.
Type of contact	• Fall from height.
Immediate cause(s)	• Slipping while using drum mover.
Basic cause(s)	• Inappropriate handling of drum mover.
Failure of SMS	• Hazard analysis and risk assessment; WSH practices and procedures.

Conduct and regularly review risk assessment for loading and unloading of drums.

Observe safe work practices for manual material handling.

Disseminate information on hazards of such operations to workers.

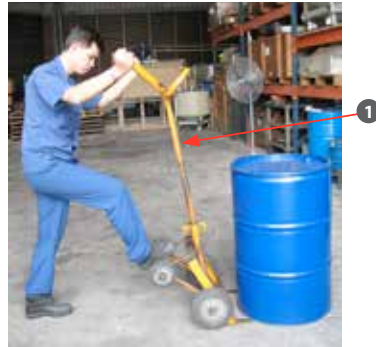
1. Normal usage of drum mover

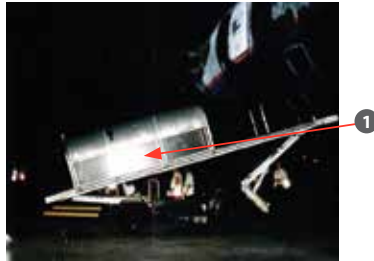
- At the time of the incident, the skyloader was operated by an Apron Officer, whose duty was to supervise the loading and unloading of cargo and baggage, but not the operating of the skyloader.
- The Apron Officer might have engaged the reverse gear accidentally, causing the skyloader to reverse and move away from the cargo hold when the worker was standing with one leg on the skyloader and the other on the entrance of the cargo hold, thus creating a gap through which the worker fell.
- There was no communication between the Apron Officer and the worker who was working at the top of the skyloader.

- The Apron Officer was not aware of the updates in the safety measures in relation to the operations of skyloaders, including the requirement for applying the handbrake and chocking the wheels before allowing personnel to climb up the skyloader.

1. The skyloader involved in the accident

Evaluation of loss	• One worker killed.
Type of contact	• Fall from height.
Immediate cause(s)	• Unsafe operation of skyloader.
Basic cause(s)	• Failure to observe safety measures relating to skyloader operation; lack of communication between parties involved in skyloader operation.
Failure of SMS	• Hazard analysis and risk assessment; WSH practices and procedures; WSH training and competency.

Conduct proper risk assessment prior to the commencement of the operation.

Disseminate and enforce WSH rules and safe work procedures.

Ensure that only qualified and authorised personnel are allowed to handle machines/equipments.

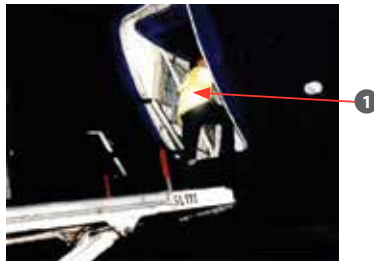
1. A worker demonstrating where the deceased stood before he fell from the skyloader

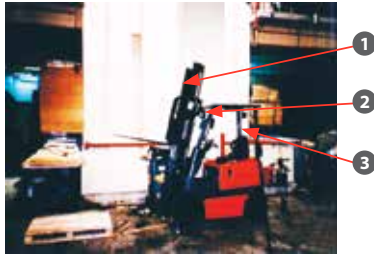
1. Mast section of the forklift truck
2. The deceased was trapped between the mast section and the operator cabin roof
3. Operator cabin

- The worker's right leg was next to the control lever which controlled the tilting movement of the mast section.
- When the worker was working on the mast section, his right leg might have accidentally come into contact with the control lever, causing the mast section to tilt towards the operator's cabin, pressing his neck against the roof of the cabin.

Evaluation of loss	• One worker killed.
Type of contact	• Caught in between objects.
Immediate cause(s)	• Servicing equipment without disconnecting the power supply.
Basic cause(s)	• Failure to implement and comply with repair procedures.
Failure of SMS	• Hazard analysis and risk assessment; WSH practices and procedures; WSH training and competency.

The supplier of the forklift was instructed to improve on the mechanism of the supporting props for the inner mast section to enhance workers' safety.

The supplier had reminded their staff to disconnect the power supply to the forklift when it was not required during repair work.

Develop and implement lockout procedures relating to the inspection, cleaning, repair or maintenance of any plant, machinery, equipment or electrical installation in the factory that, if accidentally activated or energised, is liable to cause bodily injury to any person.

Conduct proper risk assessment prior to the commencement of an operation.

Employers should ensure that their workers have received proper training on safe work procedures relevant to the tasks performed.

Conduct regular checks and supervision to ensure that workers comply with safe work procedures.

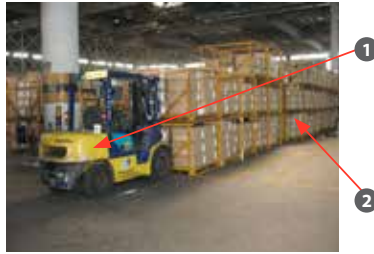
1. Forklift's position prior to pushing the metal racks
2. Deceased was caught in between the metal racks

- The labels of some of the carton boxes were not visible from the side of the metal racks, making it necessary for the tally clerk to go between the rows of racks.
- No communication nor work coordination between the tally clerk and the forklift operator.
- Cartons on the racks blocked the sight of the forklift operator.
- No checks to ensure that there was nobody between the racks before they were pushed to close the gap.

Evaluation of loss	• One worker killed.
Type of contact	• Caught in between objects.
Immediate cause(s)	• Unsafe pushing of metal racks by the forklift; lack of communication between parties working at the same premises.
Basic cause(s)	• Failure to implement safety control measures to eliminate the risk of workers being trapped between the metal racks during the forklift operation.
Failure of SMS	• Hazard analysis and risk assessment; safe work procedures; and WSH training and competency.

The occupier implemented measures to manage the movement of forklifts and workers; provided a designated work area for tally clerks to check the cargo; and required their workers to use reflective vests and safety boots.

Conduct proper risk assessment prior to the commencement of such operations.

Develop safety measures or safe work procedures to ensure the safety of tally clerk.

Ensure adequate communication between parties working at the same premises.

Conduct trainings and briefings to improve WSH competency and awareness.

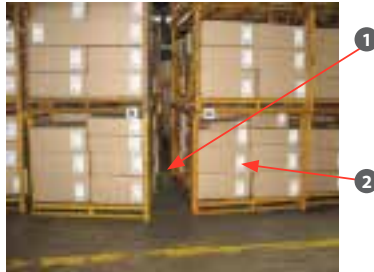
1. Deceased was caught in between the metal racks
2. Labels on carton boxes

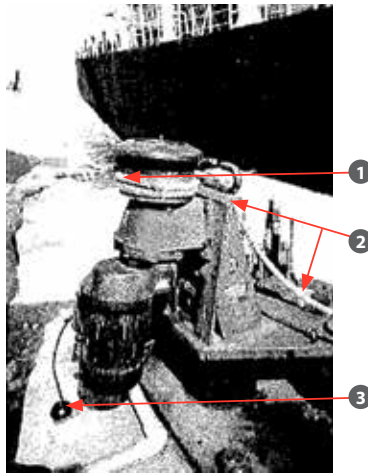
- The fault in the equipment was not detected during pre-operation checks and tests.
- The worker did not release his hand in time.
- There was no emergency "stop" button for the capstan.

1. The left hand of the injured was caught by the messenger rope winding onto the capstan
2. Two workers were here to guide the messenger rope
3. The foot pedal switch was jammed at the time of the accident

Evaluation of loss	• One worker killed.
Type of contact	• Caught in between objects.
Immediate cause(s)	• Defective tool or equipment.
Basic cause(s)	• Inadequate maintenance; absence of emergency stop control.
Failure of SMS	• Maintenance regime; WSH practices and procedures.

Implement an appropriate equipment maintenance programme taking into consideration the working environment for the capstan motor.

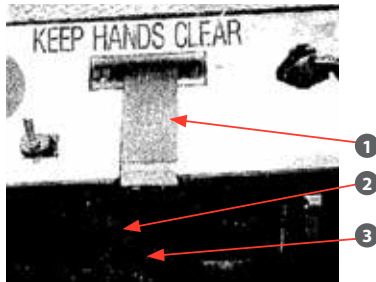
- Failure to assess the risk of testing and operating the faulty remote control.
- Failure to adopt an appropriate method of holding the hook of the tow line to prevent entangling.

1. The strap started to be coiled in shortly after the electrical supply to the tractor was being turned on
2. The tow hook of the tow line
3. The finger of the injured was caught in between the safety catch and the throat of the hook

Evaluation of loss	• One worker killed.
Type of contact	• Caught in between objects.
Immediate cause(s)	• Use of faulty equipment, adopting unsafe work method.
Basic cause(s)	• Inadequate supervision; failure to comply with work procedure.
Failure of SMS	• WSH practices and procedures; WSH training and competency.

- Implement and put in place proper repair and testing procedures.
- Faulty equipment should be serviced by competent personnel.

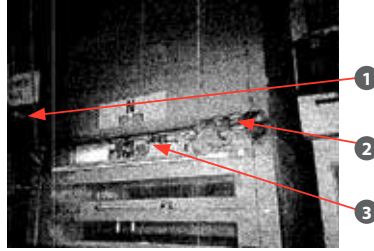
- Failure to follow procedures to have one more team member to handle long and bulky objects.

1. One of the two foldable metal supporting arms
2. The metal supporting arm that the injured was locking
3. The circuit breakers that the injured had reset

Evaluation of loss	• One worker injured – severed finger.
Type of contact	• Struck by machines.
Immediate cause(s)	• Mishandling of panel cover; inadequate manpower assigned for the task.
Basic cause(s)	• Improper work procedures; inadequate supervision.
Failure of SMS	• WSH practices and procedures.

The occupier had replaced the foldable supporting arms with lockable gas springs that would automatically push up the cover and keep it in position once opened.

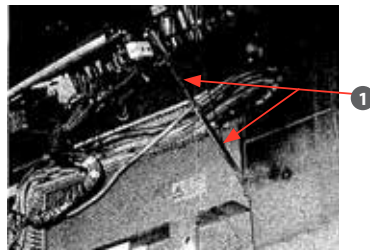
1. The two folding parts of the metal supporting arm

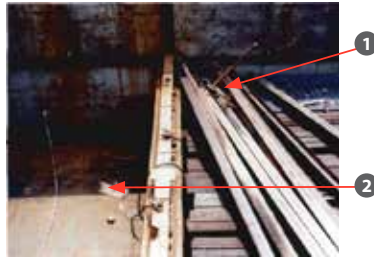
1. The deceased worker was found to be pinned at this location
2. The injured worker was found at the bottom of the cargo hold

Evaluation of loss	• One worker killed and one injured.
Type of contact	• Struck by falling metal beams and falling into lower level of cargo hold.
Immediate cause(s)	• Inadequate protective equipment such as padding for lifting.
Basic cause(s)	• Poor work planning; inadequate assessment of risk.
Failure of SMS	• Hazard analysis and risk assessment; WSH practices and procedures; control of subcontractors activities; WSH maintenance regime.

Implement a maintenance regime for lifting equipment and lifting gear.

Implement and enforce regular supervision and control of subcontractor's activities.

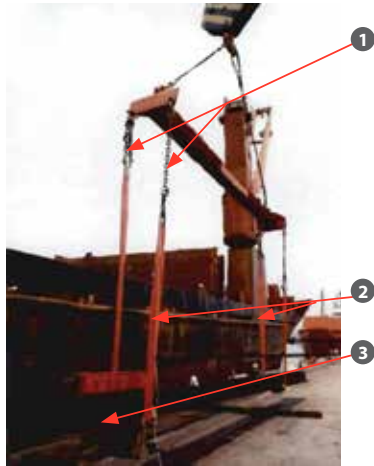
- Poor storage and maintenance might have contributed to the damaging of the webbing slings.
- Absence of padding to prevent effects of point loading and failure of the slings due to localised cutting by the edges of the beams.
- There was no check on the lifting gears prior to work commencement.

1. Chain slings with hook
2. Webbing slings
3. Metal beams

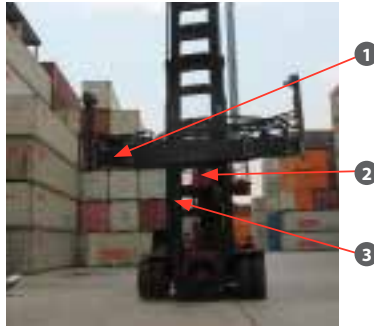
1. Spreader
2. Operator's cabin
3. Mast

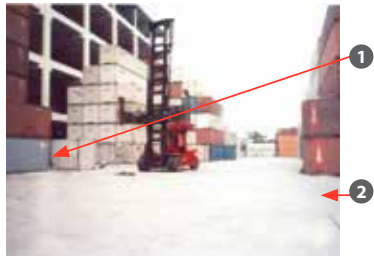
The accident could have occurred when the worker emerged from a gap between two containers and the side loader driver could not stop his side loader in time. At the time of the accident, the worker was not wearing his high visibility vest.

- Poor layout design of the container depot; no properly demarcated driveways, storage area and pedestrian passageways within the depot.
- Traffic management system not in place to control movement of vehicles and people within the container depot.

1. Deceased could have emerged from this gap between the containers
2. Driveway and container storage areas not demarcated

Evaluation of loss	<ul style="list-style-type: none">• One worker killed.
Type of contact	<ul style="list-style-type: none">• Struck by moving vehicle.
Immediate cause(s)	<ul style="list-style-type: none">• Unsafe driving of side loader; high visibility vest not used; no proper demarcation of storage area, passage way and driveway
Basic cause(s)	<ul style="list-style-type: none">• Lack of traffic control management programme.
Failure of SMS	<ul style="list-style-type: none">• Hazard analysis and risk assessment; WSH practices and procedures.

The occupier demarcated special pedestrian crossings along the lanes and required the container checkers and prime mover drivers to wear high visibility vests and adhere to rules and regulations to ensure their own safety.

Conduct regular safety inspections and enforcement to ensure workers comply with safe work procedures and safety rules such as using the designated pedestrian walkways and wearing high visibility vests.

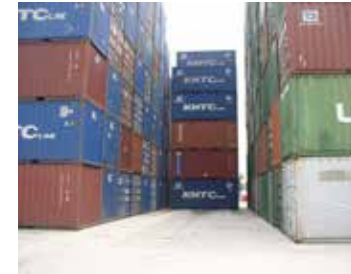
- The side loader operator claimed that he was monitoring the spreader arm of the side loader so as to avoid hitting the containers on his left; thus he was not able to adequately monitor the traffic in front of the side loader and failed to spot the worker who had just emerged from between the containers.
- The mast of the side loader might have obstructed the front view of the side loader operator.
- There was no designated walking path for workers inside the container storage yard. Workers and side loaders were allowed to roam freely.

The side loader reversed from this row of containers just before the accident

Evaluation of loss	<ul style="list-style-type: none">• One worker killed.
Type of contact	<ul style="list-style-type: none">• Struck by moving vehicle.
Immediate cause(s)	<ul style="list-style-type: none">• Unsafe driving of vehicle; no proper access route provided.
Basic cause(s)	<ul style="list-style-type: none">• Lack of traffic control measures.
Failure of SMS	<ul style="list-style-type: none">• Hazard analysis and risk assessment; WSH practices and procedures; WSH training and competency.

Proper layout design to minimise traffic hazards.

Develop and implement a workplace traffic management programme to separate the paths of pedestrians and vehicles.

Conduct regular safety inspections and enforcement to ensure workers comply with safe work procedures and safety rules such as using the designated pedestrian walkways and wearing luminous vests.

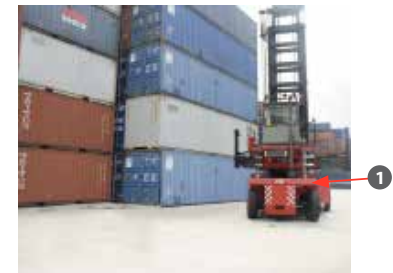
1. The side loader
