17 June 2021, Ref: 2122021

Worker fell through opening at construction site

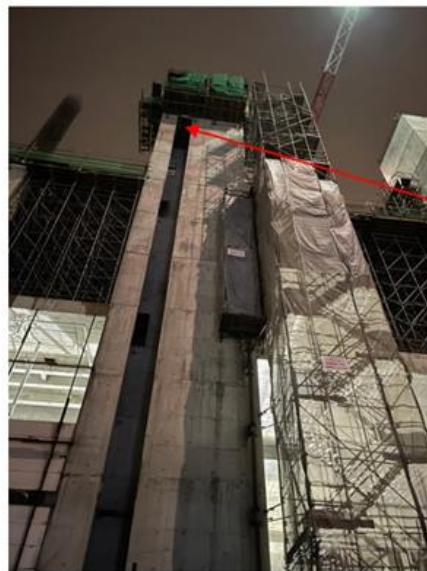
On 10 June 2021, a worker fell 40 metres to his death through a gap in the floor of a warehouse building under construction. The structure used to cover the gap gave way when the worker was crossing the structure. The worker was wearing a full body harness without a lanyard attached.

Overview of the accident scene.

- Block up all sides of structures used to cover gaps (e.g. with hoarding) to prevent workers crossing through the structure.
- Place warning signs near structures used to cover gaps to alert workers of the fall hazard.
- Brief workers on the safe route(s) of access/egress and advise them to stay clear of danger zones.
- Equip each worker with fall protection equipment (e.g. full body harness with lanyard) and ensure that they are anchored when working at height.
- Establish a Fall Prevention Plan (FPP) and a Permit-To-Work (PTW) system for hazardous works at height.

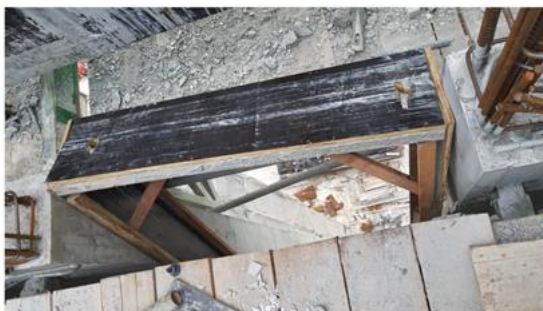
Structure used to bridge the gap.

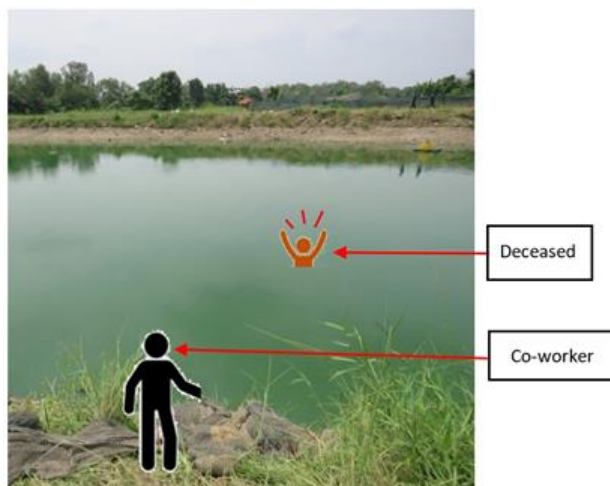
On 11 June 2021, a worker drowned while he was harvesting fish in a fish farm. He was wading in the pond harvesting the fish while a co-worker was on the shore.

Overview of accident scene.

- Workers who work in water, such as harvesting fish, must be qualified swimmers.
- Life jackets must be worn when working in or near water.

- Workers must check and be aware of the water depth.
- Life-saving equipment, such as life buoys and life lines, must be available on site.

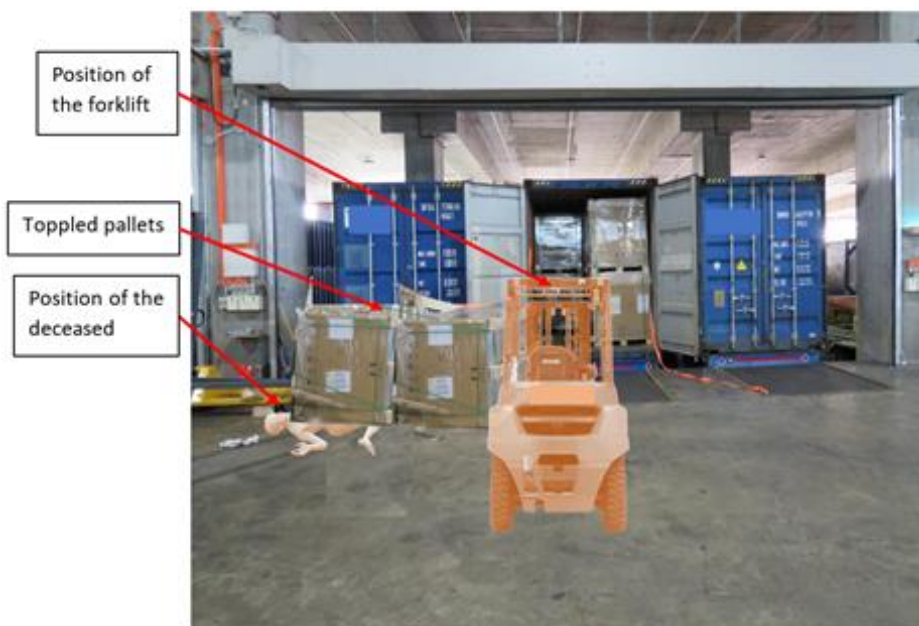
On 14 June 2021, a forklift operator was unloading palletised goods from a container using his forklift. The goods were double-stacked on the pallet and bundled using strapping tape.

With the palletised goods still on the forklift, the operator dismounted from the forklift, and was beside the goods when the goods toppled and pinned him to the floor.

Overview of accident scene.

- Never stand near palletised goods that are above shoulder-height.
- Check that palletised goods are firmly secured to avoid them collapsing during loading or unloading.
- Position palletised goods across both forks properly to avoid them collapsing while on the forklift.

- Ensure the forklift operator is trained and competent to perform loading and unloading operations.
- Palletised goods should be moved individually.
- If pallets are double-stacked, consider moving them only if they are firmly secured, and with the load positioned evenly and stably on the forks.
