# CASE STUDIES

METALWORKING INDUSTRY

WSHCOUNCIL

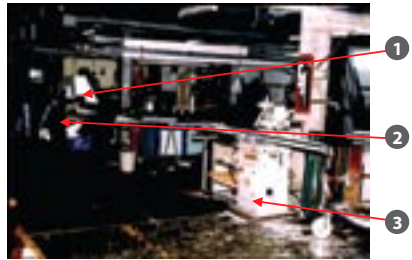
A general worker was operating a cutting machine to cut aluminium strips for scraps. While the worker was cutting a piece of 960mm long x 18mm wide x 3mm thick aluminium strip with the circular saw of the cutting machine, an aluminium strip which was pointed at both ends, flew off suddenly towards another worker, who was operating a drilling machine nearby. One end of the pointed strip pierced the drilling machine operator's neck below his left ear. The drilling machine operator died on the same day.

1. The 960mm long x 18mm wide x 3mm thick aluminium strip flew from here towards drilling operator
2. General worker was using this cutting machine to cut aluminium strips
3. Drilling operator was operating this drilling machine about 6.2m away from the cutting machine which was on his left

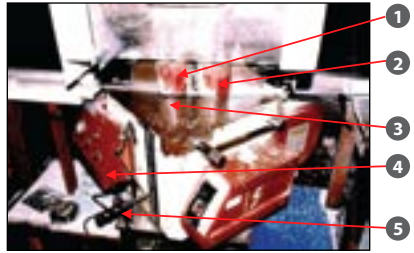
- The clamping device of the cutting machine involved in the accident was not properly maintained, i.e. not properly adjusted to enable it to clamp the work piece in position.
- The failure to clamp the work piece had resulted in the circular saw blade causing the work piece to be propelled at high speed and fatally injuring the drilling machine operator.

1. This left-hand side plastic block of the pneumatic clamp is 7mm above the worktop
2. This right-hand side plastic block of the pneumatic clamp is 4mm above the worktop
3. The slot in the worktop of the cutting machine
4. The control box of the pneumatic clamp
5. The handle for raising the concealed blade of the circular saw was mounted beneath the worktop of the cutting machine

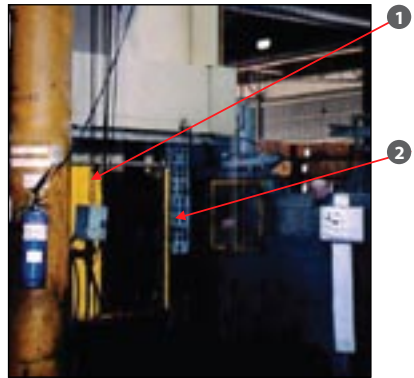
1. Sliding door
2. Control panel

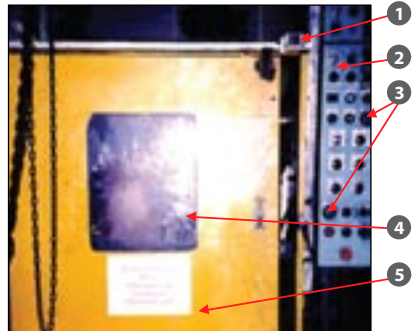
1. Limit switch  
\* Installed after the accident
2. Control panel
3. Two hand control buttons
4. Looking glass
5. Sliding door

- The sliding door was not fitted with any interlock which would have stopped the machine when the door was opened during the automatic mode of operation.
- Need for the safety interlock on the sliding door was highlighted before the accident but the installation was not carried out due to the different electrical control circuitry from the other die-casting machines.
- The worker had been trained to stop the machine first before attempting to access the die area. The worker bypassed the procedure of placing the machine on the manual mode of operation prior to opening the sliding door to access the die.

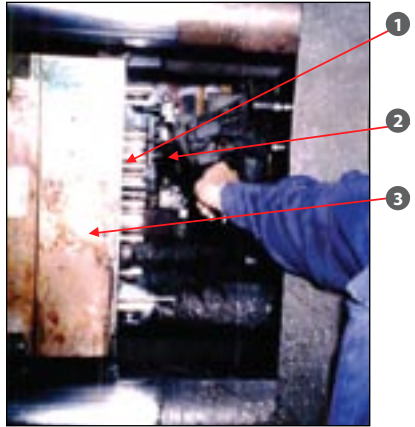
At that time, the dies were in the "open" position. Using a spanner held in his right hand, he knocked off the overflow chip from the moving die. Suddenly, the moving die closed onto the fixed die prior to the commencement of the machine's second cycle of operation. The injured was not able to retract his hand in time and his right palm was caught in between the die and was crushed.

1. Ejector pins
2. Spanner
3. Moveable die

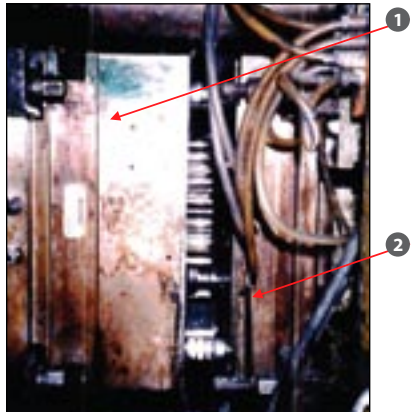
1. Moveable die
2. Stationary die

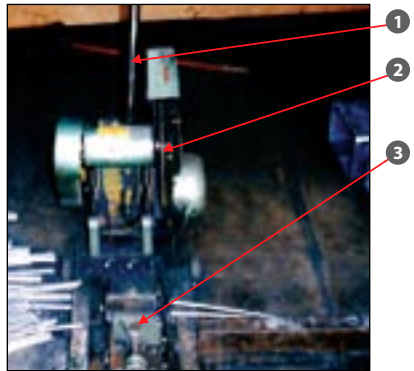
The worker was cutting a piece of a flat bar with the aid of the abrasive disc cutter. The worker used his left hand to operate the handle of the disc cutter and his right hand was holding down the flat bar that was clamped on the vice. While cutting, the machine suddenly jerked violently. However, instead of stopping the cutting operation, the worker attempted to steady the disc cutter by holding down the flat bar with his right hand and continued with the cut. However, the machine did not stop jerking and the worker then decided to release his right hand from the disc cutter and forego the cutting but was too late. On retrieval of his right hand from the machine, his right thumb came into contact with the rotating abrasive disc and the thumb was severed on the spot.

1. The handle for moving the abrasive disc for cutting
2. The abrasive disc
3. The vice for clamping material for cutting

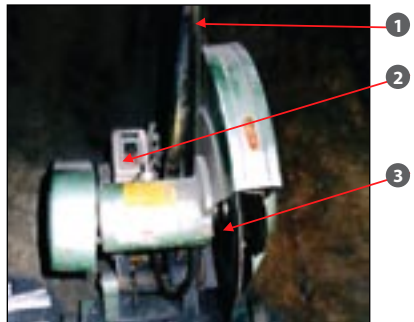
1. The handle for moving the abrasive disc for cutting
2. The "on/off" push button control for activating the disc cutter
3. The metal guard that exposed the bottom half of the abrasive disc for cutting

- The disc cutter vibrated violently probably because it was either not balanced or was not maintained properly.
- The unsafe act of the worker also contributed to the cause of the accident. He had attempted to steady the disc cutter by holding down the flat bar clamped on the vice of the disc cutter and continued with the cutting when he should have stopped the operation.
- The worker knew that he had to clamp the flat bar on the vice before he starts cutting the flat bar. He should not have held down the flat bar with his right hand when he found the machine jerking violently as his right hand would come into contact with the abrasive disc of the machine.

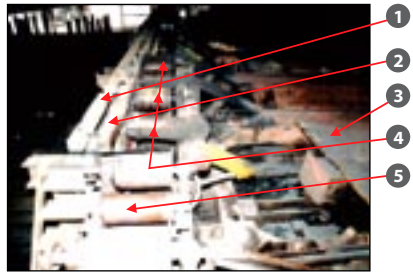
A worker and his co-worker were carrying out upgrading works to a charging table while the supervisor attempted to re-align the steel guide of the roller conveyor. As the steel guide was heavy, the supervisor requested the overhead travelling crane operator to assist with the positioning by using an electro-magnet lifter. Suddenly the guide fell onto some rollers and activated a limit switch that controlled the kicking mechanism at the charging area. This mechanism "kicked" the guide in the direction of the two workers. The worker was pinned by

1. Outer steel guide
2. Inner steel guide (involved in the accident)
3. The deceased and his co-workers were working at the platform
4. Rollers conveyor
5. Limit switch roller

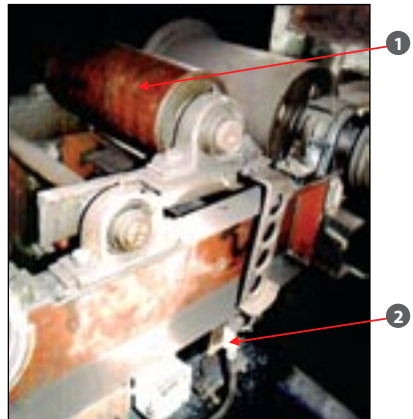
1. Limit switch roller
2. Limit switch that activated the kicking mechanism

- The factory occupier did not implement lockout procedures.
- The supervisor did not switch off the kicking mechanism of the charging areas.
- The supervisor did not restrict the movement of the guide by securing it.

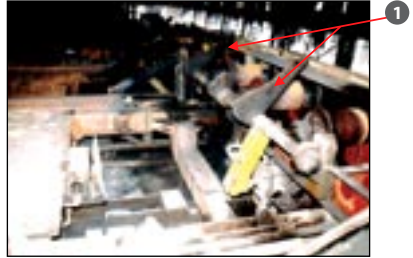
1. Kickers

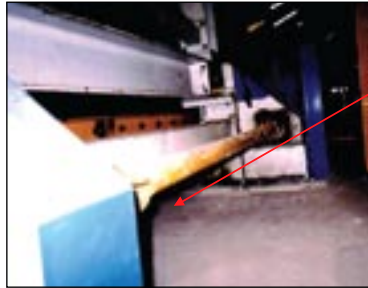
- The steel mesh machine was fenced and various parts of the machine within the fencing could move in various directions when activated.
- Two sliding gates were part of the fencing. The gates were provided with interlocking sensors. However, the interlocking sensors were not connected and hence not in working order.

1. The accident happened here

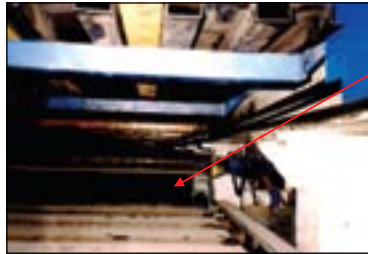
1. The deceased was found on the floor underneath the machine here

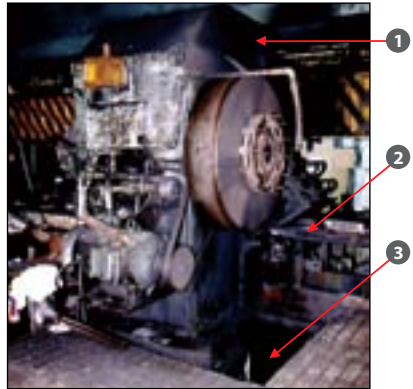
1. Cold Shear machine
2. Shear blade
3. Opening at the Cold Shear machine (Opening A)

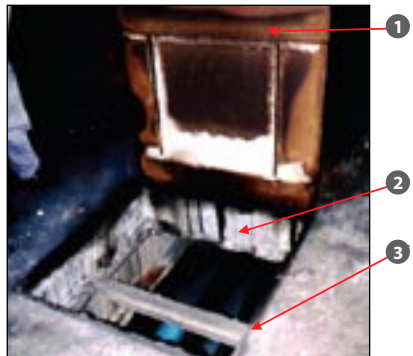
- The co-worker did not know that there was another opening (Opening B) under the steel plate and he did not notice the opening when he was lifting as his body was bent forward during the lifting.

1. Cover
2. Opening B
3. Groove

- The opening (Opening B) was part of the factory layout design. The opening was meant for electrical wiring and piping installation. The cover for such an opening should have been secured to avoid inadvertent removal.

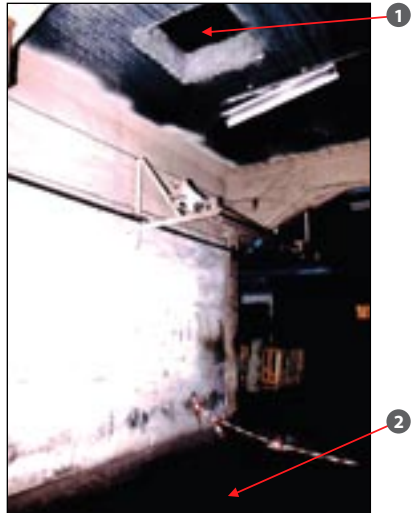
1. Opening B
2. The deceased landed here

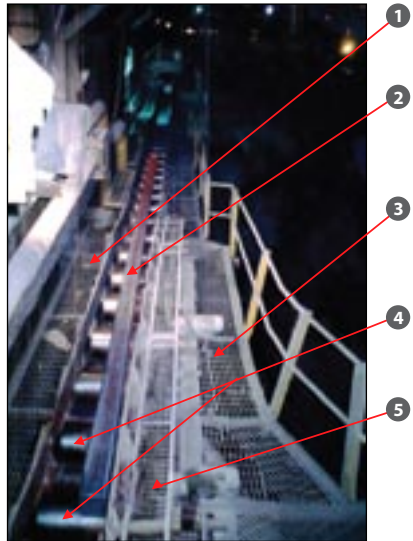
1. Inner walk platform
2. Billet
3. Outer walk platform
4. Rollers
5. Protective cover

- There was inadequate fencing provided on the belts and pulleys system driven by the motor.
- The worker was walking along the inner walk platform that was about 450mm wide with cable tray

carrying cables running along the inner walk platform at about 400mm high. After taking into account the space used by the cables and cable tray, the effective space for walking along the inner walk platform was about 250mm.

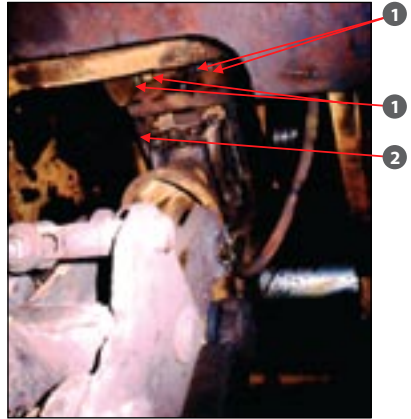
1. The rollers with four pairs of roll passes found here
2. The roller guide that had to be shifted to a new pair of roll passes

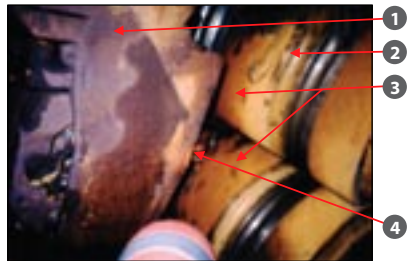
1. The roller guide
2. A brand new pair of roll passes
3. The two rollers with four pairs of roll passes
4. The guide sheave that the injured was feeling with his right hand

of the guide sheave. While doing so, his right hand was caught between the rotating rollers and the roller guide. The worker shouted for help and his co-workers came to help. On retrieving his right hand from the rollers, the worker found that the distal phalanges of his right middle and ring fingers were badly crushed.

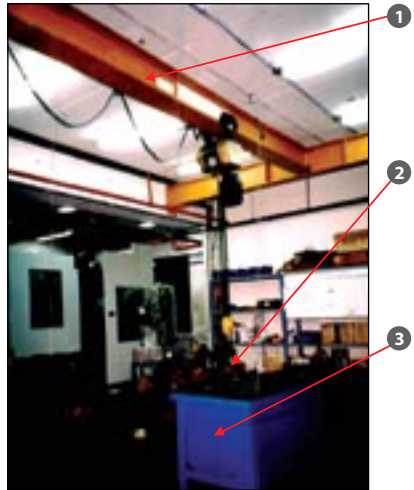
- The mould base was 460mm wide x 385mm long x 430mm high and weighed about 400kg.
- The worker used a lifting belt to tie to the two eye-bolts of the mould base to lift up the mould.
- The overhead crane had been examined by an approved person one month prior to the accident.
- The worker had been working for about three months in the factory and had four years of similar experience prior to joining the company. He had been trained on the safe operation of the overhead crane when he started work with the company.

1. Overhead crane
2. Lifting belt
3. Working table

- The worker said that when the upper half mould base was lifted up to a height of about 150mm above the working table, the mould suddenly slipped and hit his right ring finger.
- The probable cause of the accident may be due to the imbalance of the mould when it was being lifted, which caused the mould to slip and hit the worker's finger.

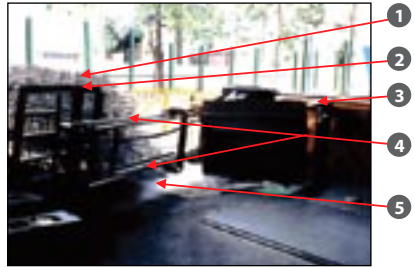
- The forklift truck was last serviced two months earlier by a contractor;
- The forklift truck was rated 3ton, the total weight of the stack of wire mesh was about 720kg, measuring 6500mm long and 1390mm wide;

1. The stack of wire mesh the operator was transporting with the forklift
2. The backrest
3. The overturned forklift truck
4. The mast
5. The deceased was pinned here under the mast

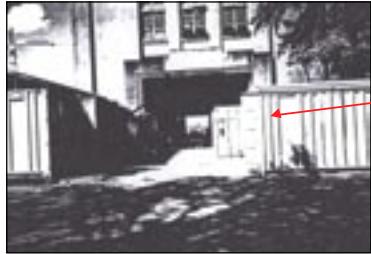
- The length of the steel angle bars was measured to be about 6m. The width of the access path for the forklift truck was measured to be about 4.4m.
- The worker alleged that he had indicated to the supervisor that it would be difficult to carry out the transferring operation as the angle bars were too long for the access

1. Containers

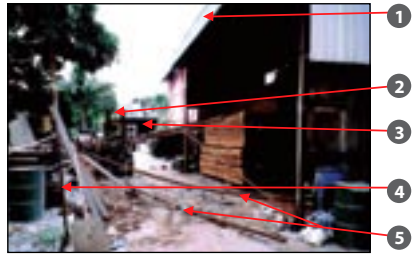
1. The shelter was extended from the roof of this timber store over the entire driveway fronting the timber store
2. Position of the forklift truck after the accident
3. The main gate of the factory
4. This steel column of the shelter was still in its upright position next to the kerb while the other column was toppled by the forklift truck
5. Structural members of the collapsed shelter

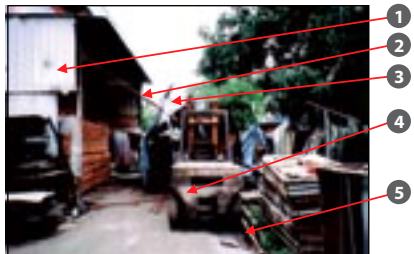
1. The material store
2. The fallen steel rafter of the collapsed shelter landed between the mast and the driver's cabin of the forklift truck
3. The shelter extended from the roof of the timber store over the entire driveway fronting the timber store

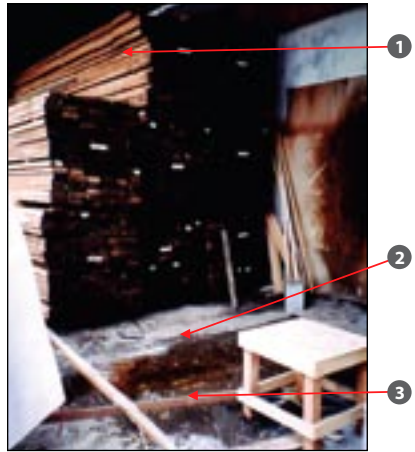
1. On the day of the accident the supervisor ferried these timber planks to this timber store from the lorry parked outside the main gate
2. At the time of the accident the supervisor was here checking and counting the timber planks in the store
3. This fallen rafter hit the supervisor

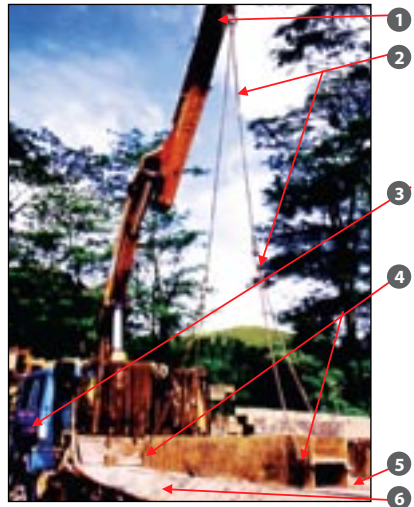
- The accident could be caused by the unsafe rigging method adopted by the lorry crane driver. He had rigged a stack of five pieces of H-piles of different lengths by securing the hooks of the chain slings to the bottom-most H-piles.

1. The crane of the lorry crane used for the unloading
2. Two-legged chain sling
3. Driver's cabin
4. The rigging of the H-pile was simulated
5. Tailboard end
6. Left sideboard

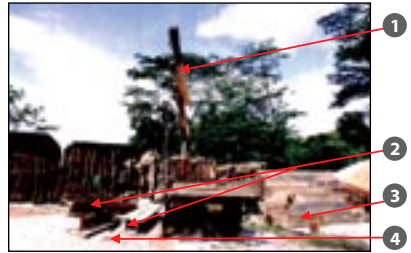
1. The lorry crane
2. Four pieces of H-pile toppled to the ground
3. Stack of H-piles before the accident took place
4. Fellow driver was fatally wounded here

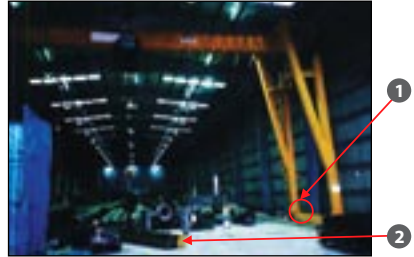
- The crane was equipped with a warning siren, blinking lights and ultrasonic sensors. These devices were to alert people in the shop and warn them to stay away from the approaching crane during lifting operations. The devices were tested after the accident and were found to be in good working condition.

1. Accident occurred here
2. Load carried by the crane at the time of accident

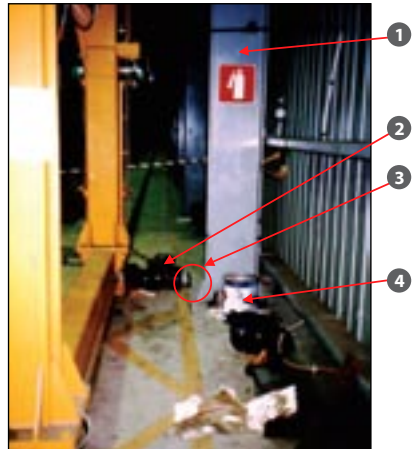
1. Columns
2. Motor of the crane
3. M was found here
4. Steel bucket

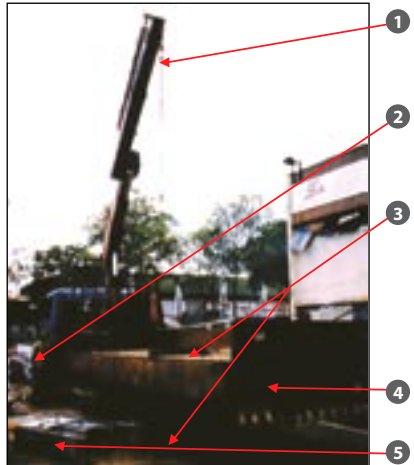
1. The lifting gear used to rig the fifth scrap electrical DB prior to the accident
2. Lorry crane operator claimed that he was standing here operating the crane (lorry loader when the accident occurred)
3. The deceased was standing here guiding the hoisted fifth scrap electrical DB when he accidentally fell to the ground
4. The lorry crane involved in the accident
5. This was the scrap electrical DB that dislodged from the lifting gear and fell onto the deceased who was on the ground

- The lifting gear used to hoist the DB comprised a two legged chain sling attached to an oval ring at the top end and two open-ended hooks (without safety catches) at the bottom end. One of the hooks was found to be defective – the hook had deformed (it had a widened throat opening) beyond its original shape.

- Investigations revealed that the worker could have probably used the chain sling with the defective hook to rig the fifth scrap DB prior to the accident, thus causing the hook to dislodge from the chain sling and resulting in the accident.

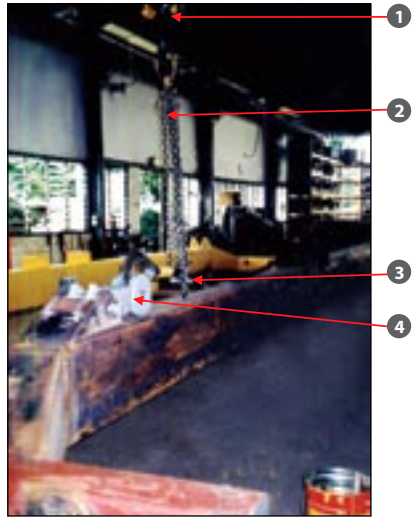
- The worker had worked in the company for about one year prior to the accident and had done similar installations on many occasions.
- Investigations revealed that the worker had probably placed part of the wire rope on top of the gravity lever and slackened the tension on the chain sling. Thus, when he was retrieving the bolt, he could have moved the wire rope or chain sling and caused the end of the wire rope to slip off from the top of the gravity lever.

1. Hook block of overhead crane
2. Chain sling
3. Wire rope
4. Gravity lever

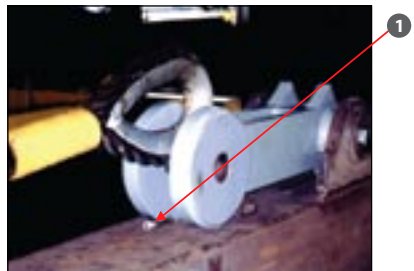
1. Bolt to be retrieved

- The cause of the accident was due to the wrong method of work adopted by the worker when attempting to retrieve the bolt during the lowering of the wire rope into the gravity lever.

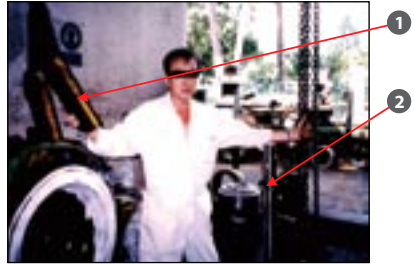
1. Control pendant
2. Valve spindle

- The cause of the accident was due to the worker holding the chain sling with his left hand while he operated the control pendant of the overhead crane to hoist up the valve spindle. In his haste to lift up the valve spindle, he could have depressed the button slightly further such that the hoisting was carried out at the higher speed. He did not realise that part of his left middle finger was placed in the gap between the chains. As such, when the chain sling tensioned, his finger was caught in between the chains.

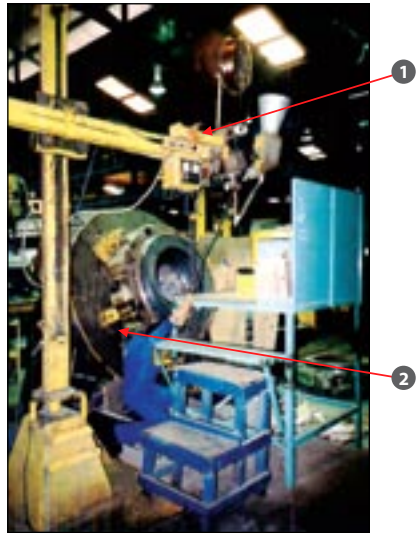
1. Lifting gear
2. Turning-table mounted with a cylinder cover

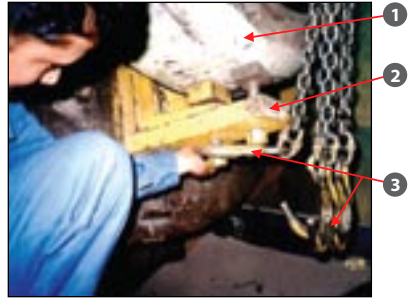
1. Cylinder cover
2. Chuck of turning-table
3. Eyehooks of lifting gear

- The factory occupier had failed to ensure that all workers were fully instructed on the proper rigging method for lifting up the turn-table with a crane, and the dangers and precautions to be observed in connection with such work.

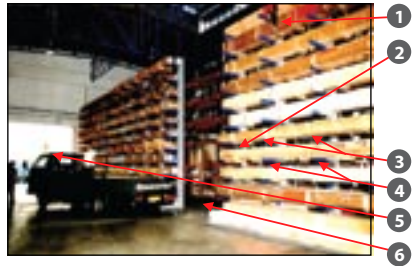
A lorry driver was at a factory to collect some stainless steel pipes from the warehouse. The store assistant, directed the lorry driver to park the lorry with its tail board near one end of a 6m high cantilever rack. The rack was used for storing crates of pipes on its arms. The store assistant was standing on the third level arms of the cantilever rack near the tail end of the lorry. With his right hand gripping the under side of a fifth level arm of the rack, the store assistant used his left hand to pull out pieces of pipes one at a time from a crate placed on the fifth level arm of the rack. The lorry driver took the pipes from the store assistant while standing on the lorry and placed them onto the lorry. While the store assistant was reaching for the crate of pipes stored on the eighth level arms of the rack from the fifth level arm, he fell from the rack and landed on the concrete floor between the rack and the lorry. The store assistant succumbed to serious head injuries a few days later in the hospital.

1. The 6m high cantilever rack that was used for storing crates of pipes on its arms
2. The store assistant was standing here on a crate stored on the third level arms to pull out piped from the crate stored on the fifth level arms
3. Fifth level arms
4. Third level arms
5. The lorry was parked here to collect the pipes
6. The store assistant landed here on the concrete floor

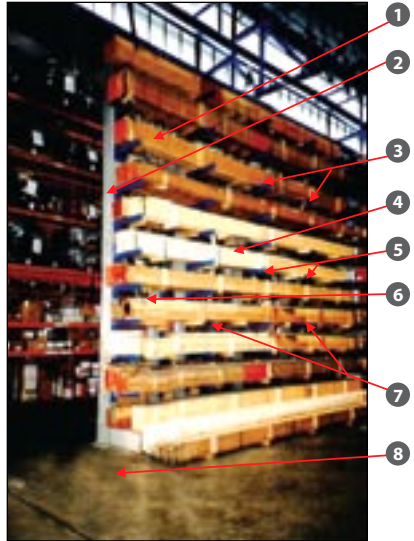
1. The crate of pipes that fell was stored on the eighth level arms of the cantilever rack
2. One of the five uprights of the rack
3. Eighth level arms
4. According to the lorry driver the crate of pipes to be transported was stored here on the fifth level arms of the rack
5. Fifth level arms
6. The store assistant was standing here on a crate stored on the third level arms to pull out pipes from the crate stored on the fifth level arms
7. Third level arms
8. The store assistant landed here on the concrete floor

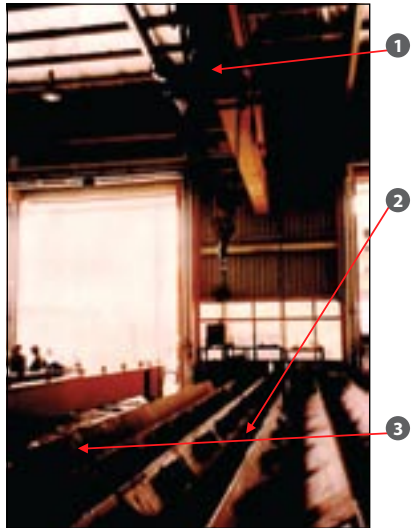
1. Overhead crane
2. Deceased was found here
3. Steel beams

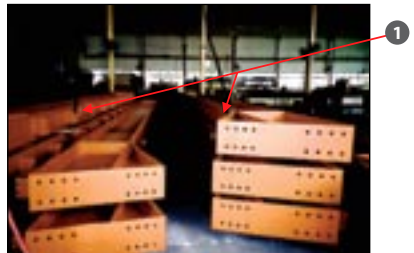
1. Steel beams

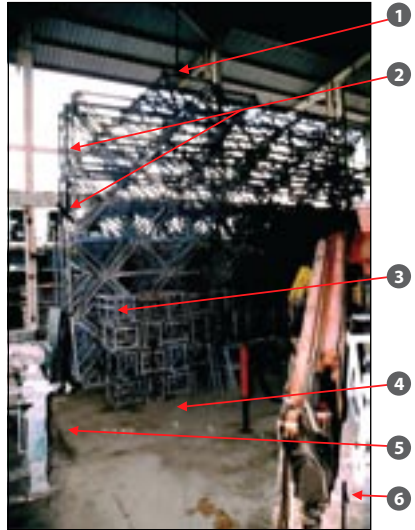
1. The ninth level of the stack of beams was not fully stacked
2. The beams at the end of the stack were stacked upright
3. The stack of masts in front of the stack of beams
4. A fallen beam landed here and hit the head of S
5. M landed here
6. Lorry Crane

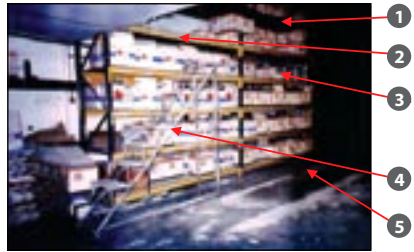
1. The shelf above the material rack
2. The fifth shelf
3. Carton box containing epoxy powder was placed here
4. The stepladder. The co-worker placed it here to go up to the fifth shelf of the material rack
5. The co-worker was found lying here after the accident

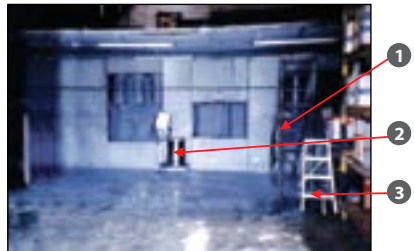
1. The stepladder
2. The electrostatic powder coating machine
3. The 'A' frame ladder

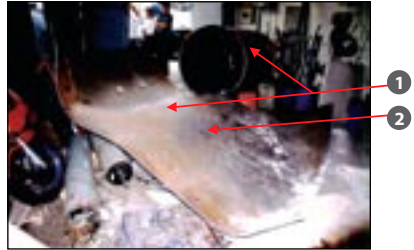
1. Two 9-mm steel plates formed the vessel shell
2. One of the steel plates had 'opened' up after the accident

- The refrigeration plant pressure receiver that had ruptured was about 330cm long and about 93cm in diameter. The shell was made up of two 9mm-thick steel plates welded together. After the accident, one of the steel plates of the shell had opened up completely and the 12mm thick dish-end that was joined to it was

- completely detached and found a distance away.
- The factory owner revealed that the pressure receiver was operated at pressures up to 15 bars. There was no design calculation.

- The workers had fabricated the vessel based on a schematic drawing and a Bill of Materials.
  - Examination of the weld seam of the damaged pressure receiver revealed that there was lack of penetration and lack of fusion of the welds into the parent metal.

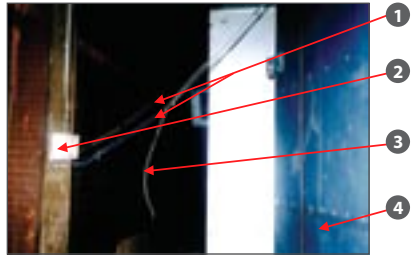
Some workers were preparing to shift an aluminium container to a new premise. One of the workers went to the back of the aluminium container to remove the extension cable from a double 3-pin electrical socket outlet of 230 volts. The extension cable was connected to a fluorescent light and a refrigerator inside the container. About 10 minutes later, his co-worker realised that the worker who went to the back of the container had not returned. The co-worker then went to the back of the container to look for him and found him lying motionless on the floor. The worker was pronounced dead by paramedics upon their arrival at the scene. According to the autopsy report, there was an electric mark over the palmar surface of the worker's right hand thumb. The cause of death was stated as electrocution.

1. Two electrical wires of the fluorescent light that was directly connected to the electrical socket outlet
2. The electrical socket outlet of 230 volts
3. Disconnected grey wire
4. Aluminium container

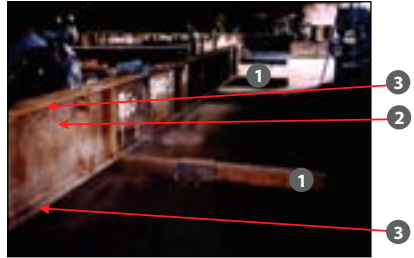
1. Supporting I-beams
2. Web of the I-beam
3. Flange of the I-beam

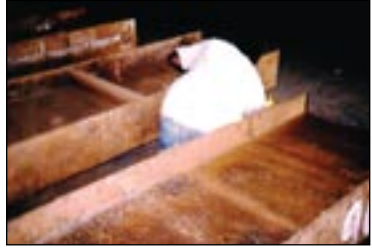
Photograph showing the position of the deceased during the accident (simulated by the co-worker)
