JIVZ Forum #7: Process Safety Local Case Studies + Learning Points

Er. Nicholas Yip

Major Hazards Department
Occupational Safety and Health Division

Local Case Studies & Learning Points

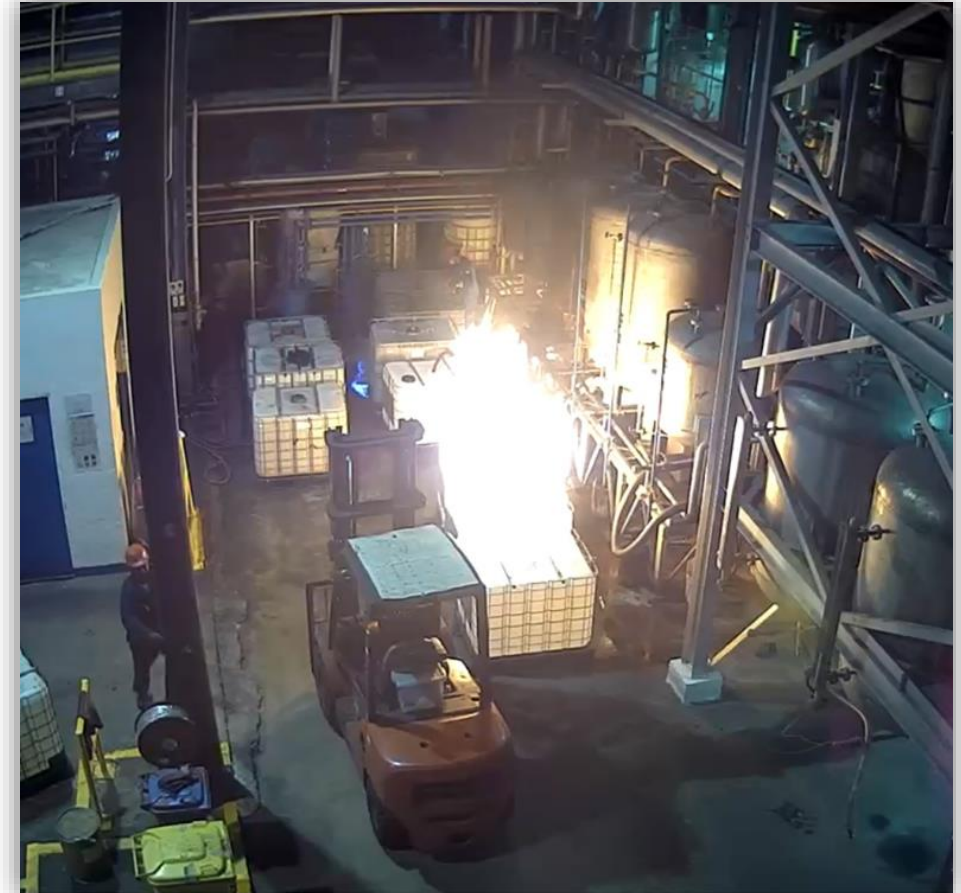
1. Flash Fire due to Static Discharge

- **Electrostatic ignition** of flammable vapours occurred when flammable liquid was discharged into **plastic IBC** from a product tank.
- Investigation revealed that the main factor was due to **inappropriate use of plastic IBC** for handling flammable liquid.
- Operator failed to **ground the metal cage** of plastic IBC and failed to immediately **clean up flammable liquid spills** which has earlier overflowed from product tank.
- **Poor operating practices** contributed to presence of flammable atmosphere around work area (e.g. operator allowed discharge of product onto the floor to drain off water first. The draining stopped only when flammable liquid was observed to be evaporating off the floor)

- **Semi-conductive IBCs** or **metal IBCs** should be used to store flammable liquid. Plastic IBCs must never be used for storing flammable liquids.
- A thorough **risk assessment** must be carried out to consider the possibility of a flammable vapour or aerosol mist being produced from the liquid while taking into account the flashpoint and process parameters such as temperature and pressure. **Hazard of electrostatic discharges** must be considered as well.

- **Grounding clamps** and **conductive hoses** used must be checked for its electrical continuity at regular intervals by competent personnel.
 - Splash filling should be avoided by **bottom filling** via an earthed conductive fill pipe or via grounded dip pipe. At the start of the discharging process, the linear velocity of the system should be no greater than 1 m/s until the inlet pipe is fully submerged.

- Operators should be equipped with **personal gas detectors** when working in potentially flammable atmosphere for early detection.

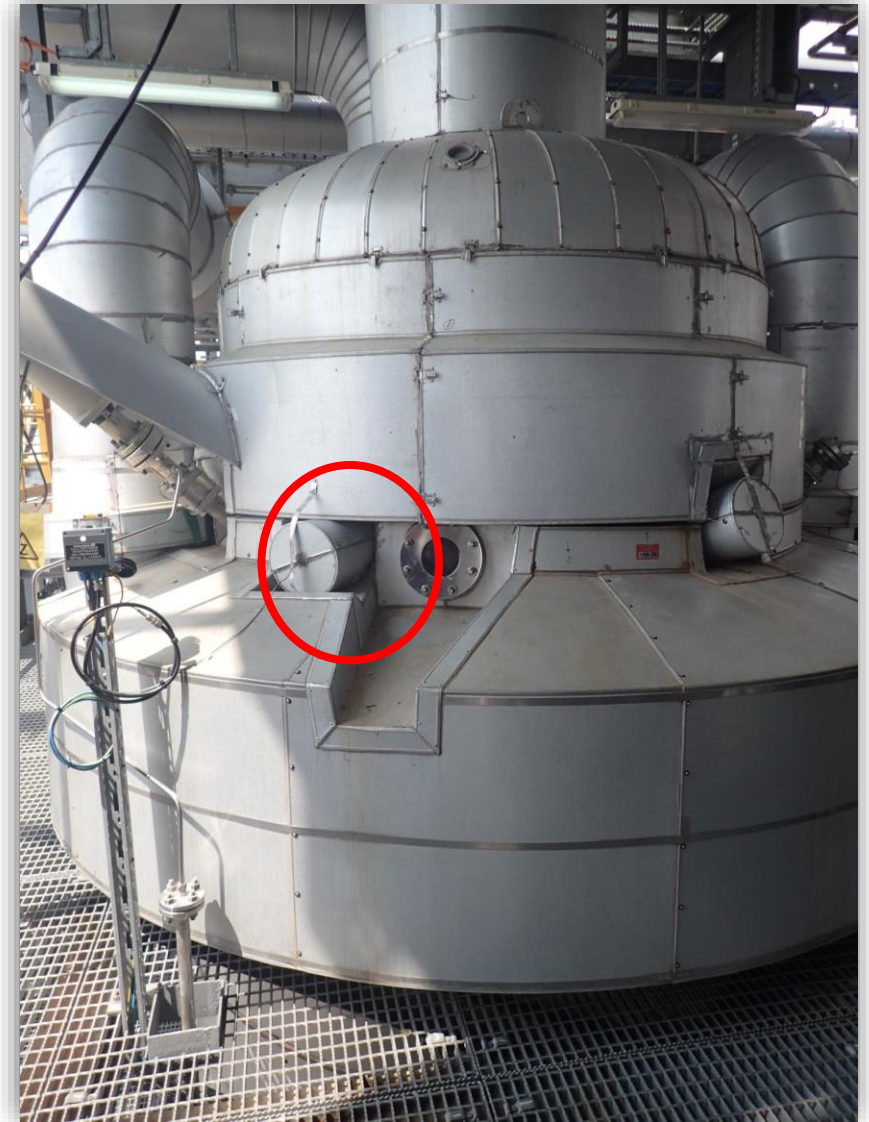
2. Toxic Exposure during Maintenance

- Three employees and one contractor were **exposed to highly toxic gas** during leak check of a reactor sight glass. The check was conducted following replacement of a sight glass that turned opaque with use.
- Investigation revealed that reactor was **not completely gas-free** due to a **passing valve**. **Toxic gas backflow** from downstream vessel into reactor. The passing valve issue was known but the **risk assessment** failed to include **safety impacts** on maintenance activity.
- Other findings include:
 - Lack of positive isolation between reactor and downstream vessel
 - Permit failed to cover the leak test job (only up to replacement job)
 - Lack of SWP developed for leak test job
 - No alarm raised by workers when personal toxic gas detector sounded
 - Alarms were raised by several fixed toxic gas detectors to the DCS but no actions were taken by those in control room

Passing Downstream Valve

- Repair or replace leaky isolation valve promptly.

Positive Isolation

- Explore mechanical solutions to achieve positive isolation of reactor from downstream system due to large piping (i.e. >30”).

Risk Assessment and Procedure

- Train all involved on importance of conducting RA to cover all risks and communicating risks, prior to starting job.
- Develop leak test procedure to minimise toxic gas presence in downstream system.
- Verify gas-free status within work scope.

DCS Alarm

- Display fixed detector alarms more prominently in the control room.

Emergency Response

- Re-train to inculcate right behaviour and response following detection by personal toxic gas detector.

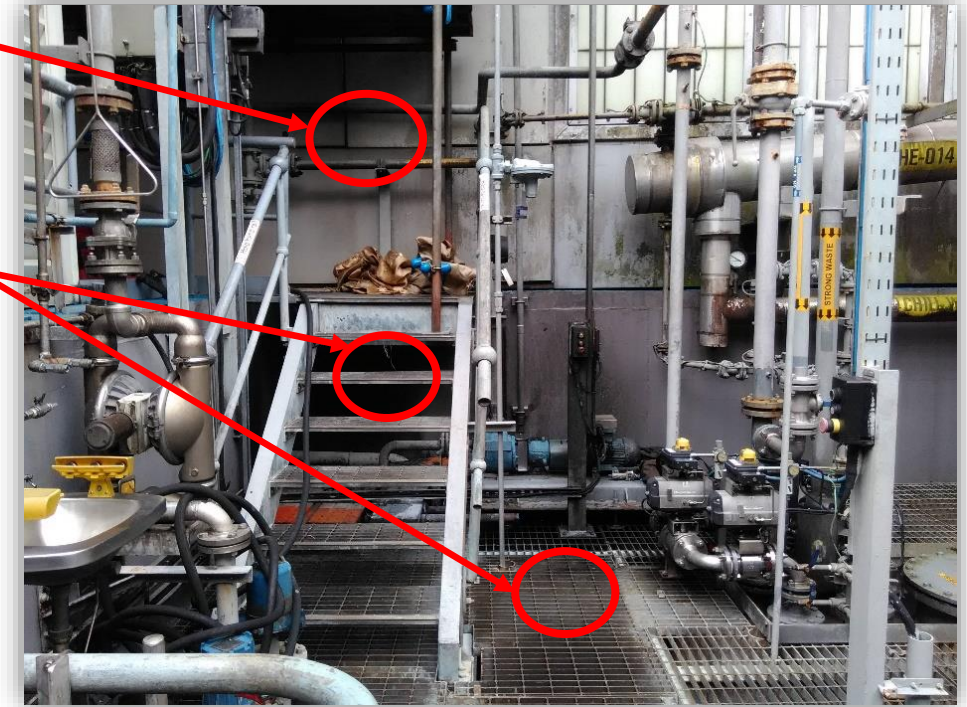
3. Flash Fire during Hot Work

- A group of workers was carrying out hot work when a **flash fire** broke out. Two workers suffered burns and were conveyed to the hospital.
- Investigation revealed that there was a leak at the **strainer** beneath one of the waste tanks. This resulted in the **accumulation of flammable gas** in the area, which was ignited during hot work.
- Prior to incident, there was a **previous near-miss** where the strainer leaked as the solvent in the waste tank corroded the **O-ring** in the strainer cover. The O-ring was replaced, but the **valve handle seal**, which could also be corroded by the solvent, was not identified and replaced, resulting in the new leak that occurred.

Location of hot work

Location of injured workers

Near Miss (NM) Reporting	Management of Change (MOC)	Hot Work Permit	Gas Detectors	Training	Personal Protection
<ul style="list-style-type: none">• Identify root cause and put in measures that address root cause of all NM incident reports.• Identify materials or components of tank strainer could be corroded by the solvent in the tank.	<ul style="list-style-type: none">• Measures identified through NM reporting need to be managed.• MOC assessment includes assessing the scope for change.• This includes systemically identifying and replacing incompatible seals used plantwide.	<ul style="list-style-type: none">• Conduct gas checks and implement other control measures• Prevent fires and explosions, before issuing any hot work permit.	<ul style="list-style-type: none">• Install fixed gas detectors at strategic locations near hot work.• Equip at least one worker carrying out hot work with a portable gas detector.	<ul style="list-style-type: none">• Ensure workers are familiar with the SWP before starting work.• Otherwise, provide the workers with refresher training.	<ul style="list-style-type: none">• Provide suitable PPE, such as fire-retardant clothing to all workers performing works involving flammable substances.
