# CASE STUDIES

## MARINE INDUSTRY

WSHCOUNCIL

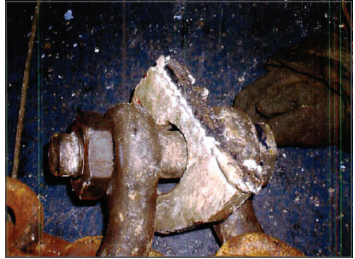
The lifting lug gave way along its welding joint, detaching the elbow pipe.

- The lifting lug was sent for failure analysis. It was found that the welding between the lifting lug and the elbow pipe was inadequate, and was unable to sustain its load during the lifting operation. As a result of overloading, the elbow pipe detached itself from the lifting lug.

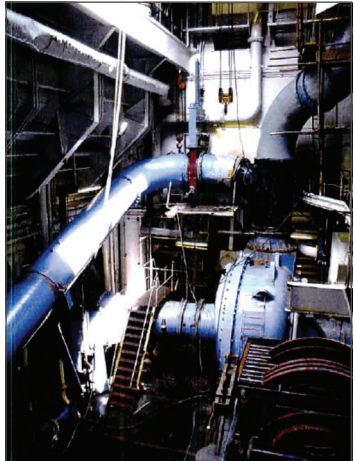
Overview of the accident scene.

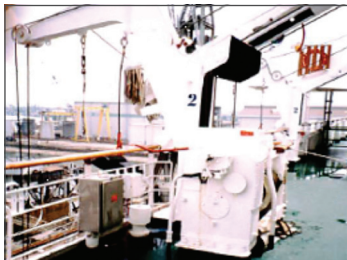
Winch system which was used to lower the lifeboat.

- The safety system failed to function as intended.
- Interlocking device of the winch system failed due to a limit switch overrun. Maintenance and inspection of the limit switches was found to be inadequate and their activation point limits overlooked.

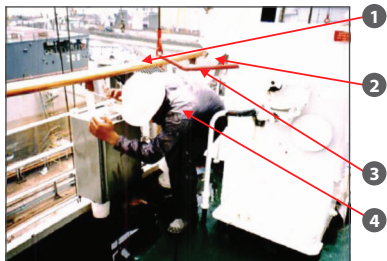
Deceased was struck on his head by the moving metal handle when he attempted to get out of the narrow space he was working in.

1. Shipside railing.
2. Constrained space.
3. Metal handle.
4. The deceased's position when crouching out & re-enactment.

- Detachable metal handle was not removed after the alignment work.
- Deceased exited the work area through an unsafe path that exposed him to risks.
- Lack of proper communication or coordination between workers.

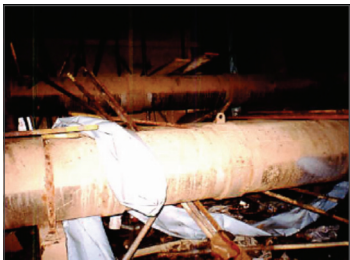
The scaffold tubes struck a structure and fell while they were being winched up.

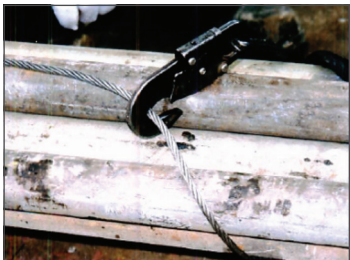
Snap hooks could be left open if not positioned properly.

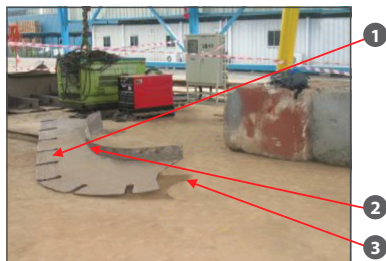
Overview of accident scene.

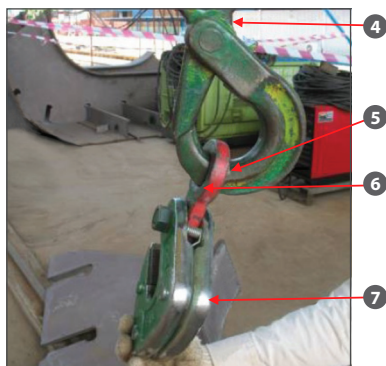
The clamp used was not compatible with the hook of the chain sling.

1. The fifth web frame which slipped out of the clamp.
2. Location of the horizontal clamp.
3. Position of the deceased.
4. Hook of the chain sling.
5. The horizontal clamp could not "sit" vertically on the hook of the chain sling as the base of the hook is thicker than the eye of the clamp.
6. Eye of the clamp.
7. Horizontal clamp.

- The control measures stated in the risk assessment, Safe Work Procedures and toolbox briefings were not implemented.
- The rigging method of the web frame was inadequate. Only one horizontal clamp was used when lifting the web frame which, due to the frame's irregular shape, did not allow for a firm grip on it.

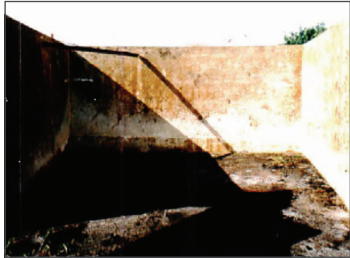
Close-up view of the other uncut U-shaped scrap steel structure.

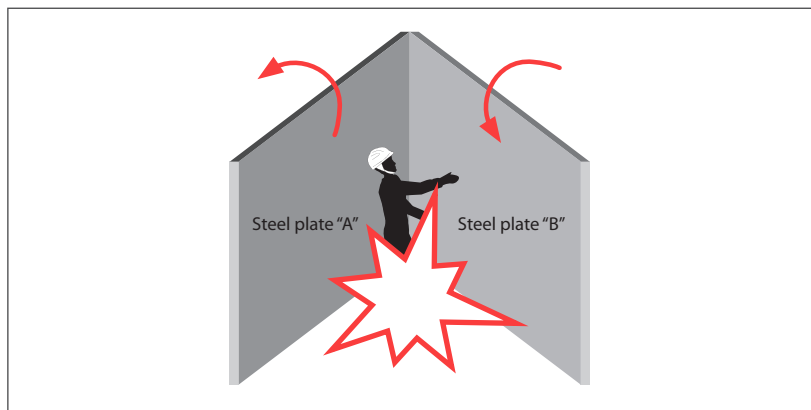
Plates A and B were not supported to prevent toppling when the deceased cut through them.

- The yard manager had instructed the deceased to use the forklift to support the plates during cutting. However, he did not explain or demonstrate how he intended for the deceased to use the forklift to support the plates during the cutting work.
- The deceased was not a trained forklift operator and it was the first time he had cut such a U-shaped steel structure. The deceased should not have used the forklift to access heights, which is an unsafe act.
- The SWP developed was too general and did not state the type of support needed. There was no support during the cutting of the L-shape plate.
- Based on the size and weight of the structure, a forklift could not have provided sufficient support while cutting.

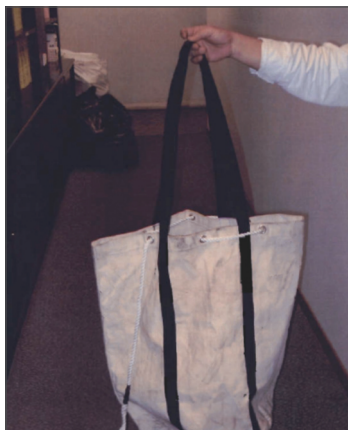
Type of sling bag used.

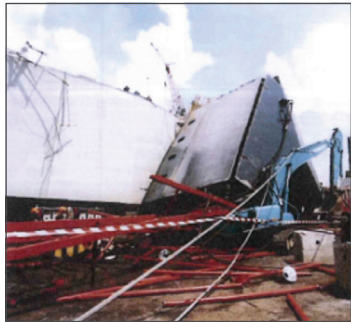
Shows accident site from seaward view.

- It was found that the crane was placed on inclined ground, and that it exceeded 18 times the

tolerance limit. Also, the leveling indicators used to ensure that the ringer was kept level were not precise or sensitive enough to be able to detect that the inclination was beyond 0.1 degrees which was the manufacturer's recommended equipment for such a purpose was the manometer.

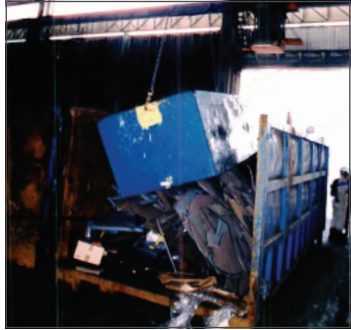
Side view of the overhead crane, chain sling, scrap box and dumping container.

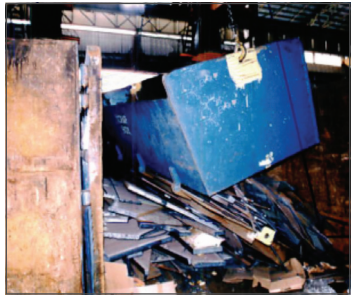
Showing scrap box and dumping container.

- The foundation upon which the scrap boxes were placed was unstable.

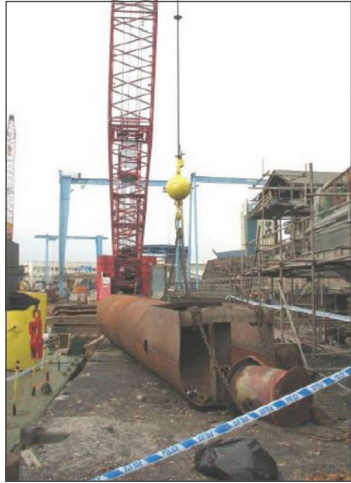
Insufficient clear working area and lack of barricades while working next to barges.

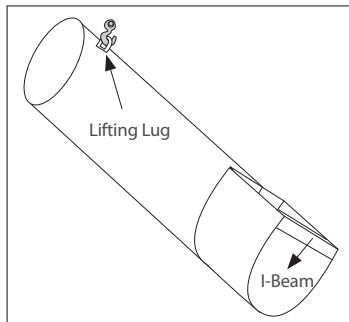
Following an initial failed attempt, the pipe was lifted at an angle in an effort to fit it into the desired location on board the vessel.

- The lifting angle exceeded those recommended by the sling manufacturer.
- The hook latch used to hold the O-ring was securing the tow lifting chains to one end of the inner pipe. According to the crane manual, however, the latch was not meant to support any loads.

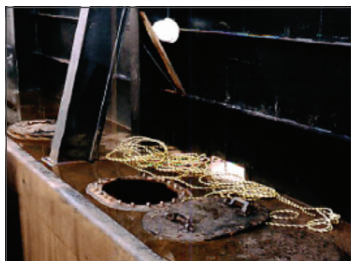
Manhole entry point of port number 6 tank.

- The tanks were inadequately ventilated. No permit to work for confined space entry was displayed on the tanks to indicate that they were safe to enter.

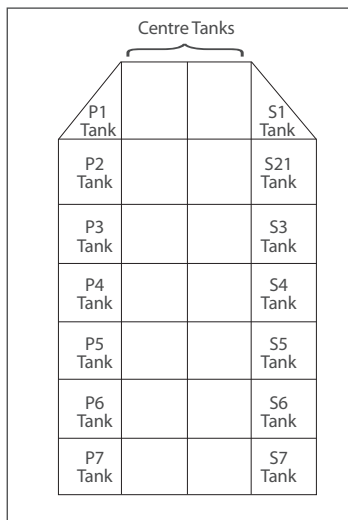
The body of deceased was found in port number 6 tank.

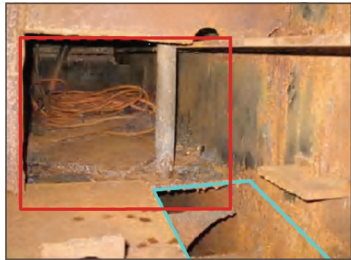
Steel removal work done on top side tank.

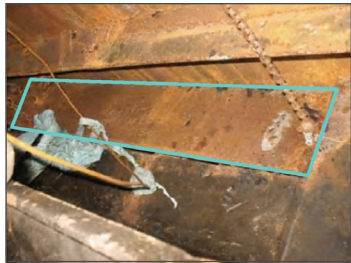
New steel plate to be fitted to the bottom of top side tank.

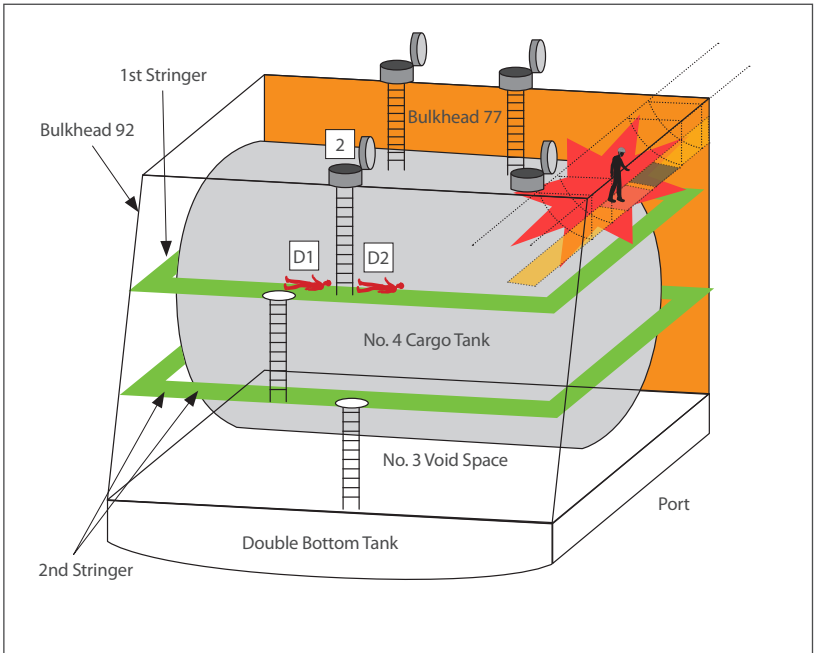
Deceased 1 (D1) and deceased 2 (D2) found near manhole 2.

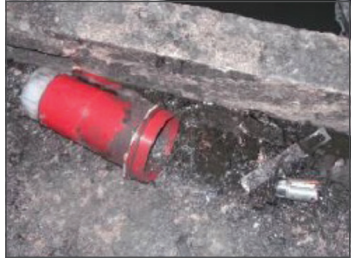
Shattered battery operated torch found in the water ballast tank.

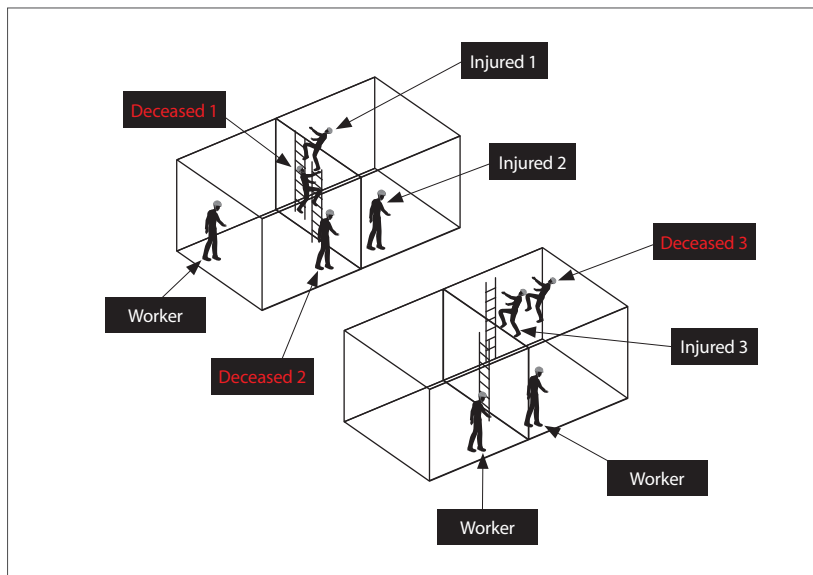
Location of workers involved in spray painting works shown in four different ballast tanks.

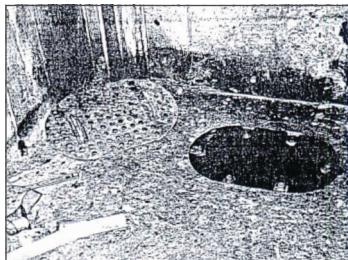
Showing the bilge well of the cargo hold.

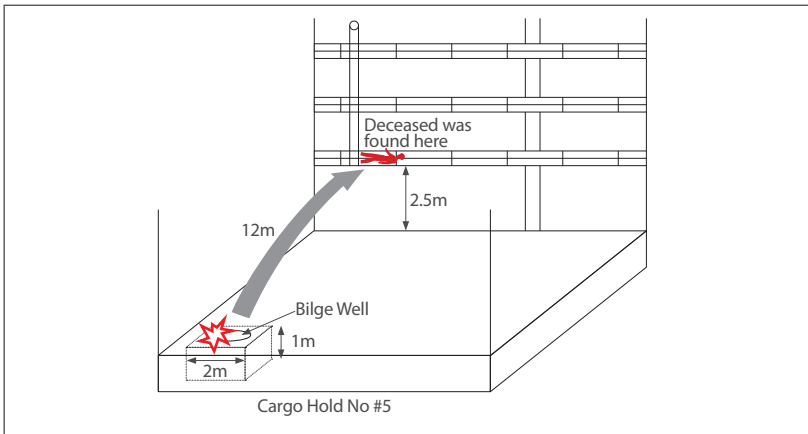
Showing where the deceased was found.

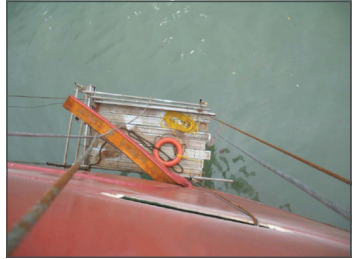
Top view of scene.

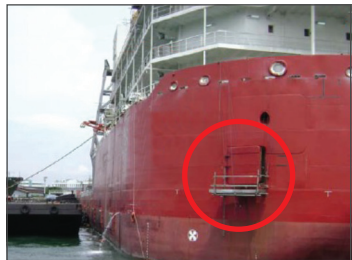
Hanging scaffold that the deceased and his co-worker were dismantling, on the bow of a vessel.

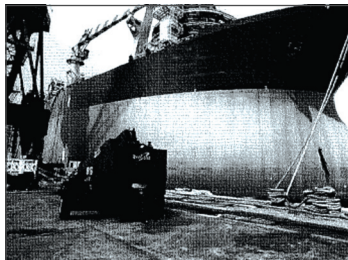
Location of boom lift next to ship anchor.

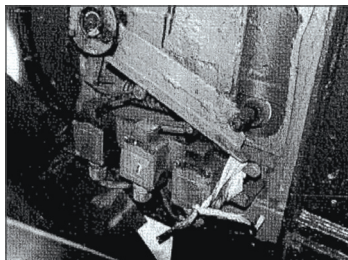
Limit switch being bypassed.
