SUMMARY OF INQUIRY COMMITTEE REPORT FOR ACCIDENT AT STARS ENGRG PTE. LTD.

A large explosion occurred at Stars Engrg Pte Ltd's ("Stars Engrg") premises on 24 February 2021. The accident resulted in three deaths, five major injuries, two minor injuries, and severe property damage. An Inquiry Committee ("IC") was appointed soon after the accident.

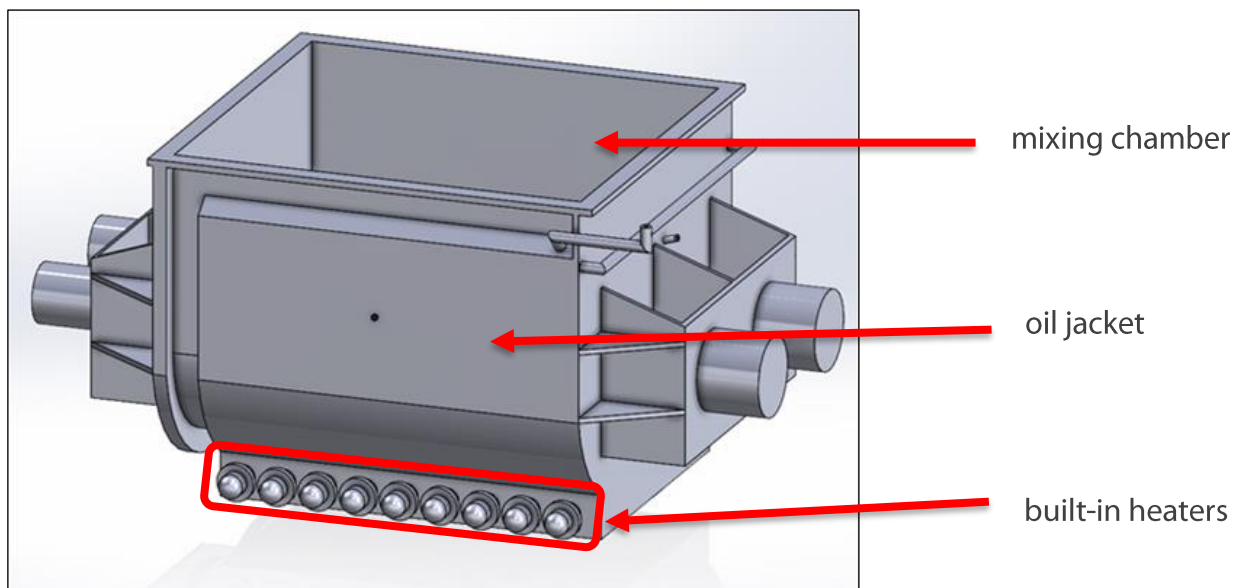
Back view of the mixer machine

Unsafe use of mixer machine	Insufficient oil in the mixer's oil jacket caused poor heat transfer and overheating of the oil.
	Temperatures of the heat transfer fluid in the oil jacket were not monitored. Only temperatures of the contents in the mixing chamber were monitored.
	All the mixer machine's vents were sealed off, and pressure within the oil jacket was not monitored. Pressures built up in the oil jacket due to the high temperatures that the oil was subjected to.
	Repeated heating and cooling weakened the mechanical strength of the oil jacket, and the weld repairs done by Stars Engrg's workers were of poor quality. The oil jacket eventually ruptured at the weak points, fracturing at the weld seams.

- Buyers of industrial equipment are encouraged to certify purchased equipment to SS 537-1: Code of Practice for the Safe Use of Machinery – General Requirements.
- Review and expand the Fifth Schedule of the WSH Act to include higher-risk machineries.
