WSHCOUNCIL

Case Studies

Food Manufacturing

Published by
WSH Council

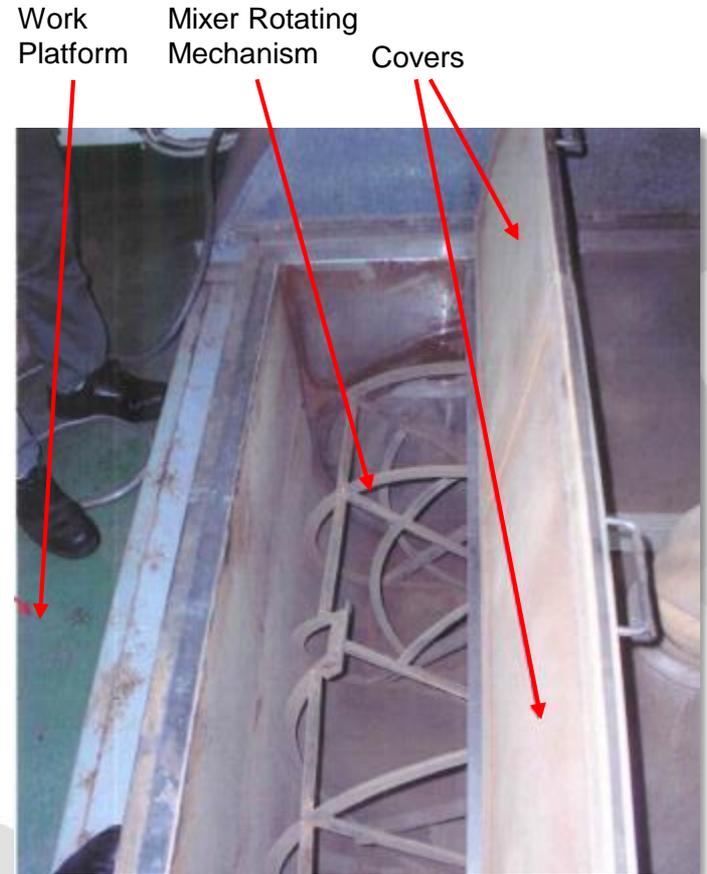
Investigation revealed that the worker could have fell in the mixing tank when he opened the cover of the tank to collect a sample of the blended product.

Figure 1: The mixing tank where the worker was found.

1. Carry out a risk assessment (RA) for the sample collection work activity (e.g., by conducting a job safety analysis).
2. Establish and implement a documented safe work procedure (SWP) for sample collection, e.g.,:
 - Collect the sample from the mixing tank only if the mixer rotating mechanism has been de-energised and come to a standstill; and
 - Collect the sample from an alternate safe location (from the blended product storage container) instead of directly from the mixing tank.
3. Install a safety interlock to make sure that the electrical power to the mixer rotating mechanism is cut off the moment the cover of the mixing tank is opened.
4. Put up a warning sign “*Moving parts. Do not open during operation.*” on the cover of the mixing tank.

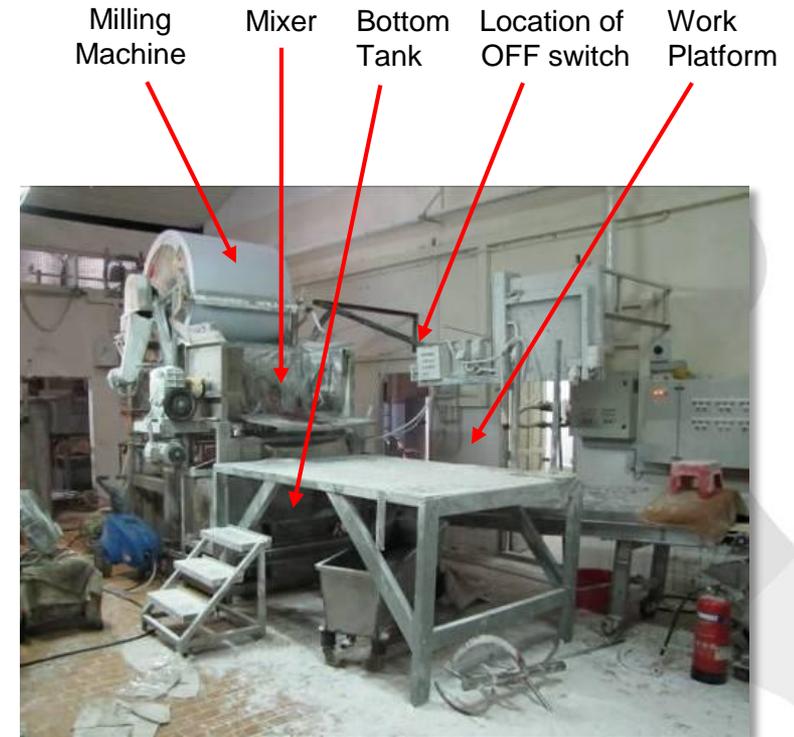
The worker's hand was suddenly pulled into the rotating blades of the mixer while he was cleaning the wall of the mixer. The mixer was still running when he was cleaning the mixer.

Figure 2: The mixing machine which the worker was dragged into.

- There was no machine guard to protect workers from the rotating blades of the mixer.
- The mixer "OFF" switch was situated far from the work location.

1. Check risk assessment (RA) to ensure that all work activities are covered (i.e., the cleaning work activity was missed out in this case).
2. Establish and implement a documented safe work procedure (SWP) for the cleaning work activity, e.g., lockout procedure for all maintenance and cleaning activities. This is to make sure that all energy sources are de-energised before starting work.
3. Install suitable guarding and safety interlock to make sure that the electrical power to the mixer is cut off once the guarding is removed.
4. Provide suitable cleaning tools (e.g., a long hand-held scraper) so that a safety distance between the mixer's blades and the worker's hands can be maintained at all times. To eliminate risks that may arise during manual cleaning, consider implementing automatic cleaning solutions where possible.

5. Install an emergency stop button at the location of work and at multiple locations so any worker can immediately stop the mixer in the event of an emergency.
6. Provide formal training for workers on the SWP for machine cleaning. Set up training records so that a worker's training history will be documented and review the need for refresher training.
7. Carry out regular housekeeping to keep work areas free from dust. Dust poses a slipping hazard which can cause the worker to fall in the vicinity of the mixer.

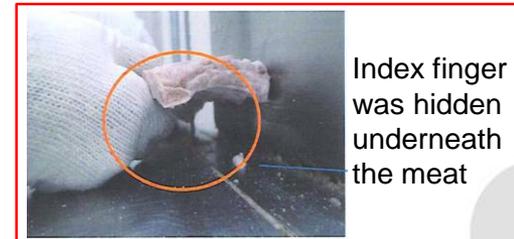
While he was holding the frozen pork rib, he did not realise that his right hand index finger was hidden under the meat. His finger had come into the path of the saw blade and consequentially cut his finger.

Figure 3a:
The worker was trying to cut the frozen pork rib to size when the injury occurred.

- An adjustable guard for the saw blade was provided but was ineffective. With the said guard fully deployed, 10 cm of the cutting blade was still exposed.
- The sliding table and pusher were provided but were ineffective in pushing the large and irregular-shaped frozen meat into the band saw for cutting.

1. Provide effective guarding to minimise exposure to the cutting blade.
2. Provide workers with suitable gloves for the task (e.g., consider using cut-resistant stainless steel mesh gloves or layered gloves with an inner layer for thermal protection and an outer layer for food hygiene). These gloves must be form fitted to each worker. This is to make sure that the gloves do not introduce draw-in hazards when working with a band saw.

3. Design and fabricate a customised sliding table and adjustable gripper to handle large and irregularly-shaped frozen meat. The design should make sure that workers do not have to use their hands to directly hold the frozen meat as it goes through the cutting blade.
4. Conduct specific risk assessment and implement safe work procedure (SWP) on the safe use of band saw machine for cutting various types and sizes of meat.
5. Provide the necessary supervision especially for new or inexperienced workers, so that workers are aware of the risks and able to carry out the work safely.
6. Consider automating the meat cutting process (e.g., using a meat block auto feeder) so as to eliminate the man-machine interface, thereby making the process inherently safer.

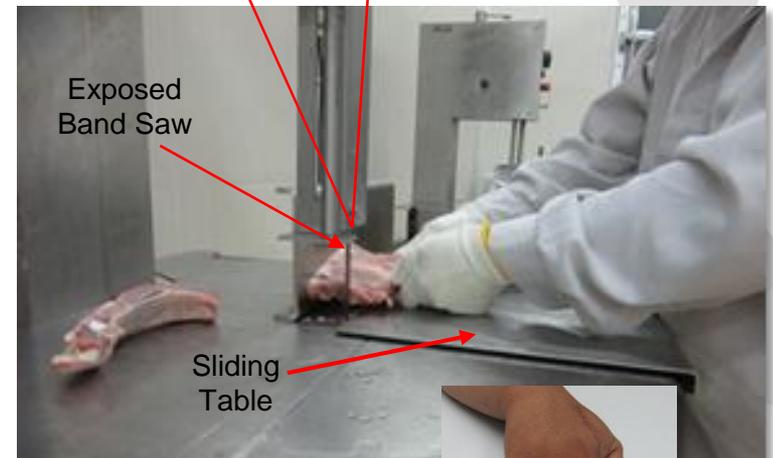
The worker was immediately sent to the hospital where his right index finger had to be amputated due to the severity of the injury.

Figure 3b:
Photo of the worker's right hand after the amputation.

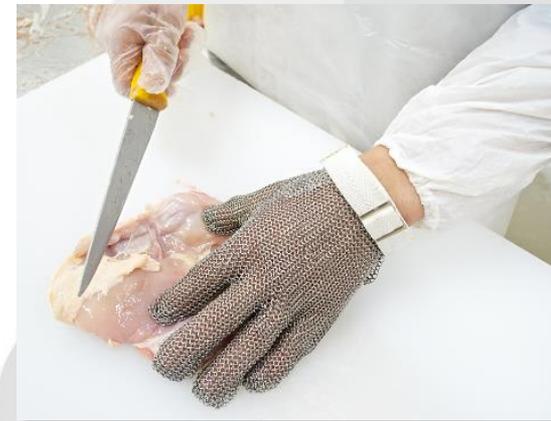
Figure 3c: Example of cut-resistant mesh gloves used in butcheries

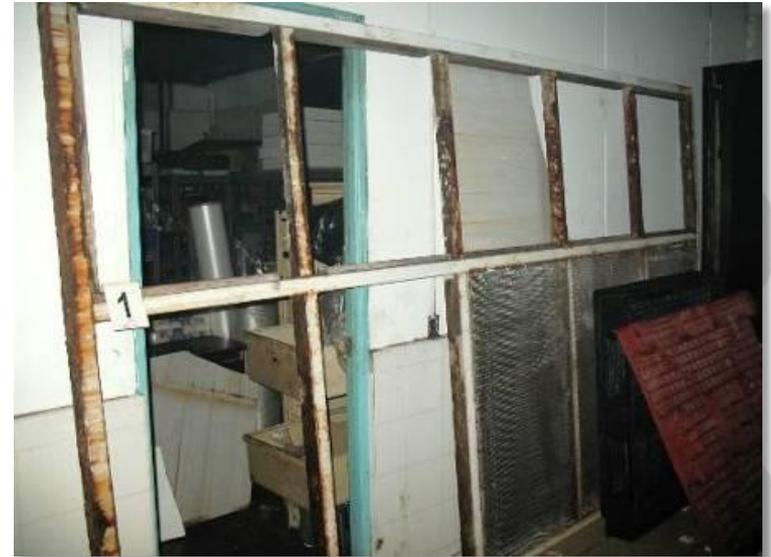
Figure 4a: Fallen window sash measuring 3.6 metres tall and 2.2 metres wide.

- The window sash was badly corroded in some areas.

2. Incorporate workplace facility inspection into the housekeeping checklist. A periodic inspection of the windows would have revealed that the hazard was caused by a corroded window sash. Early identification of the hazard would have called for measures (e.g., window part replacement or painting to reduce the rate of corrosion) to be taken to prevent the window sash from deteriorating to such a state that it could collapse from its supports.

3. The use of aluminium alloy for windows is recommended. The relevant Singapore Standard is SS 212: 2007 Specification for Aluminium Alloy Windows. Refer to Building Control Act and the Building Maintenance and Strata Management Act for more information.

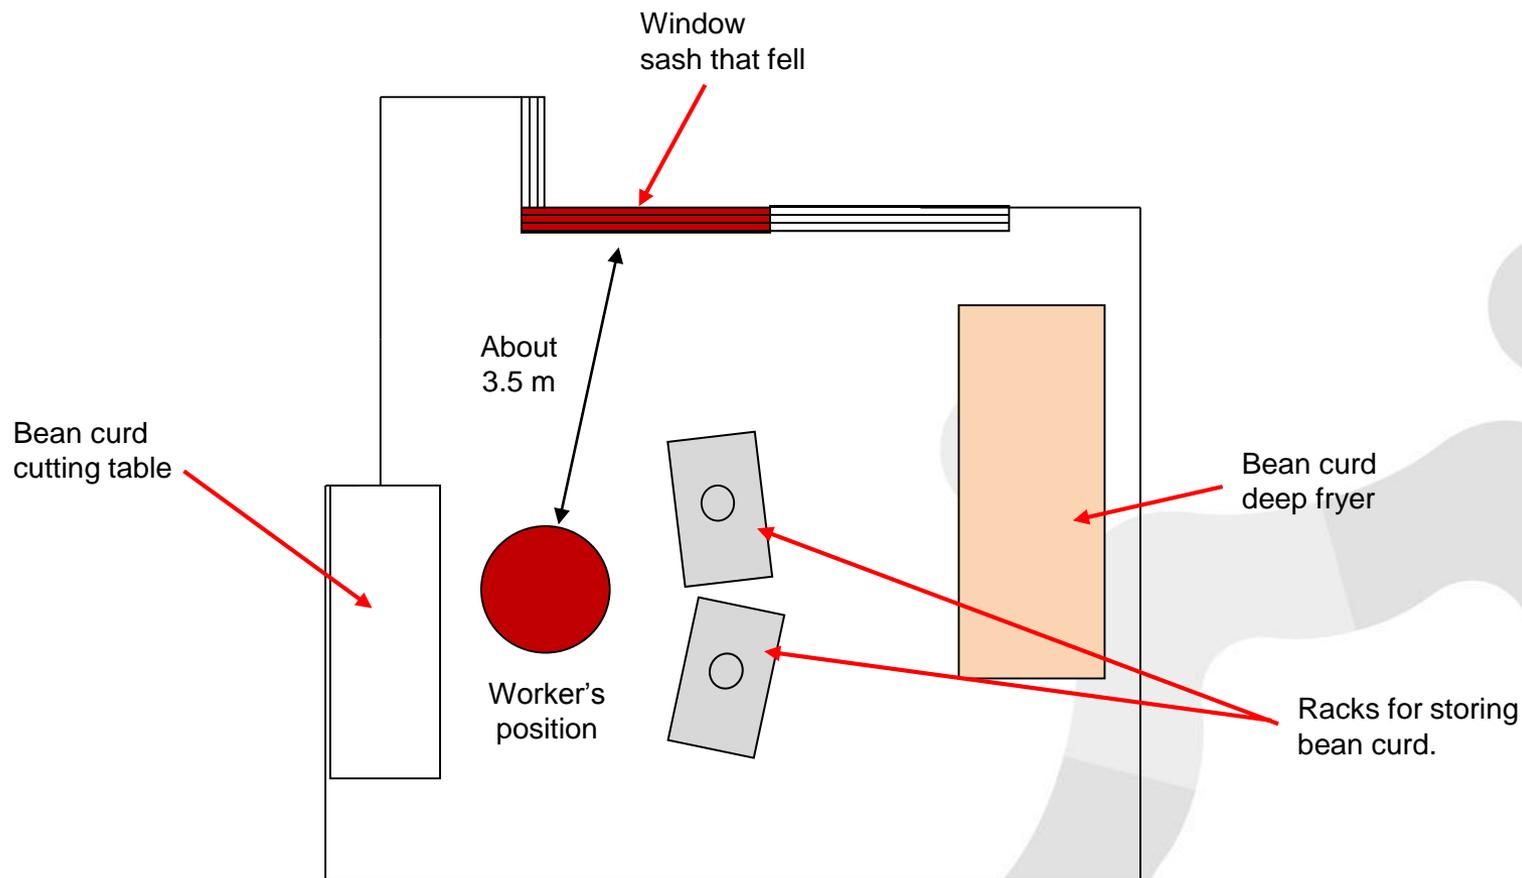
Figure 4b: Layout plan showing the relative position of the worker to the window sash.

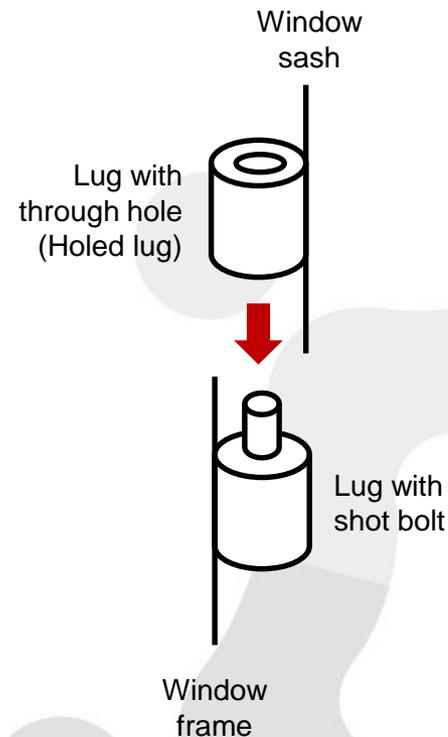
Figure 4c: Illustration showing how the window sash is attached to the window frame.

Evaluation of loss	<ul style="list-style-type: none">• One fatality
Type of contact	<ul style="list-style-type: none">• Struck by falling object
Immediate cause(s)	<ul style="list-style-type: none">• The window sash was supported only by its top hinge. Two out of three hinges had their holed lugs broken off from the sash due to severe corrosion.
Basic cause(s)	<ul style="list-style-type: none">• Failure to inspect and maintain the window
Failure of WSH Management System	<ul style="list-style-type: none">• No preventive facility maintenance regime

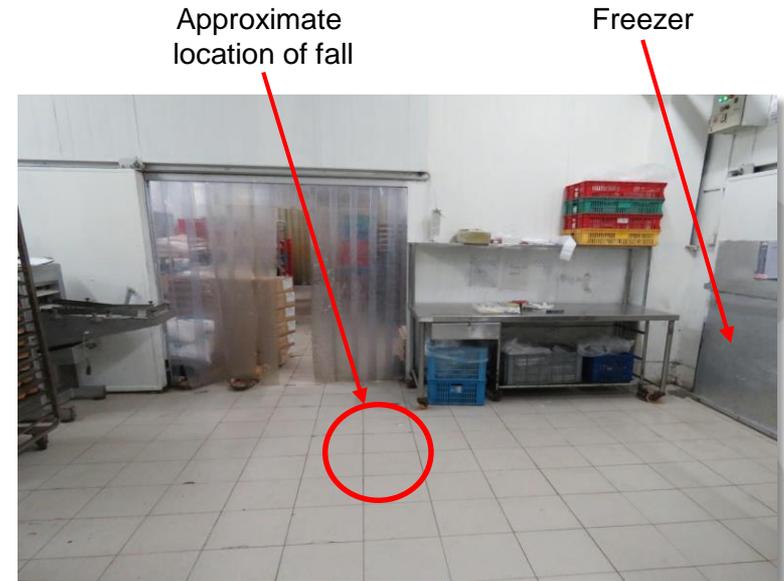
Figure 5: Scene of the accident where the worker slipped and fell.

- The floor outside the freezer was slightly wet due to condensation.

1. Provide workers with appropriate non-slip footwear.
2. Implement a footwear inspection programme where footwear is checked regularly (e.g., every 4 to 6 months) for wear and tear, and replaced as necessary.
3. Increase the floor slip resistance (e.g., use non-slip tiles, apply a slip resistant coating on an existing walking surface, or strategically place anti-slip mats and anti-slip tape/stickers). For more information on floor slip resistance, refer to SS 485: 2011 Specification for Slip Resistance Classification of Pedestrian Surface Materials.
4. Carry out regular floor inspection and maintenance to make sure that floors are in good condition and remain safe for use. If the floor becomes slippery (e.g., due to water or oil) during the course of work, specify in the safe work procedure the requirement to dry or degrease the floor as often as reasonably practicable.

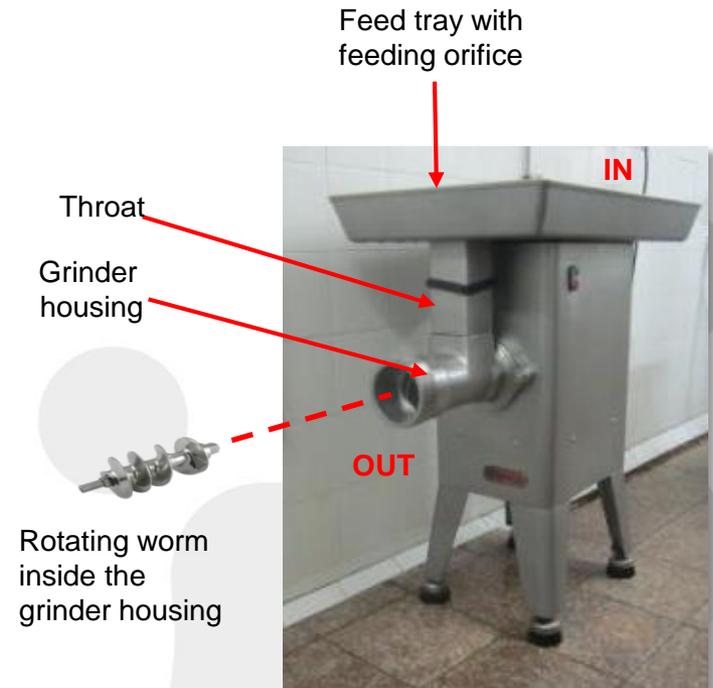
The worker accidentally dropped a cuttlefish head into the feeding orifice. He inserted his left hand directly into the feeding orifice to remove it and his fingers came into contact with the rotating worm of the meat mincer. His left hand was drawn into the throat and crushed by the meat mincer machine.

Figure 6a: Typical industrial meat mincer

- There was no guarding at the feeding orifice of the meat mincer.

1. Carry out a specific risk assessment (RA) and/or job safety analysis (JSA) for all activities involving each type of meat mincer machine in use.
2. Develop a safe work procedure (SWP) for the meat mincing activity, help workers to understand the risks associated with the task, and train workers to carry out the procedure. In the event that access into the throat of the meat mincer is necessary, workers must ensure that the meat grinder is fully de-energised and Lockout Tagout (LOTO) implemented before attempting access (e.g., by using a long stick).
3. Install a physical guard at the mouth of the feeding orifice so that it is not possible to insert one's hands into the throat of the meat mincer.

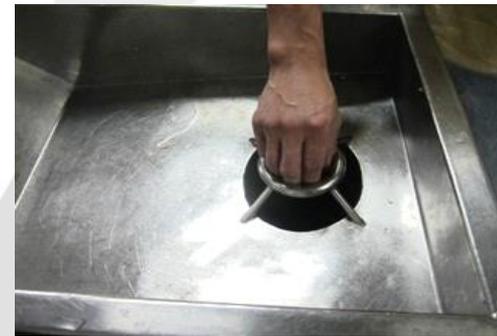
Figure 6b. Guarding installed to protect hands and fingers from contact with the rotating worm

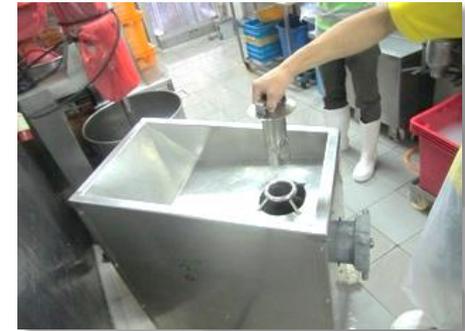
Figure 6c. Push stick specially designed to go through the guarding and towards the rotating worm

4. Provide a push stick (or a pair of tongs) which workers can use to safely push meat towards the rotating worm of the meat grinder during operations.
5. Install warning sign on the meat mincer to alert operators of the presence of machine hazards.
6. Conduct a comprehensive equipment review at the point of purchase to ascertain the risks arising from machine operation and the adequacy of existing safeguards.
