# CASE 2

## WORKER'S PALM GETS CRUSHED

# CASE 5

## WORKER GETS KILLED BY A STEEL MESH MACHINE

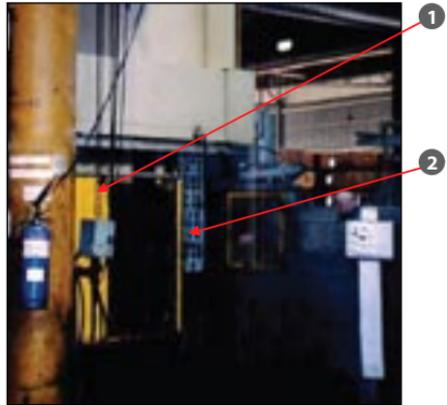
1. Sliding door
2. Control panel

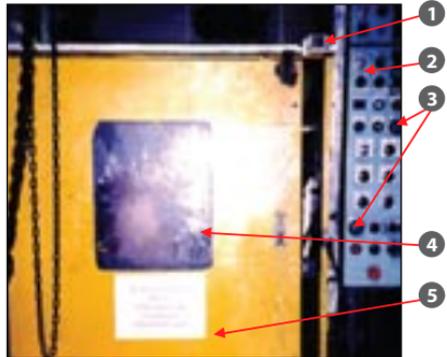
1. Limit switch  
\* Installed after the accident
2. Control panel
3. Two hand control buttons
4. Looking glass
5. Sliding door

- The sliding door was not fitted with any interlock which would have stopped the machine when the door was opened during the automatic mode of operation.
- Need for the safety interlock on the sliding door was highlighted before the accident but the installation was not carried out due to the different electrical control circuitry from the other die-casting machines.
- The worker had been trained to stop the machine first before attempting to access the die area. The worker bypassed the procedure of placing the machine on the manual mode of operation prior to opening the sliding door to access the die.

Risk Assessment	<ul style="list-style-type: none"><li>• Risk assessments must be carried out prior to work operations.</li></ul>
Safe Work Procedure	<ul style="list-style-type: none"><li>• Safe work procedures must be developed and implemented.</li></ul>
Equipment and Tools	<ul style="list-style-type: none"><li>• The machine should be fitted with safety interlocks to stop the machine whenever the door is opened during an operation.</li><li>• Preventive maintenance of interlocking devices should be put in place to ensure that such devices do not breakdown.</li></ul>
Others (Process design, etc.)	<ul style="list-style-type: none"><li>• The operator should have stopped the machine before opening the door to access the die.</li></ul>

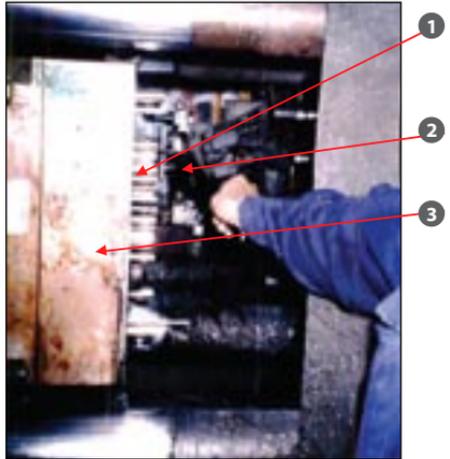
1. Ejector pins
2. Spanner
3. Moveable die

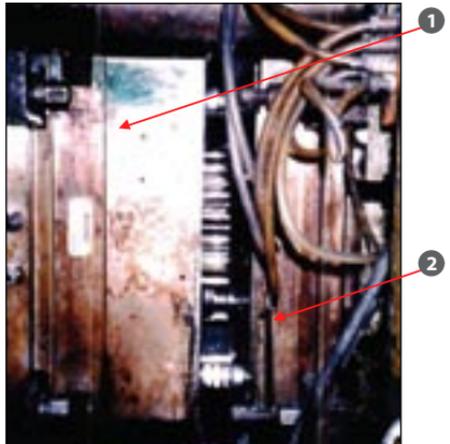
1. Moveable die
2. Stationary die

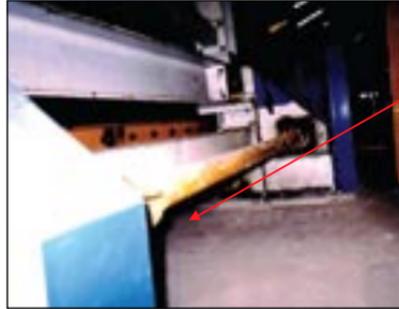
- The steel mesh machine was fenced and various parts of the machine within the fencing could move in various directions when activated.
- Two sliding gates were part of the fencing. The gates were provided with interlocking sensors. However, the interlocking sensors were not connected and hence not in working order.

1. The accident happened here

Risk Assessment	<ul style="list-style-type: none"> <li>• Risk assessments must be carried out prior to work operations.</li> </ul>
Safe Work Procedure	<ul style="list-style-type: none"> <li>• Safe work procedures must be developed and implemented; i.e. Procedure for Testing and Commissioning and Procedure for Lockout/Tagout.</li> </ul>
Work Planning	<ul style="list-style-type: none"> <li>• Testing and commissioning should not be carried out at the same time as grouting work.</li> </ul>
Equipment and Tools	<ul style="list-style-type: none"> <li>• Safety interlocking sensors should be working at all times.</li> </ul>
Training and Awareness	<ul style="list-style-type: none"> <li>• All workers involved must be briefed on and understand the hazards and risks involved and the contents of safe work procedures.</li> </ul>
Coordination and Communication	<ul style="list-style-type: none"> <li>• All workers should be cleared away from the machine before conducting testing and commissioning of machine.</li> </ul>

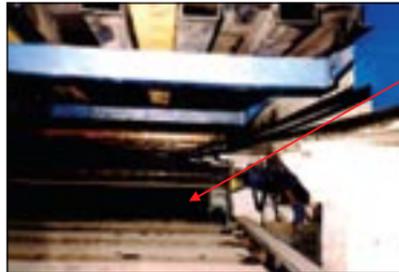
1. The deceased was found on the floor underneath the machine here

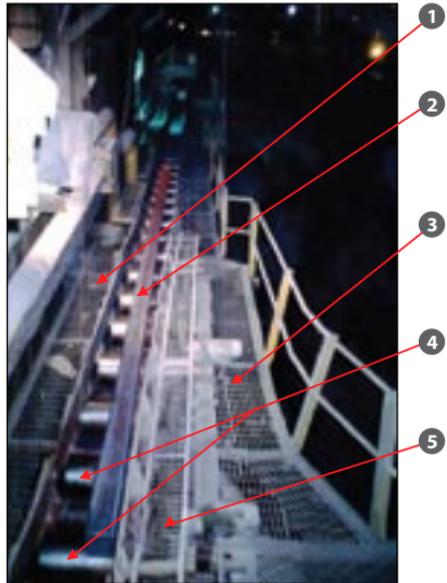
1. Inner walk platform
2. Billet
3. Outer walk platform
4. Rollers
5. Protective cover

- There was inadequate fencing provided on the belts and pulleys system driven by the motor.
- The worker was walking along the inner walk platform that was about 450mm wide with cable tray

Risk Assessment	<ul style="list-style-type: none"><li>• Risk assessments must be carried out prior to work operations.</li></ul>
Safe Work Procedure	<ul style="list-style-type: none"><li>• Safe work procedures must be developed and implemented.</li><li>• Lockout/Tagout procedures should be implemented before any inspection, adjustment or repair is carried out.</li></ul>
Work Planning	<ul style="list-style-type: none"><li>• Present cable tray location is a hindrance to conveyor adjustment and repair works and should be relocated.</li></ul>
Equipment and Tools	<ul style="list-style-type: none"><li>• All exposed moving parts should be adequately covered.</li></ul>

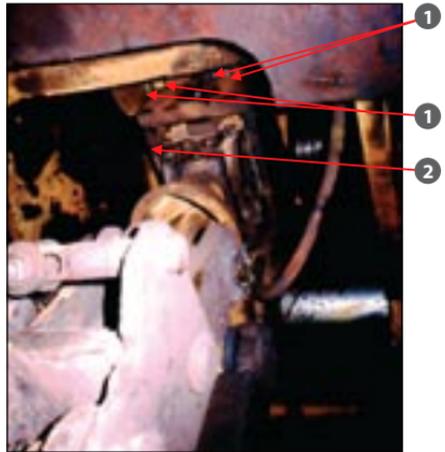
1. The rollers with four pairs of roll passes found here
2. The roller guide that had to be shifted to a new pair of roll passes

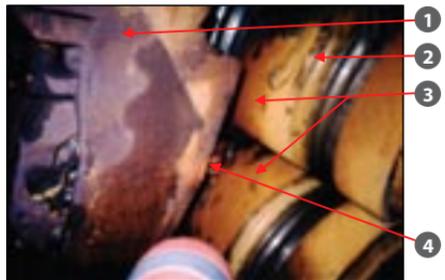
1. The roller guide
2. A brand new pair of roll passes
3. The two rollers with four pairs of roll passes
4. The guide sheave that the injured was feeling with his right hand

- The worker had misjudged the time taken for the rollers to come to a standstill when he put his right hand in to feel the guide sheave.
- The worker had disregarded the instructions from his supervisor to work at Roll Stand A and had instead gone on to check the roller guide at Roll Stand B.

Risk Assessment	<ul style="list-style-type: none"><li>• Risk assessments must be carried out prior to work operations.</li></ul>
Safe Work Procedure	<ul style="list-style-type: none"><li>• Safe work procedures must be developed and implemented.</li></ul>
Training and Awareness	<ul style="list-style-type: none"><li>• Constant reminders of safe work methods should be given.</li></ul>
Coordination and Communication	<ul style="list-style-type: none"><li>• All relevant workers should adhere to stipulated work instructions and avoid taking short cuts.</li></ul>
