Case study 1: Worker's thumb severed by circular saw

Case study 2: Worker's fingers severed by table saw

Case study 3: Worker's fingers severed by table saw

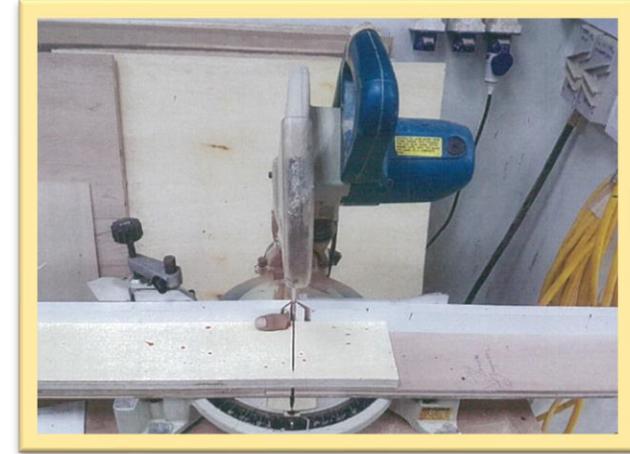
The accident happened when the injured worker was holding onto the shorter side of the timber piece while cutting using the circular saw machine. His right hand's thumb was placed directly below the blade of the circular saw and was consequently severed off.

Pic 1: Injured's right thumb during the accident

- The **method** adopted by the injured worker of using the circular saw machine to cut the timber into the desired size by placing one's hand directly below the rotating saw blade of the circular saw was an **unsafe practice**
- The company should conduct Risk Assessment to identify hazards and implement appropriate control measures for all work activities and operation of machineries in the workplace
- Workers **should not hold** the timber piece (especially the short side of the timber) **during the cutting** process; and the **hand must be kept away** from the **cutting blade** at all times. For thicker and heavier timber pieces, the workers would need to **secure** them using the **F-clamp** or appropriate clamp(s) before cutting is carried out
- The company should use appropriate machine, equipment or tool when carrying out special task

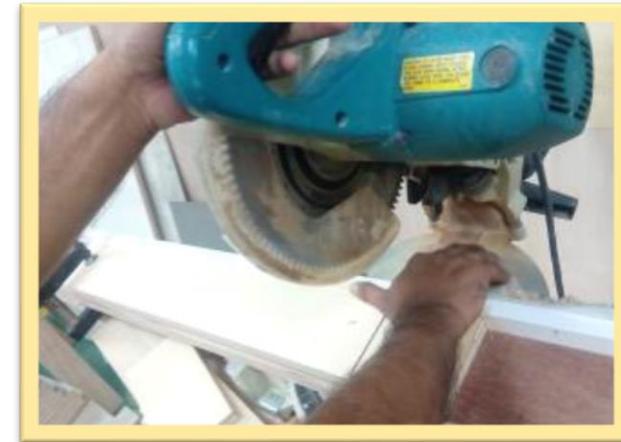
Pic 2: Re-enactment of cutting process during the accident

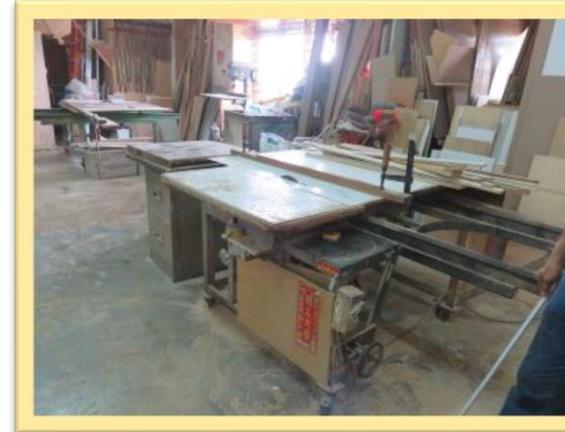
The carpenter was using the table-saw machine to cut the plank into the desired size, where he hold and push the material towards the rotating saw-blade with his hands that resulted in having his fingers severed by the exposed rotating saw blade.

Pic 1: The table saw that was involved in the accident

- The company should conduct a risk assessment to identify hazards and implement appropriate control measures for all work activities and operation of machineries in workplaces; such as provision of safety features or devices (i.e. guards) to prevent its accidental removal and to maintain its effectiveness

- The company should use safety means or tools for safe handling of the work piece, and in this case, such as a **push stick** to push the material to the saw blade and prevent the injured's hands from coming into contact with the rotating saw-blade

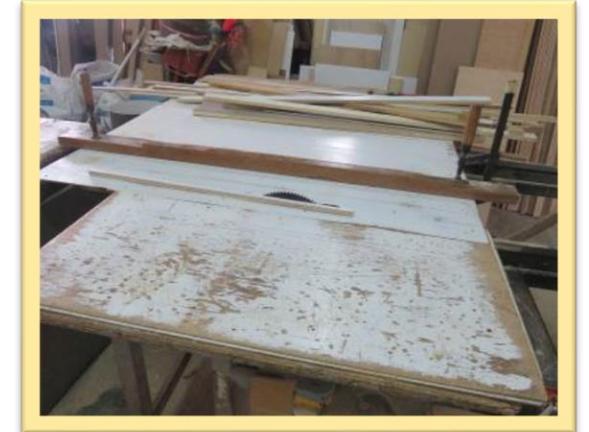
Pic 2: Guard was not installed during the day of accident

- The worker was operating the table saw with **exposed rotating saw-blade without** the **safety guard** installed
- There was **no risk assessment** conducted for the table saw activities and **safe work procedures were also not established** for the use of table saw

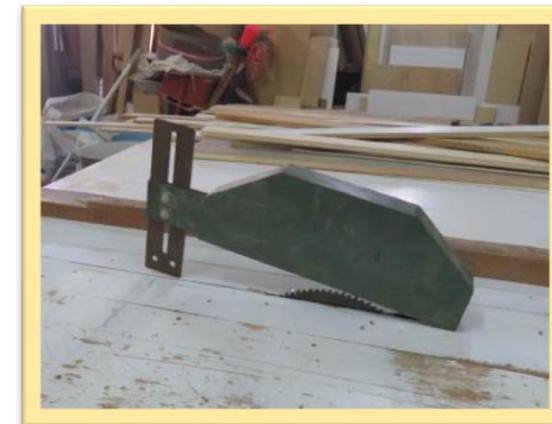
Pic 3: Table saw guard was available but was removed prior to the accident

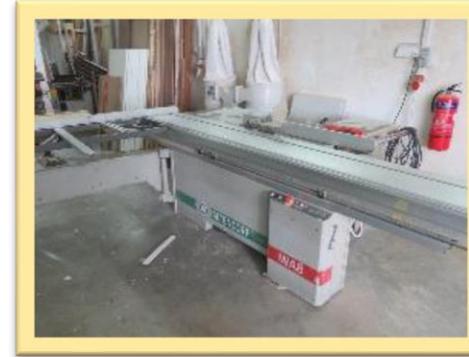
The injured worker used the table saw for cutting the groove on the bottom panel of timber door frame (see pic 3) as he had seen his senior did it. In the process of doing that, he used his hands instead of a push stick; the injured's fingers came into contact with the rotating saw blade of the table saw which resulted in amputation.

Pic 1: The table saw that was involved in the accident

- **Safe work procedures** on cutting of groove on timber or wooden plank using table saw were **not established**
- The **method** adopted by the company to remove the safety guard to cut the groove on timber or wooden plank using the table saw machine, where he hold and push the material towards the exposed rotating saw-blade with his hands was an **unsafe practice**
- The company should **adopt a safer method** to cut the groove for the bottom panel of the timber door frames with an **appropriate equipment (router) solution** which was available in the market currently, instead of using the table saw

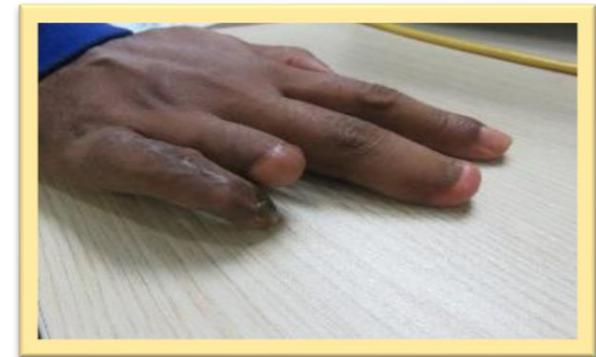
Pic 2: Injured worker's fingers after the accident

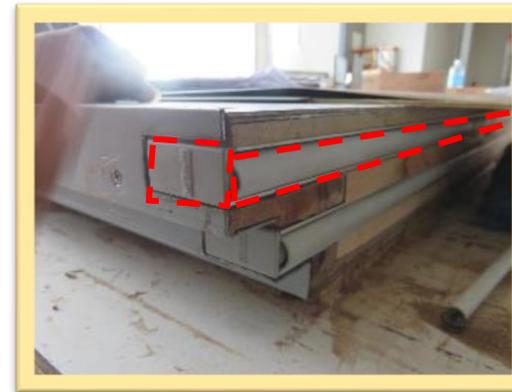
It was also the occupier practice to use the table saw to cut the groove on timber or wooden plank. In carrying out such operation, the safe guard hood for the rotating saw blade must be removed as it would obstruct the timber from being pushed forward.

Pic 3: To cut the groove (highlighted in red) for installing bottom panel of timber door frames.

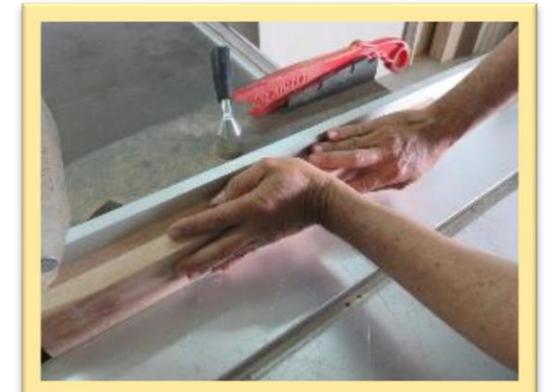
Pic 4: Table saw guard was available but was removed prior to the accident.
