Slips Trips Falls & Falls from Height

Recent Inspection Observations & Fatal Accidents

MINISTRY OF
MANPOWER

14 July 2022

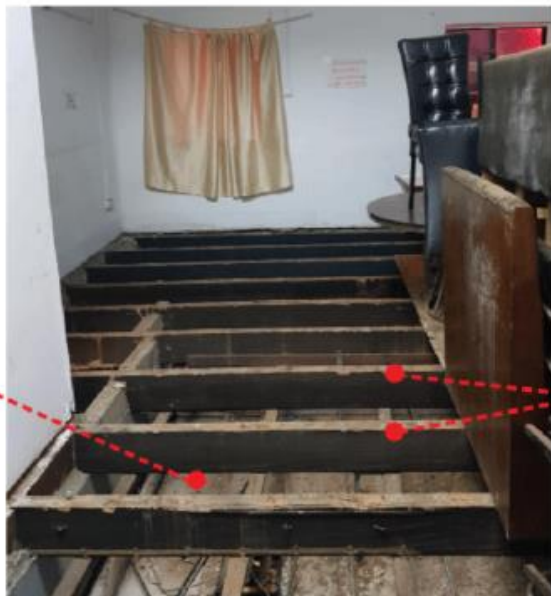
Renovation company owner fell through ceiling board

On 2 May 2022, the sole proprietor of a renovation company was surveying the 2nd floor of a shophouse, where the wooden flooring had been removed, exposing the floor beams and the false ceiling board of the 1st floor. He fell between the exposed floor beams, through the false ceiling board and landed about four metres below. He was sent to the hospital where he passed away.

No fall prevention or protection measures were implemented.

False ceiling
board under
the exposed
floor beams

Expose
beams

Overview of the 2nd storey of the shophouse.

- **Pre-start Assessments**
- *Identify, mark and communicate the locations of fragile surfaces to workers*

- *Use safe work method eg roof ladders, crawl boards, gangways etc*

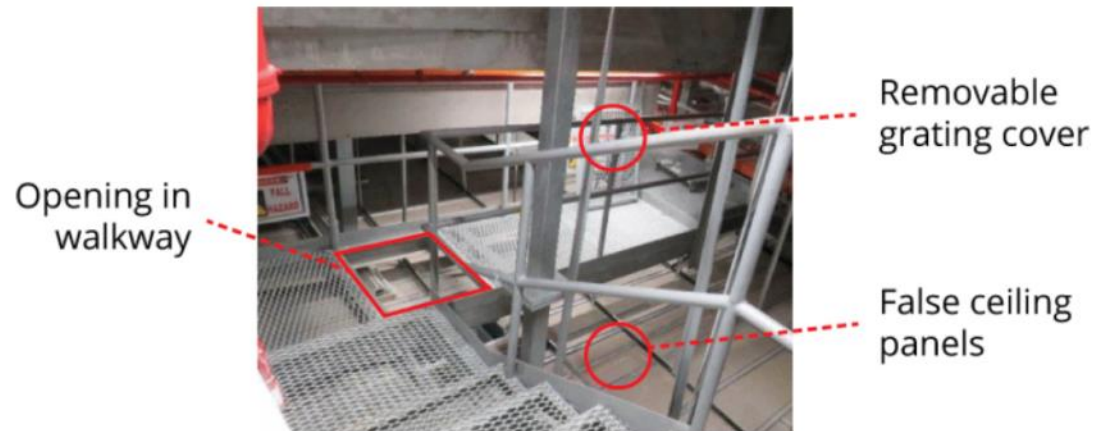
Engineer dies after falling through false ceiling

On 8 April 2022, an engineer was on a maintenance catwalk performing inspections at the maintenance level of a building. One of the grating covers of the catwalk above the false ceiling had been removed as part of the inspection works. The engineer stepped on a false ceiling panel below the catwalk opening. The panel gave way, causing her to fall about 30 metres to her death.

The engineer was not wearing fall arrest equipment.

Opening in
walkway

Removable
grating cover

False ceiling
panels

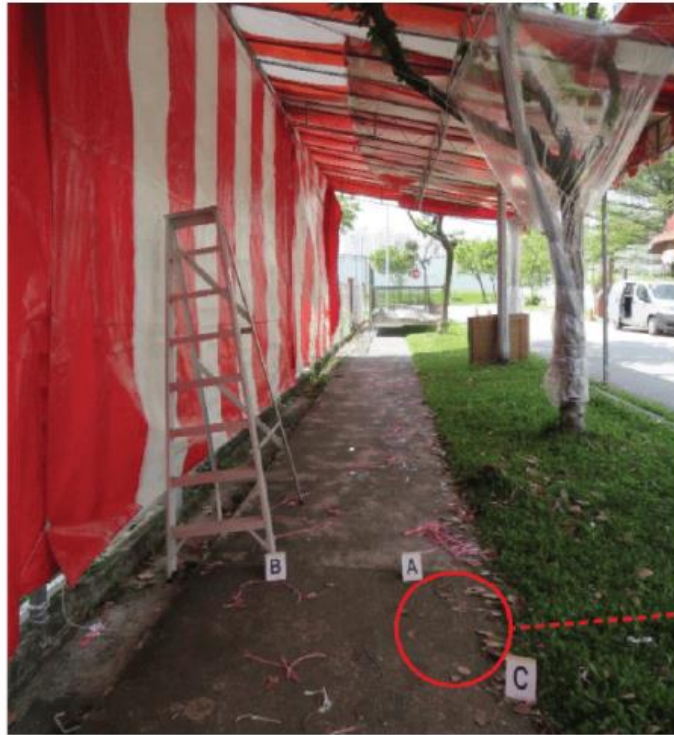
Worker dies after falling from a ladder

On 21 April 2022, a worker suffered head injuries after falling about 1.2m from an A-frame ladder while trying to hang items to the top of a tentage. He passed away two days later.

The worker was wearing slippers when using the ladder, and the floor was wet from rain.

Location where
worker was
found.

- **Pre-start Assessments**
- *Use the right ladder*
- *Ladder to be secured*
- *Buddy to hold the ladder*
- *3 point contact*
- *...refer to established guidelines*

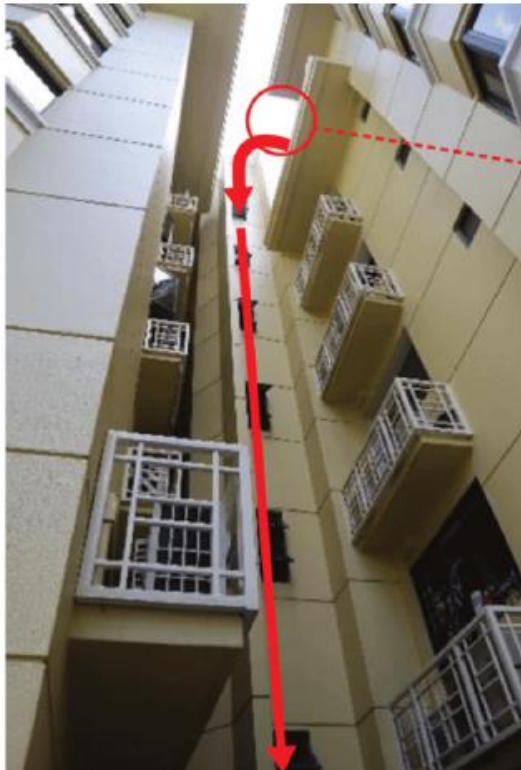
Worker slipped and fell off roof

On 24 May 2022, a worker was carrying out repair works on a sloping roof of a residential building when he slipped and fell about 20 metres to the ground. He was sent to the hospital where he passed away.

Preliminary investigations revealed that the worker was not wearing fall arrest equipment at the time of accident.

Location from
where the
worker fell

- **Pre-start Assessments**
- *Use proper access equipment*

- *Physical barriers to open sides;*

- *(if barriers not possible) Fall restraint;*
- *(if barriers & fall restraint not possible) Fall arrest*
- *...refer to established guidelines*

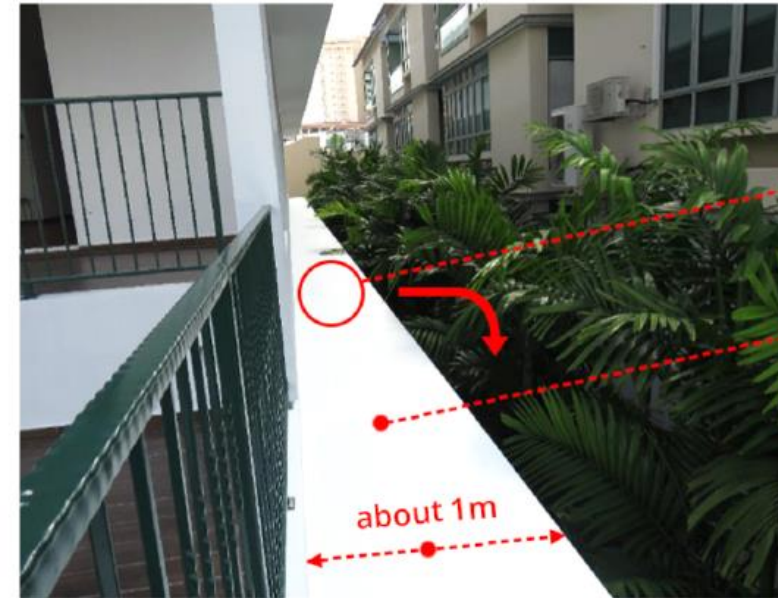
Worker fell off open side of landed residence

On 2 March 2022, a worker was doing inspection and painting works at a newly constructed three-storey house when he fell off an open side. The worker was likely on the second storey ledge when he fell. He was wearing a pair of slippers and not equipped with personal fall prevention equipment. The worker was sent to the hospital where he passed away.

Likely location of the
worker before he fell

Second storey ledge
with open side

about 1m

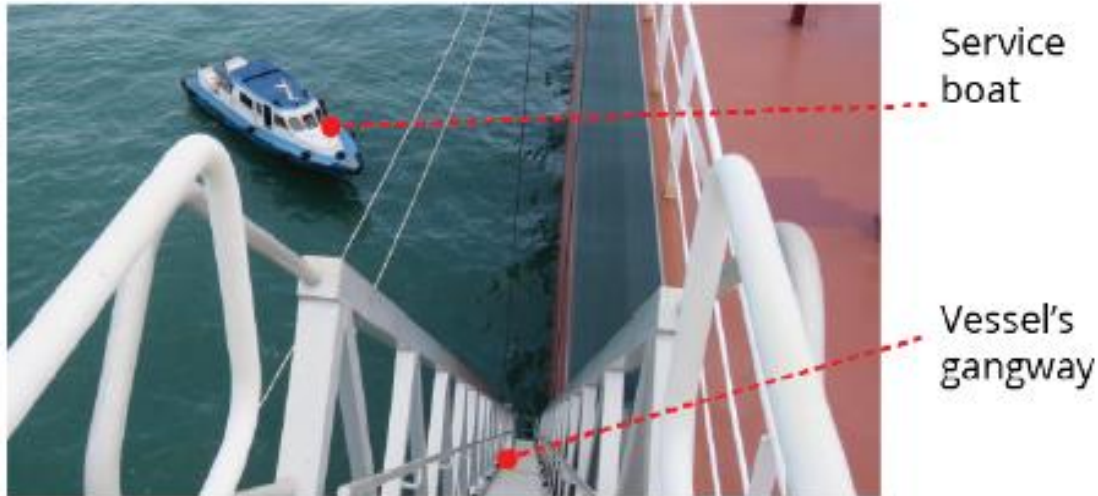
Worker fell into sea while boarding service boat

On 17 May 2022, a worker had just crossed a gangway from a marine vessel to a service boat when he lost his balance and fell into the sea. The worker's body was later found on 21 May 2022.

Preliminary investigations revealed that the worker was wearing a life jacket and carrying a backpack containing equipment at the time of accident.

• ***Pre-start Assessments***

• *Housekeeping*

• *Proper footwear*

• *Safe manner of transfer*

• *Life vests*

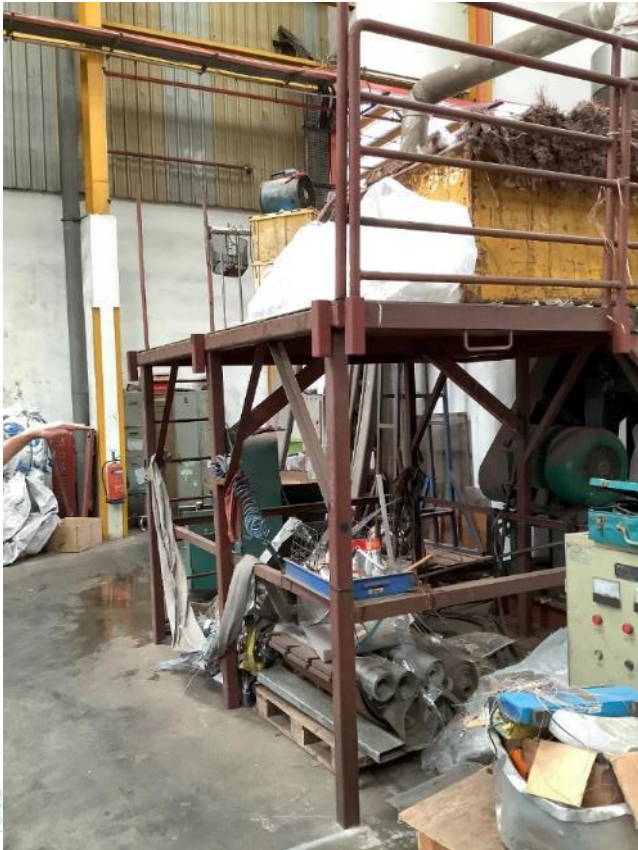
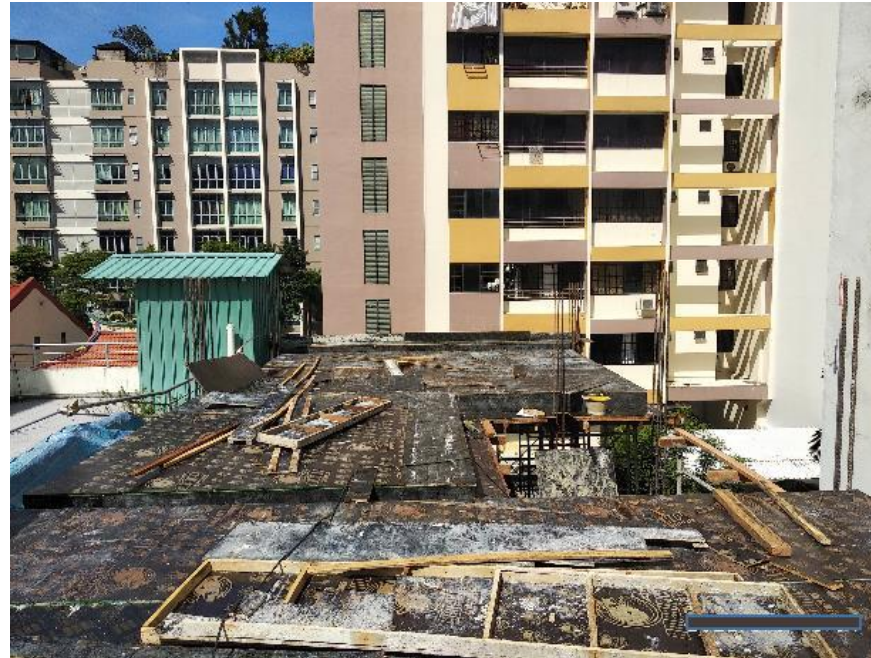
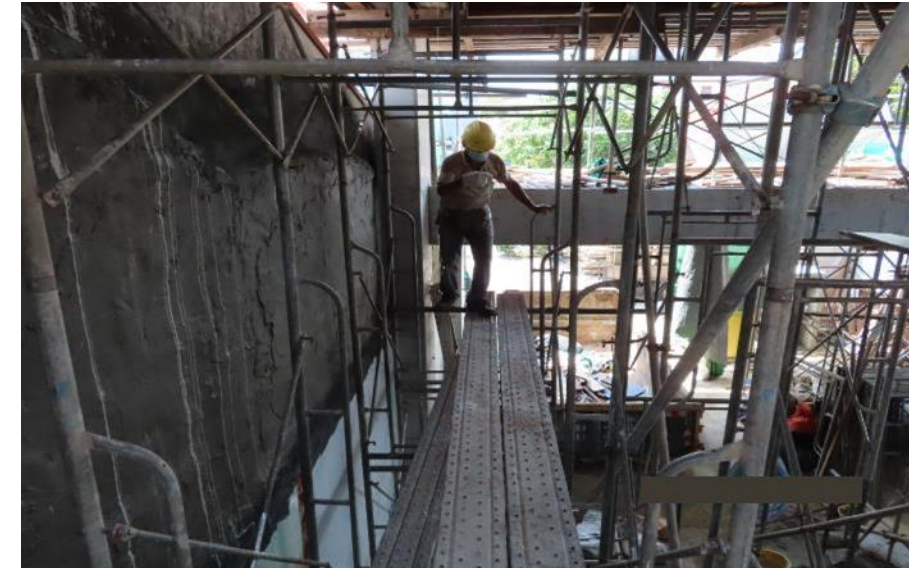
Open Sides and Openings

Reg 8(2) of WSH (Work at Height) Regulations

*.... every **open side or opening** into or through which a person is **liable to fall more than 2 metres** shall be **covered or guarded by effective guard-rails or barriers** to prevent fall.*

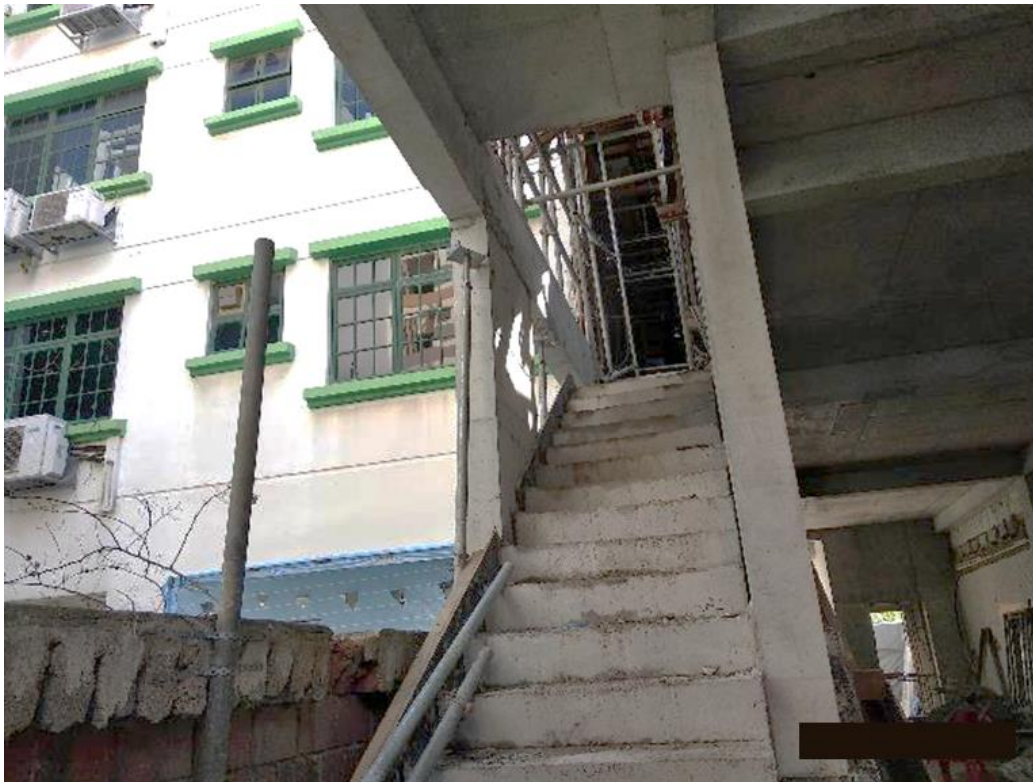
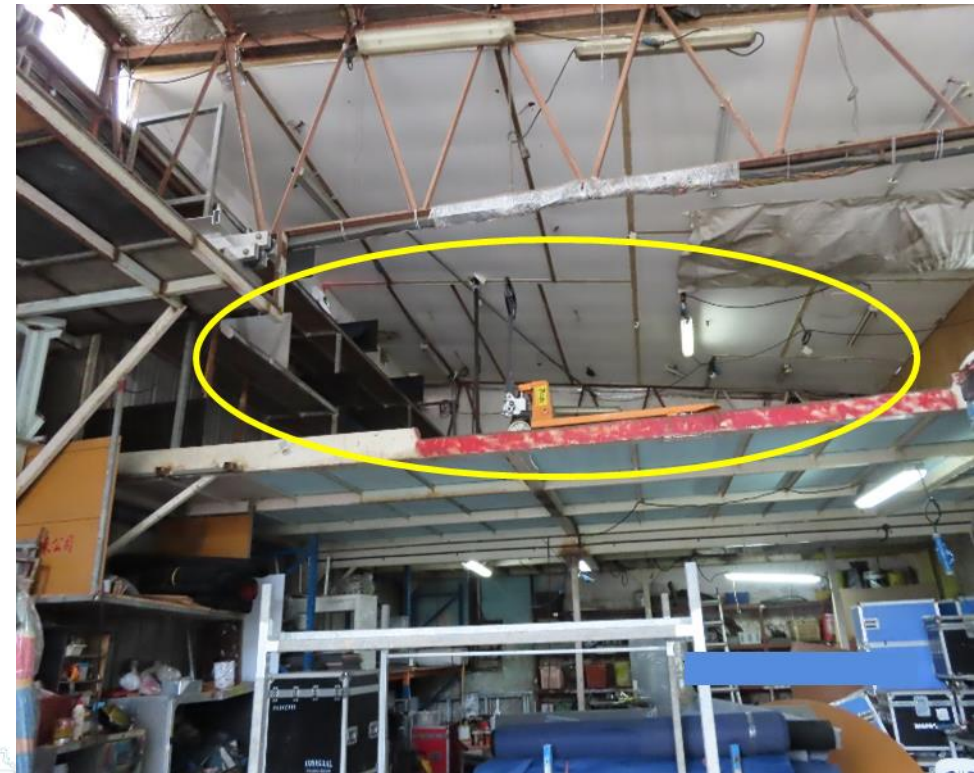
Open Sides and Openings

Reg 8(2) of WSH (Work at Height) Regulations

.... every **open side or opening** into or through which a person is **liable to fall more than 2 metres** shall be **covered or guarded by effective guard-rails or barriers** to prevent fall.

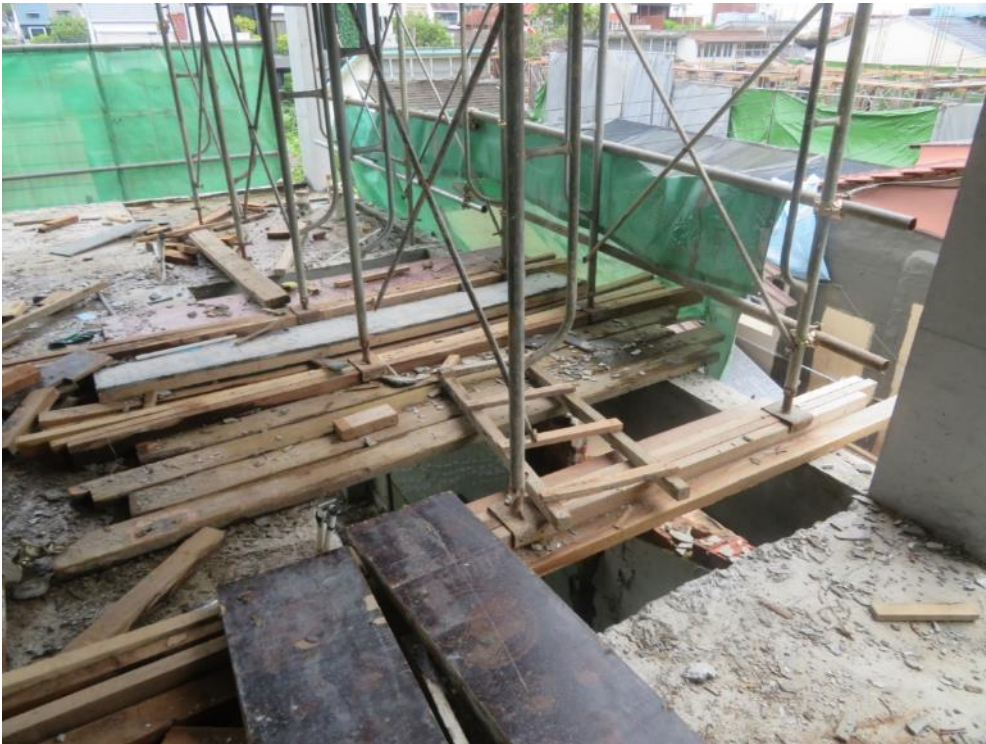
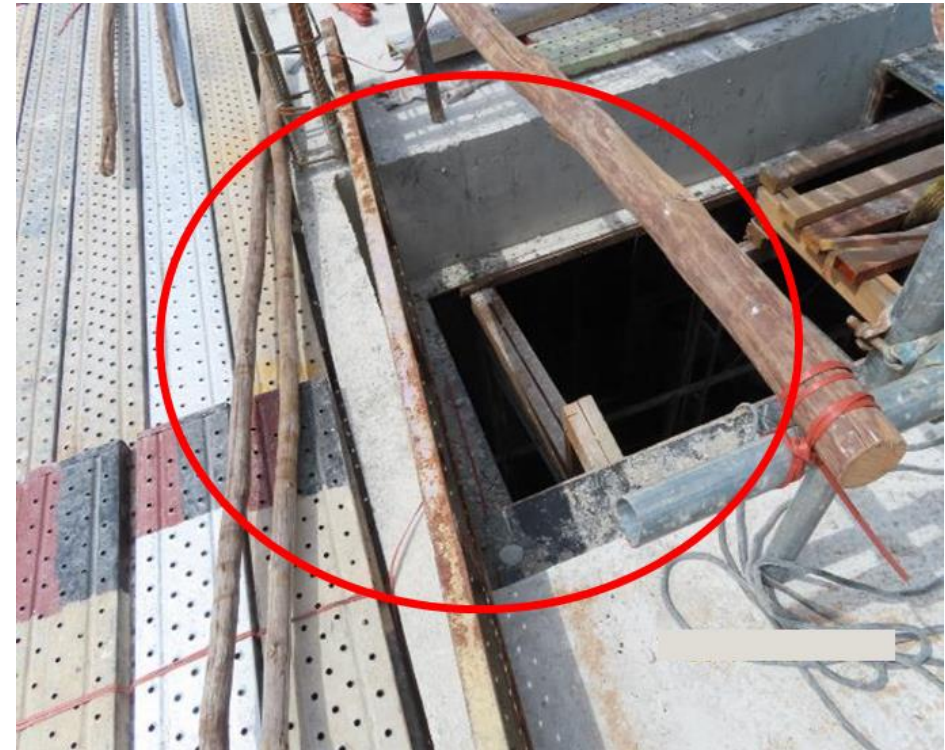
Open Sides and Openings

Reg 8(2) of WSH (Work at Height) Regulations

.... every **open side or opening** into or through which a person is **liable to fall more than 2 metres** shall be **covered or guarded by effective guard-rails or barriers** to prevent fall.

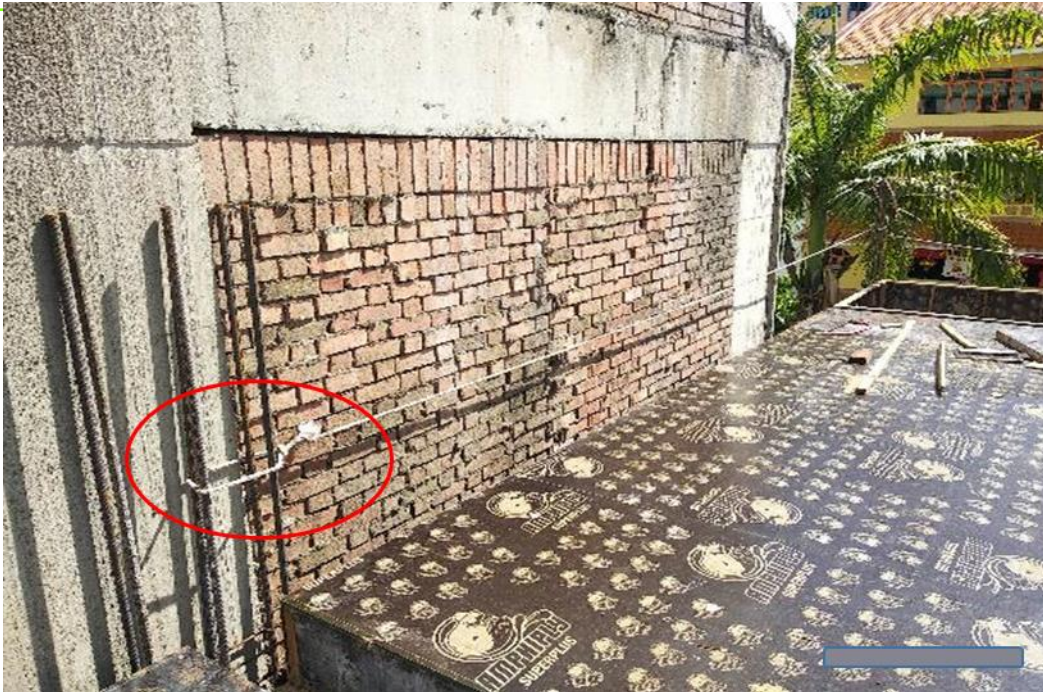
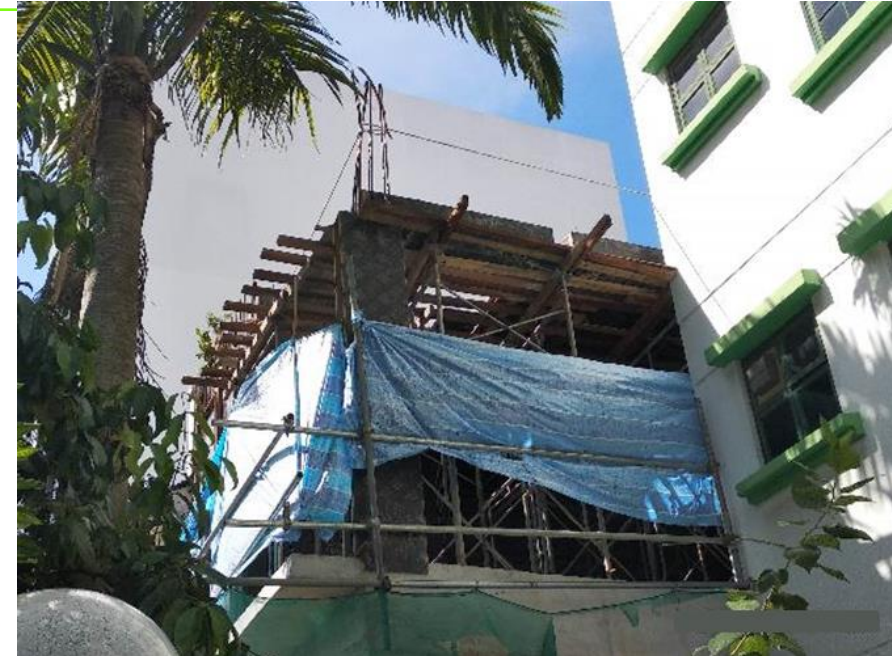
Fall Restraint & Fall Arrest

Reg 8(5) of WSH (Work at Height) Regulations

Where it is **not reasonably practicable to comply** with paragraph (2), or where a cover, guard-rail or **barrier is removed under paragraph (3)**, or during the **installation, alteration or removal of the covers, guard-rails or barriers** —

- (a) **a travel restraint system shall be used** to prevent a person falling into or through the open side or opening referred to in paragraph (2); or
- (b) where it is **not reasonably practicable to comply with sub-paragraph (a)**, **a fall arrest system shall be used**.

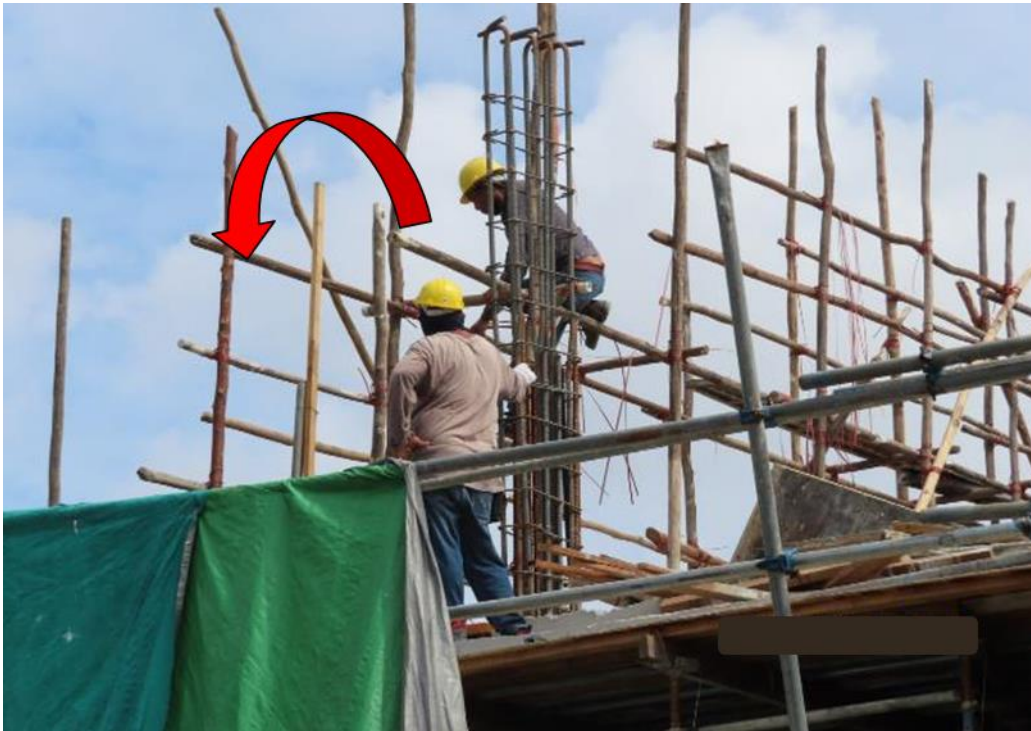
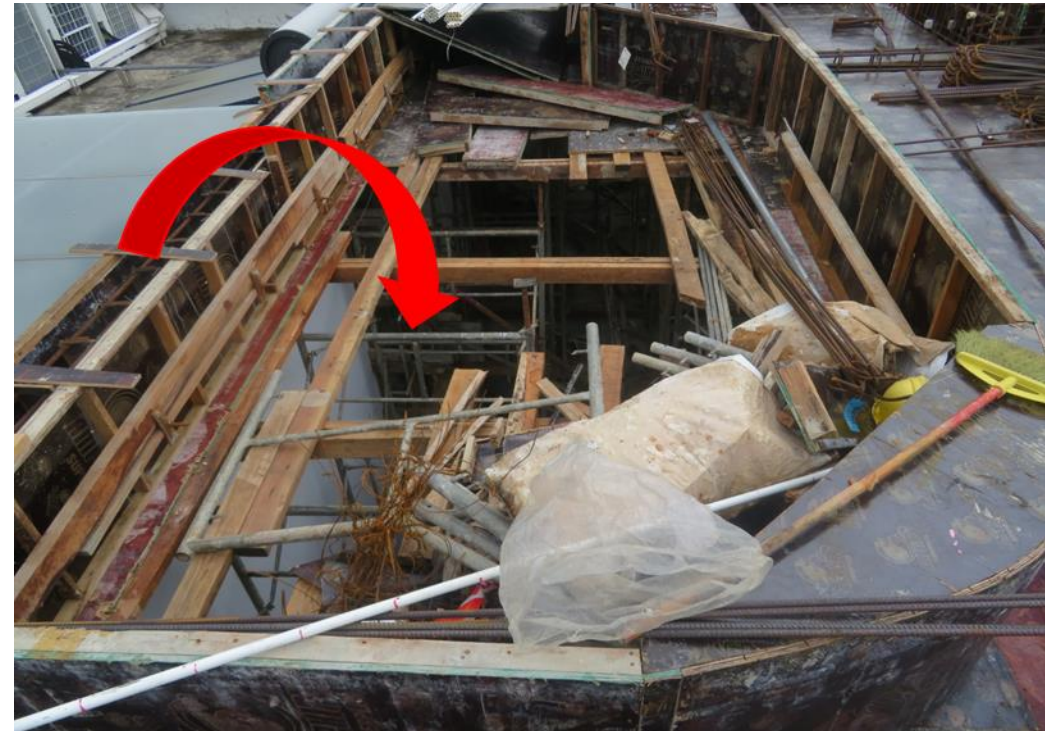
Unsafe Work Procedures

S12(3)(b) / S14(4)(b) of WSH Act

*Duty (on Employer / Principal) to ensure that **adequate safety measures** are taken in respect of any machinery, equipment, plant, article or **process**...*

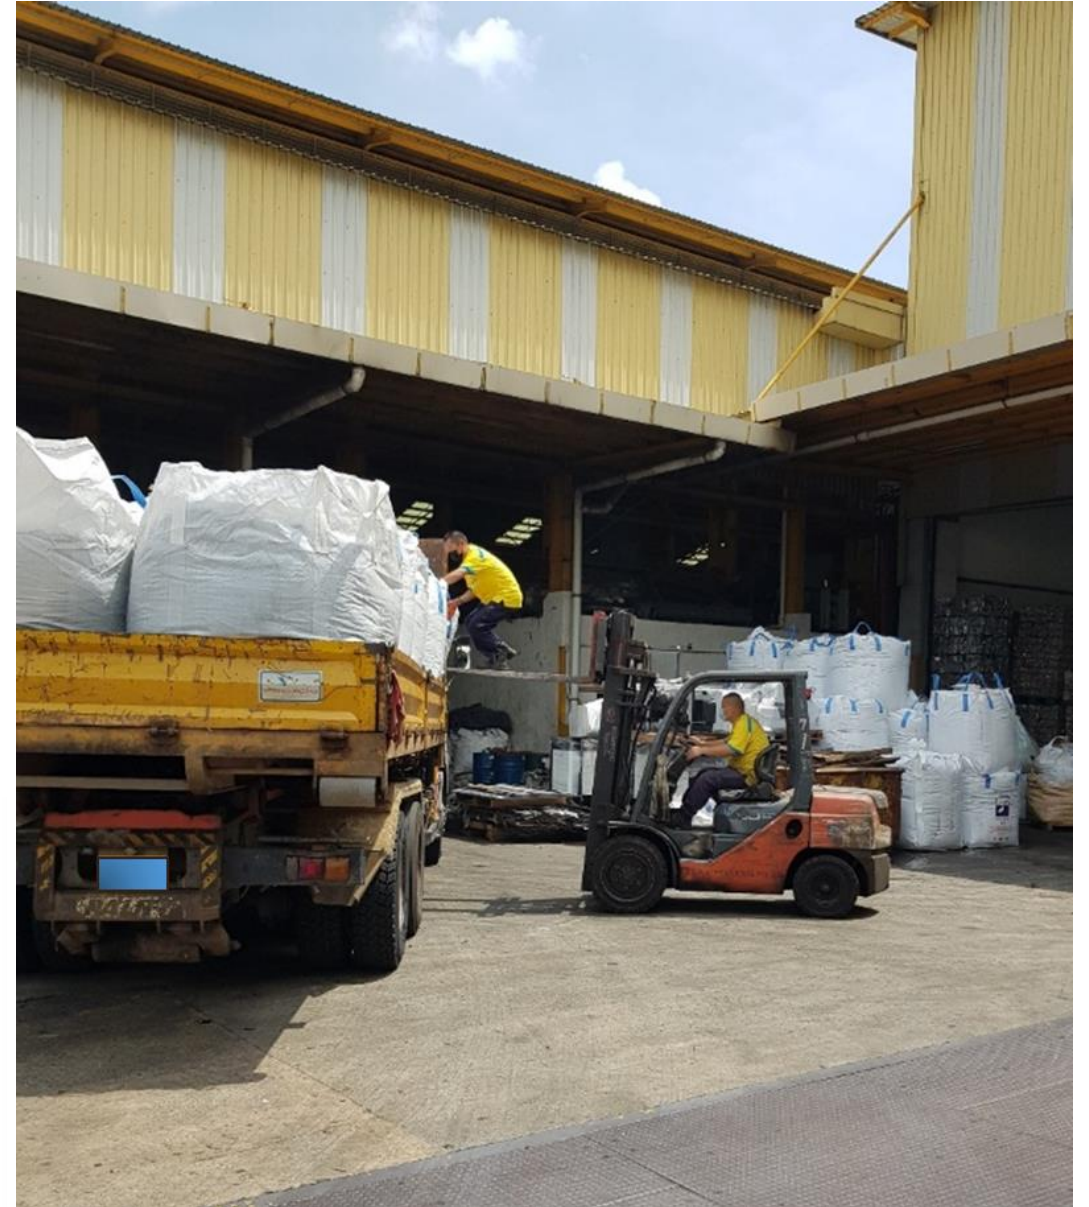
Unsafe Work Procedures

S12(3)(b) / S14(4)(b) of WSH Act

*Duty (on Employer / Principal) to ensure that **adequate safety measures** are taken in respect of any machinery, equipment, plant, article or **process**...*

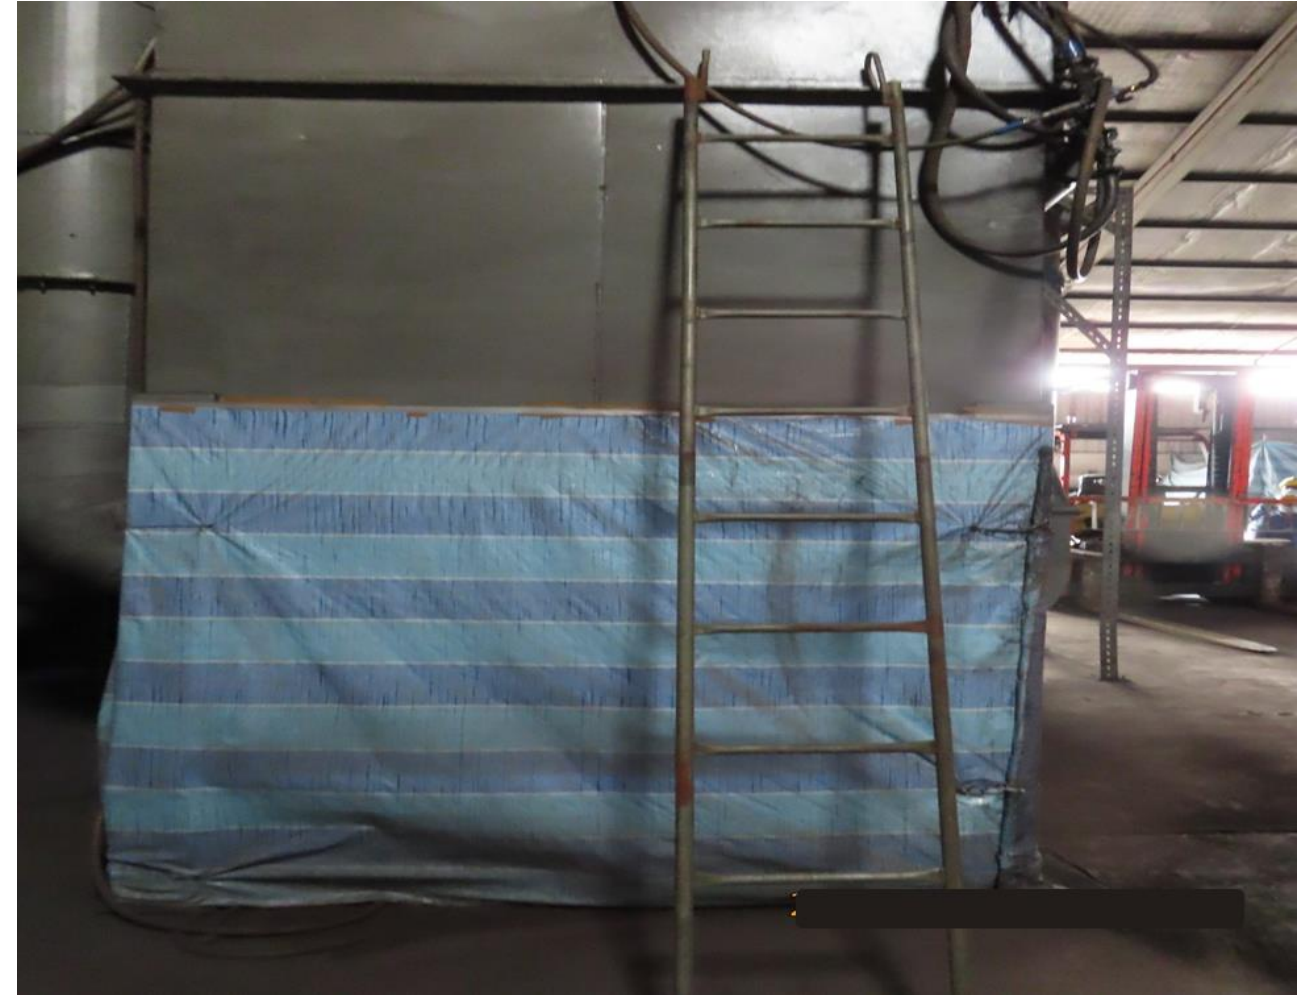
Unsafe use of Ladders

Regs 18(3) & 18(4) of WSH (Work at Height) Regulations

*(3) The **surface** upon which any ladder (except for fixed ladders) rests or bears upon when used by a person shall —*

*(a) be **stable**;*

*(b) be **level and firm**; and*

*(c) be of **sufficient strength to safely support** the ladder and any person and load intended to be placed on it.*

*(4) Every ladder in a workplace shall be **so positioned as to ensure its stability during use**.*

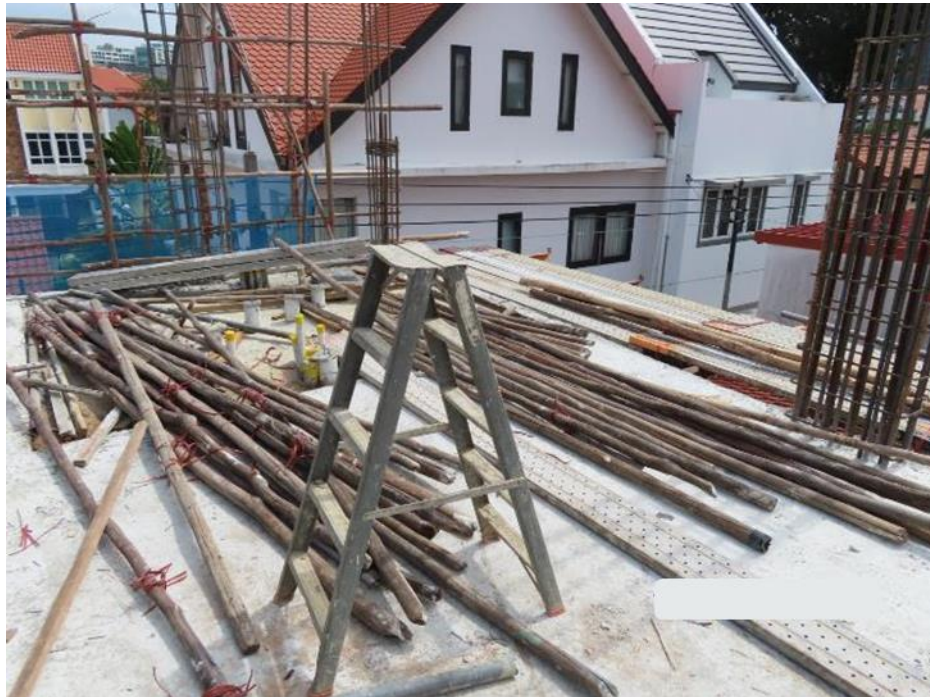
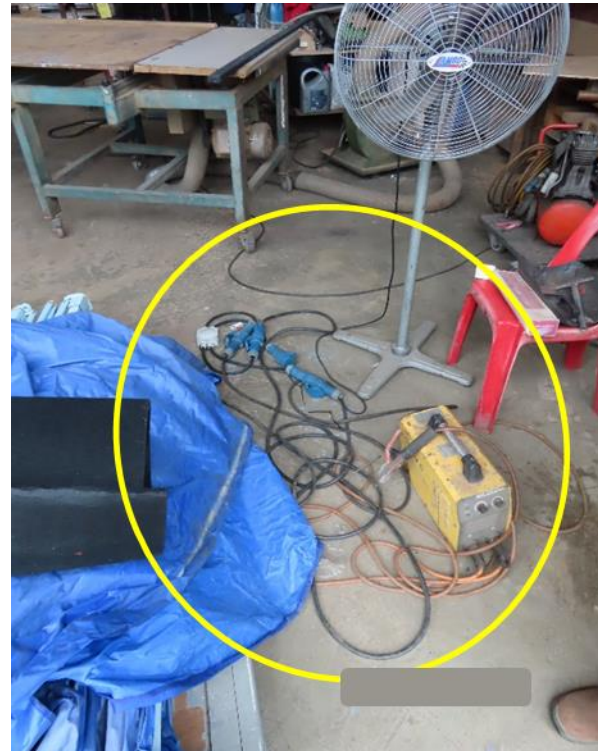
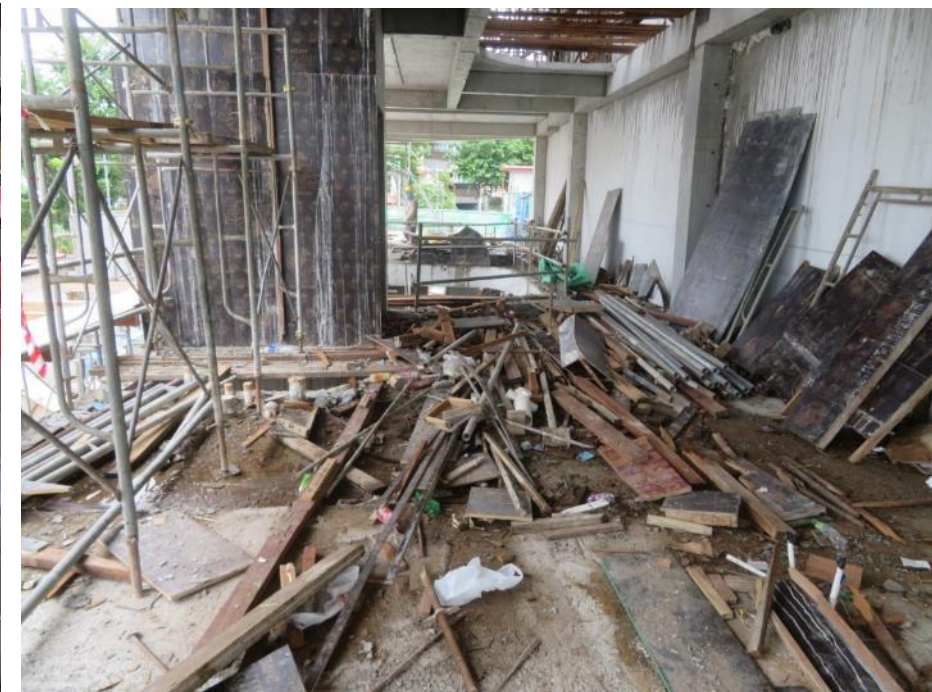
Tripping Hazards

Reg 27 of WSH (Construction) Regulations

*.... ensure ... all passageways, stairs, platforms and other means of access or places of work ... are **kept free from debris** or protruding objects or any other obstruction **that could cause tripping**.*

Reg 24(1)(a)(iii) of WSH (General Provisions) Regulations

All goods, articles and substances ... are stored, stacked or placed ...so as not to interfere with the unobstructed use of passageways ...
