Work At Heights Accident Case Studies and Learning Points

MINISTRY OF
MANPOWER

Occupational Safety and Health Inspectorate

7 Sep 2023

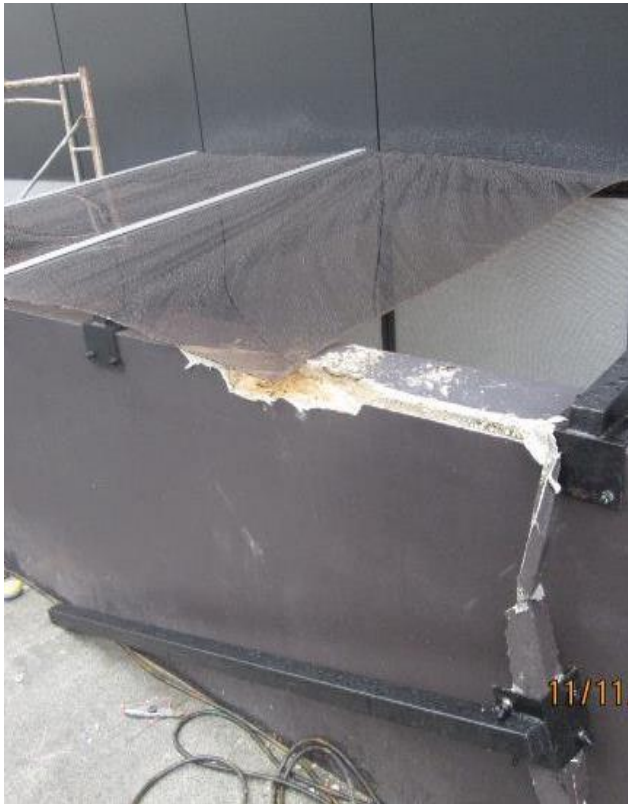
Case Study #1 – Fall through Fragile Surface

- The Deceased stood on a metal frame over a staircase to install roof sheets, when the metal frame broke
- He lost his footing, fell and landed on the staircase landing below

- The company did not provide any personal fall arrest system to protect its workers performing work at heights (WAH)
- The company also did not provide adequate WAH training for its workers
- **The company director was prosecuted and issued an \$80,000 fine**

- Establish a fall prevention plan (FPP) for the roof works to address all potential hazards and their control measures
- Ensure that any structure a worker would be required to stand on is able to bear load, including any additional load during roof installation
- If a surface has been identified as fragile, no person should be allowed to be standing on the fragile surface
- Implement effective control measures, including providing safe means of access to work locations at heights, implementing travel restraint or personal fall arrest system

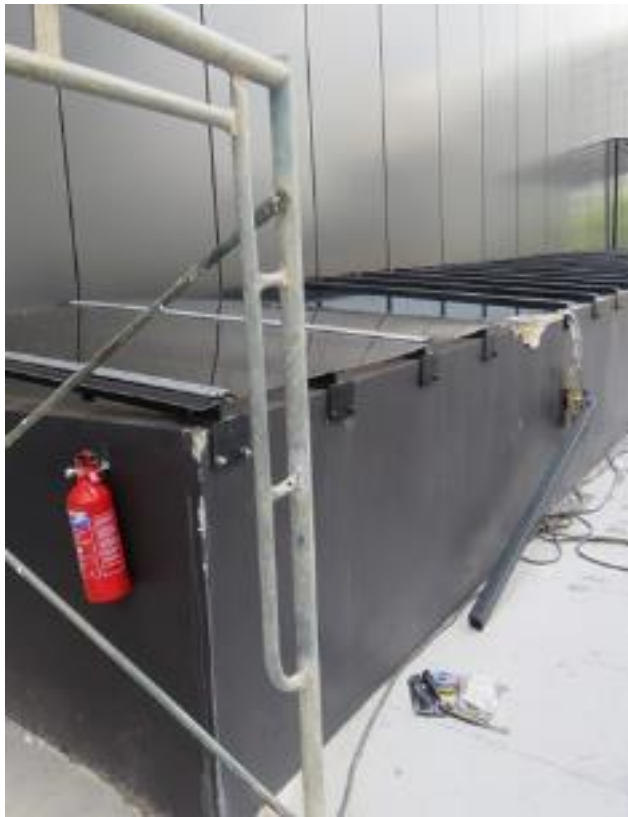
Case Study #1 – Fall through Fragile Surface

Learning Points

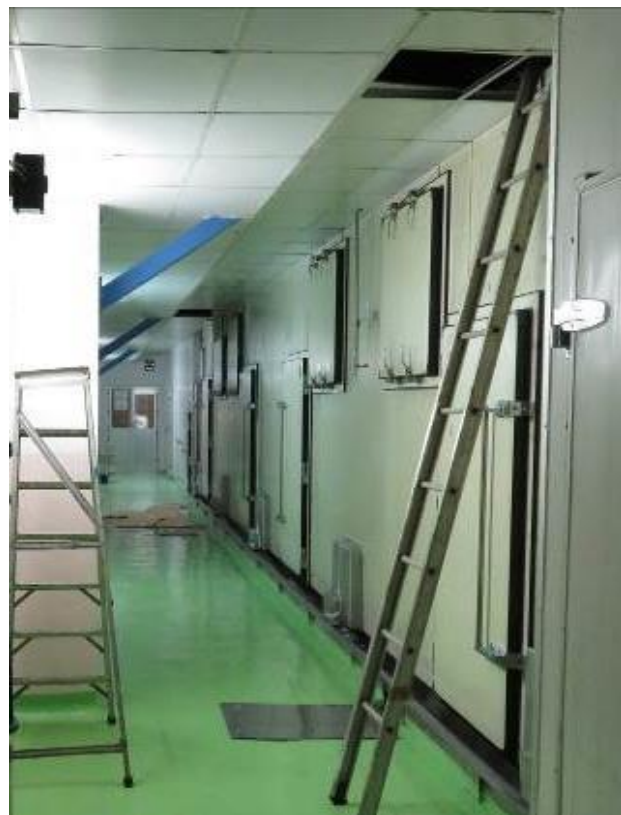
Case Study #2 – Fall through Fragile Surface

- The Deceased was working above a false ceiling in a building when he fell through the fragile surface and landed on the walkway 3m below.

- There was no safe means of access to the Deceased's work area
- Within the false ceiling, only the structure atop the machine was able to bear weight. However, there was no barricade for the said structure, nor demarcation of fragile surfaces within the false ceiling
- Lighting was poor and no additional lighting was provided
- **Both the occupier and the employer of the Deceased were prosecuted and each issued a \$220,000 fine**

- Provide suitable means for height access (e.g., vertical personnel platform) to eliminate the need to step directly on fragile surfaces
- Substitute ladders with safer alternatives (e.g., step platform) to provide more foothold/ stability
- If using a vertical ladder to access another level, ensure it is of adequate height and secured at the base
- Provide adequate supervision and ensure workers are trained in WAH

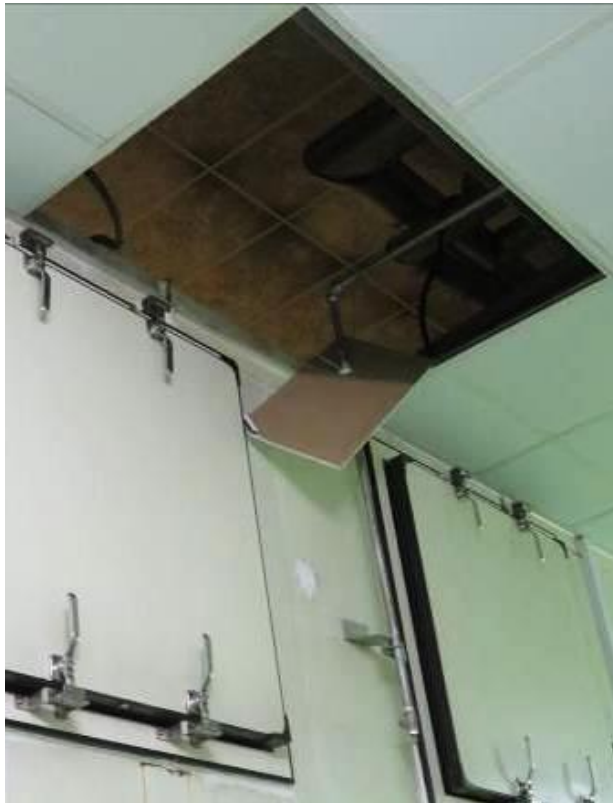
Case Study #2 – Fall through Fragile Surface

Learning Points

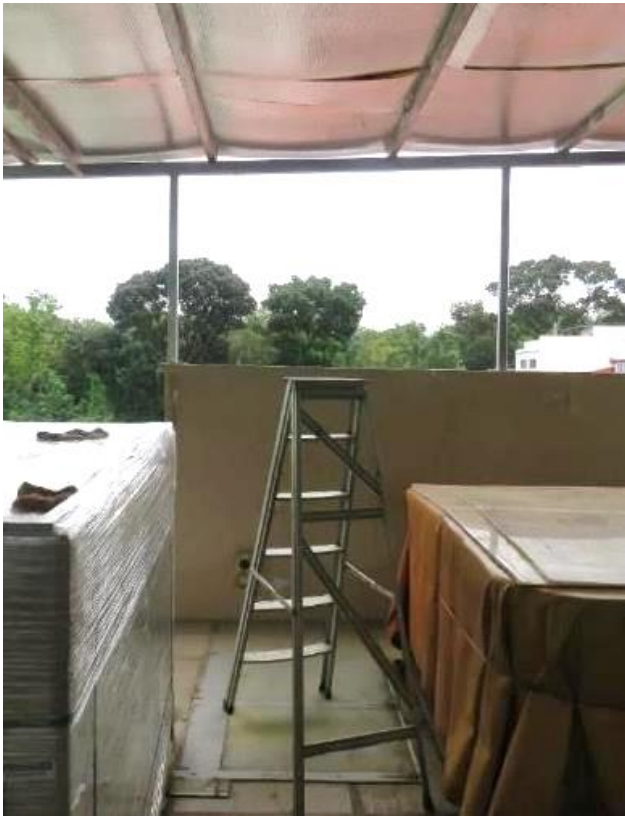
Case Study #3 – Fall from Ladder

- The Deceased was working at the roof terrace of a private dwelling when he fell from a ladder and landed on the floor

- The company had failed to communicate its RA to its employees before allowing them to commence work
- Inadequate supervision – no supervisor deployed for the worksite
- Inadequate training – the Deceased had not attended any WSH training
- **The company was prosecuted and issued a \$100,000 fine**

- Ensure that ladder is of sufficient height for the worker to access the designated work area without having to stand on its top rungs
- Set up the ladder only on firm, level ground and ensure that the spreaders are locked in place prior to using the ladder
- Always maintain three points of contact when using a ladder
- Ensure that the ladder is suitable for the work and workers need not overreach
- Consider using a platform ladder to provide handhold and a more stable foothold

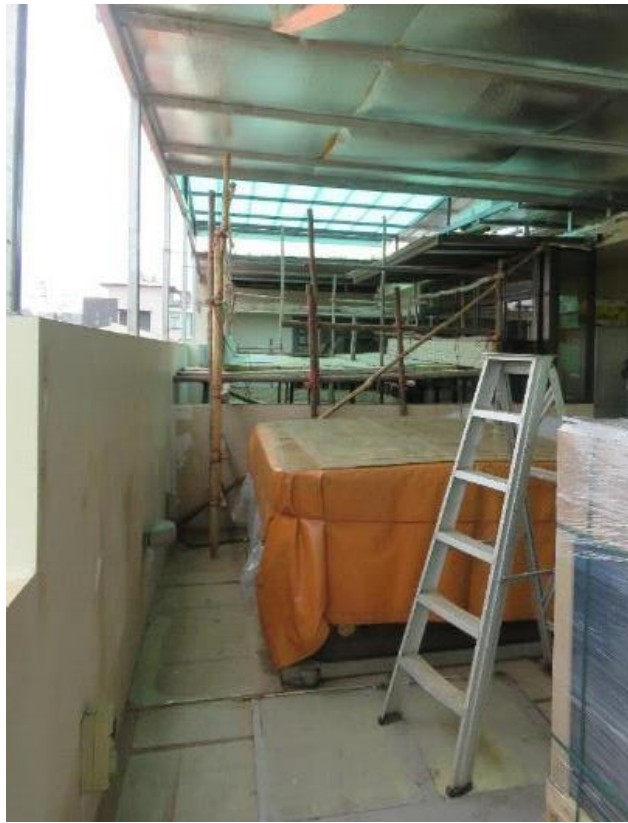
Case Study #3 – Fall from Ladder

Learning Points

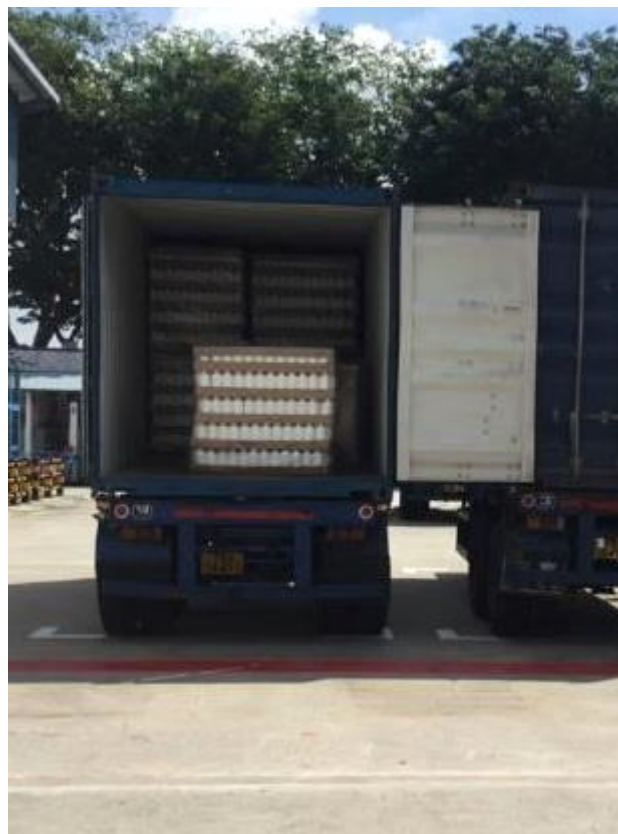
Case Study #4 – Fall from Edge of Container

- The Deceased was working inside a container, shifting material towards the edge of the container to be unloaded by a forklift
- In the process, he fell backwards over the edge of the container and hit his head against the ground

- The Deceased had been spotted to work near the open edge on several occasions; there were no fall prevention measures in place
- The items to be shifted were bulky and heavy, which increased the risk of the Deceased missing his footing at the edge of the container
- **The company was prosecuted and issued a \$50,000 fine**

- Eliminate the need to work at height by unpacking only at a suitable unloading bay or when the container is placed on the ground
- Ensure workers are able to adopt a safe working position away from unprotected edges
- If manual handling is required, ensure goods are packed into small packages to avoid bulky packages which may block one's view
- Provide adequate manpower to perform unpacking of container

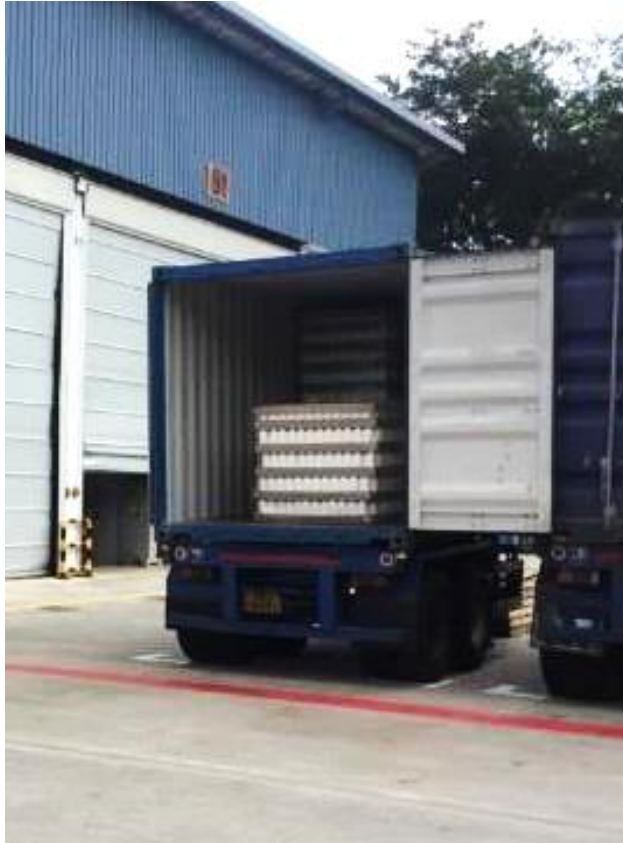
Case Study #4 – Fall from Edge of Container

Learning Points

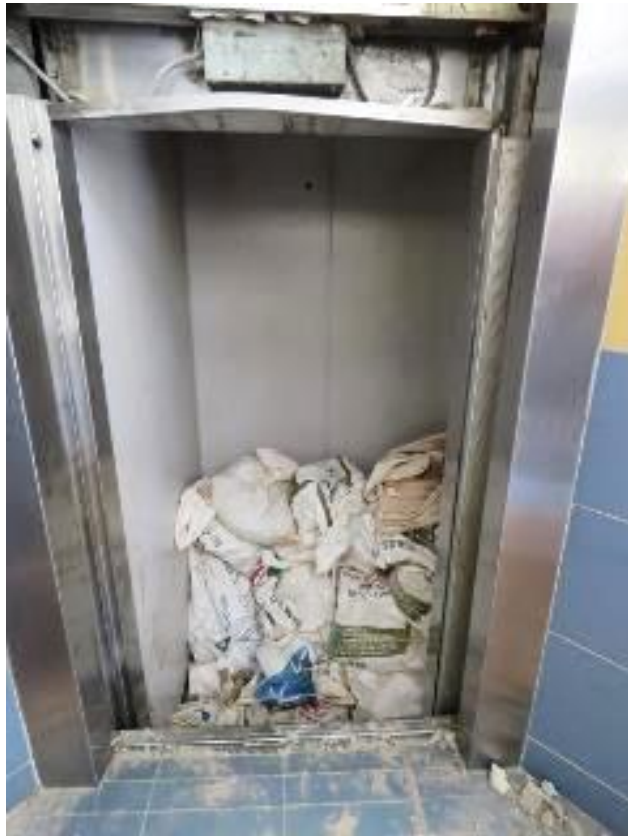
Case Study #5 – Caught between Lift Car and Landing

- The Deceased was using a lift car to bring debris down to the ground floor, with a co-worker operating the lift controls atop the car
- While the Deceased reached out of the lift door, the lift car suddenly descended and he was caught between the lift landing and the lift car

- There was gross overloading of the lift car, which resulted in its fast descent. The lift's wire rope was worn, which contributed to the accident
- The employer had deviated from its work procedure and failed to conduct any RA for use of the lift car to transport debris
- **The company director was prosecuted and issued a \$125,000 fine**

- Ensure that the lift system has a valid certificate from an authorised examiner before using it for material transport
- Material transported in the lift car must be within its safe working load
- Conduct a thorough risk assessment, taking into consideration any work at surrounding areas could introduce hazards to workers using the lift
- Develop and implement safe work procedures for the lift car to be used safely, including worker/s who need to access the lift shaft

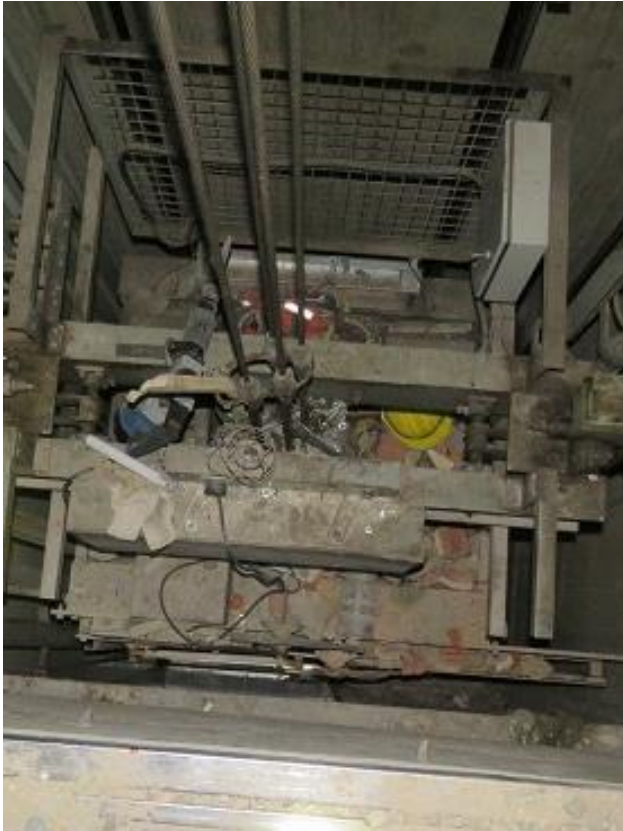
Case Study #5 – Caught between Lift Car and Landing

Learning Points

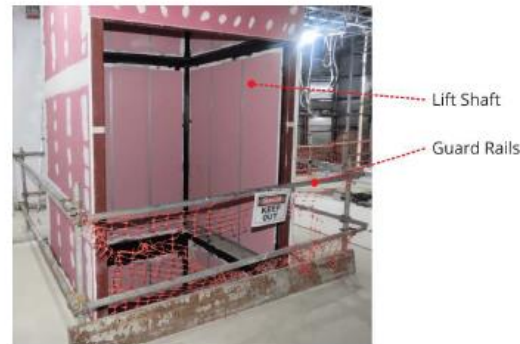
Figure 1: Scene of the accident.

On 18 April 2023, a worker was carrying out welding work at a newly constructed lift shaft when he fell into the shaft and landed on the ground about six metres below. The worker was sent to the hospital where he died of his injuries.

Preliminary investigations revealed that guard rails were present around the open side of the lift shaft. The worker was not equipped with any fall-arrest equipment or travel restraints when the accident occurred.

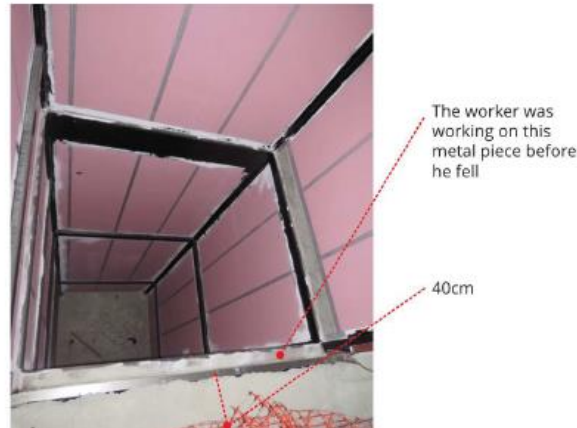
The worker was working on this metal piece before he fell

40cm

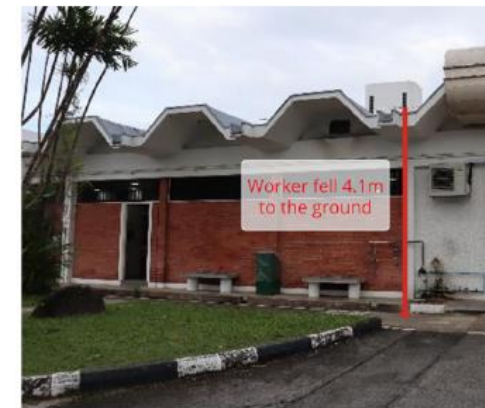
Figure 1: Scene of the accident.

On 26 February 2023, a worker was preparing to carry out water-proofing works on the roof of a factory when he fell 4.1 metres to the ground. He was sent to the hospital but died of his injuries on 1 March 2023.

Preliminary investigations revealed that a horizontal lifeline was installed on the roof, but the worker was not wearing a safety harness or a safety helmet at the time of the accident.

- **Fall Prevention Plan (FPP):** Establish and implement a site-specific FPP to reduce the risk of falling from height when working on roofs.
