View in browser Ref: 2122072

March 2022

# Worker injured after falling from work platform

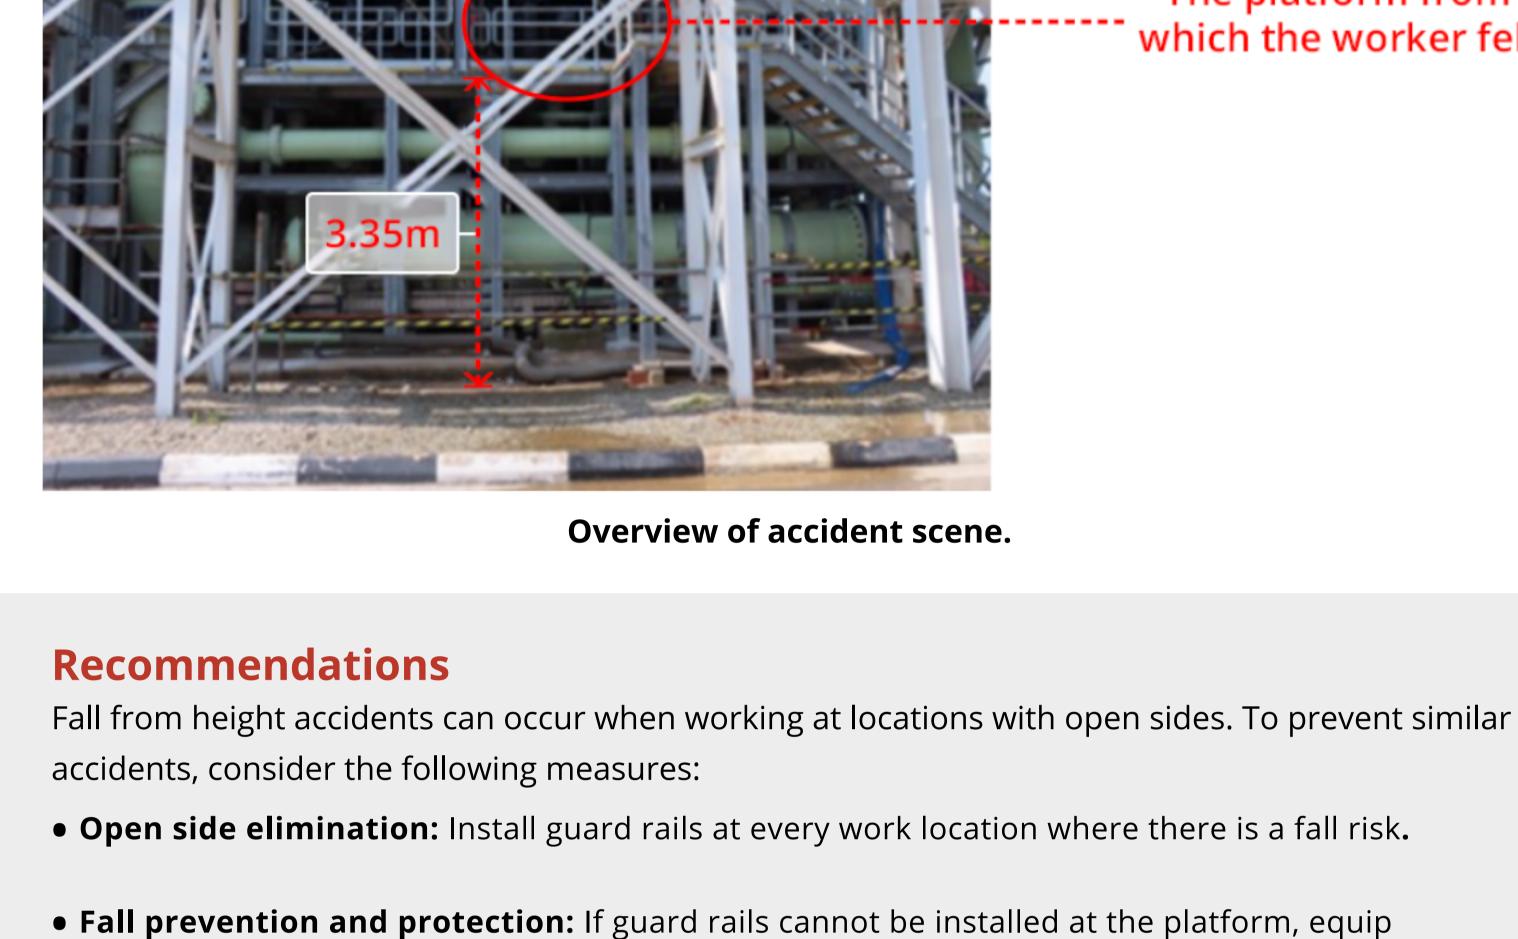
A worker was standing on the second level of a work platform draining rainwater from a tarpaulin

sheet, when he lost his balance and fell 3.35 metres to the ground. He was conveyed to the hospital

The platform was unguarded (i.e. without railings) at the time of the accident, and the worker did not wear travel restraints.

The platform from

which the worker fell

workers with a suitable travel restraint system so that they cannot get close to the open side(s). In cases where a worker could fall more than 5m, he should wear a fall arrest system.

worker could fall a distance of more than 3 metres.

• Strict access control: Prevent unauthorised access by cordoning off hazardous work areas using effective barricades and safety signs. Only persons aware of the on-site danger(s) and risk

• Permit-to-Work (PTW): Implement a PTW system for all work at height locations where a

controls may be allowed to enter the hazardous work area (the platform in this case).
