WSH ALERT

Worker dies after falling from a ladder

Workers injured when boom lift failed

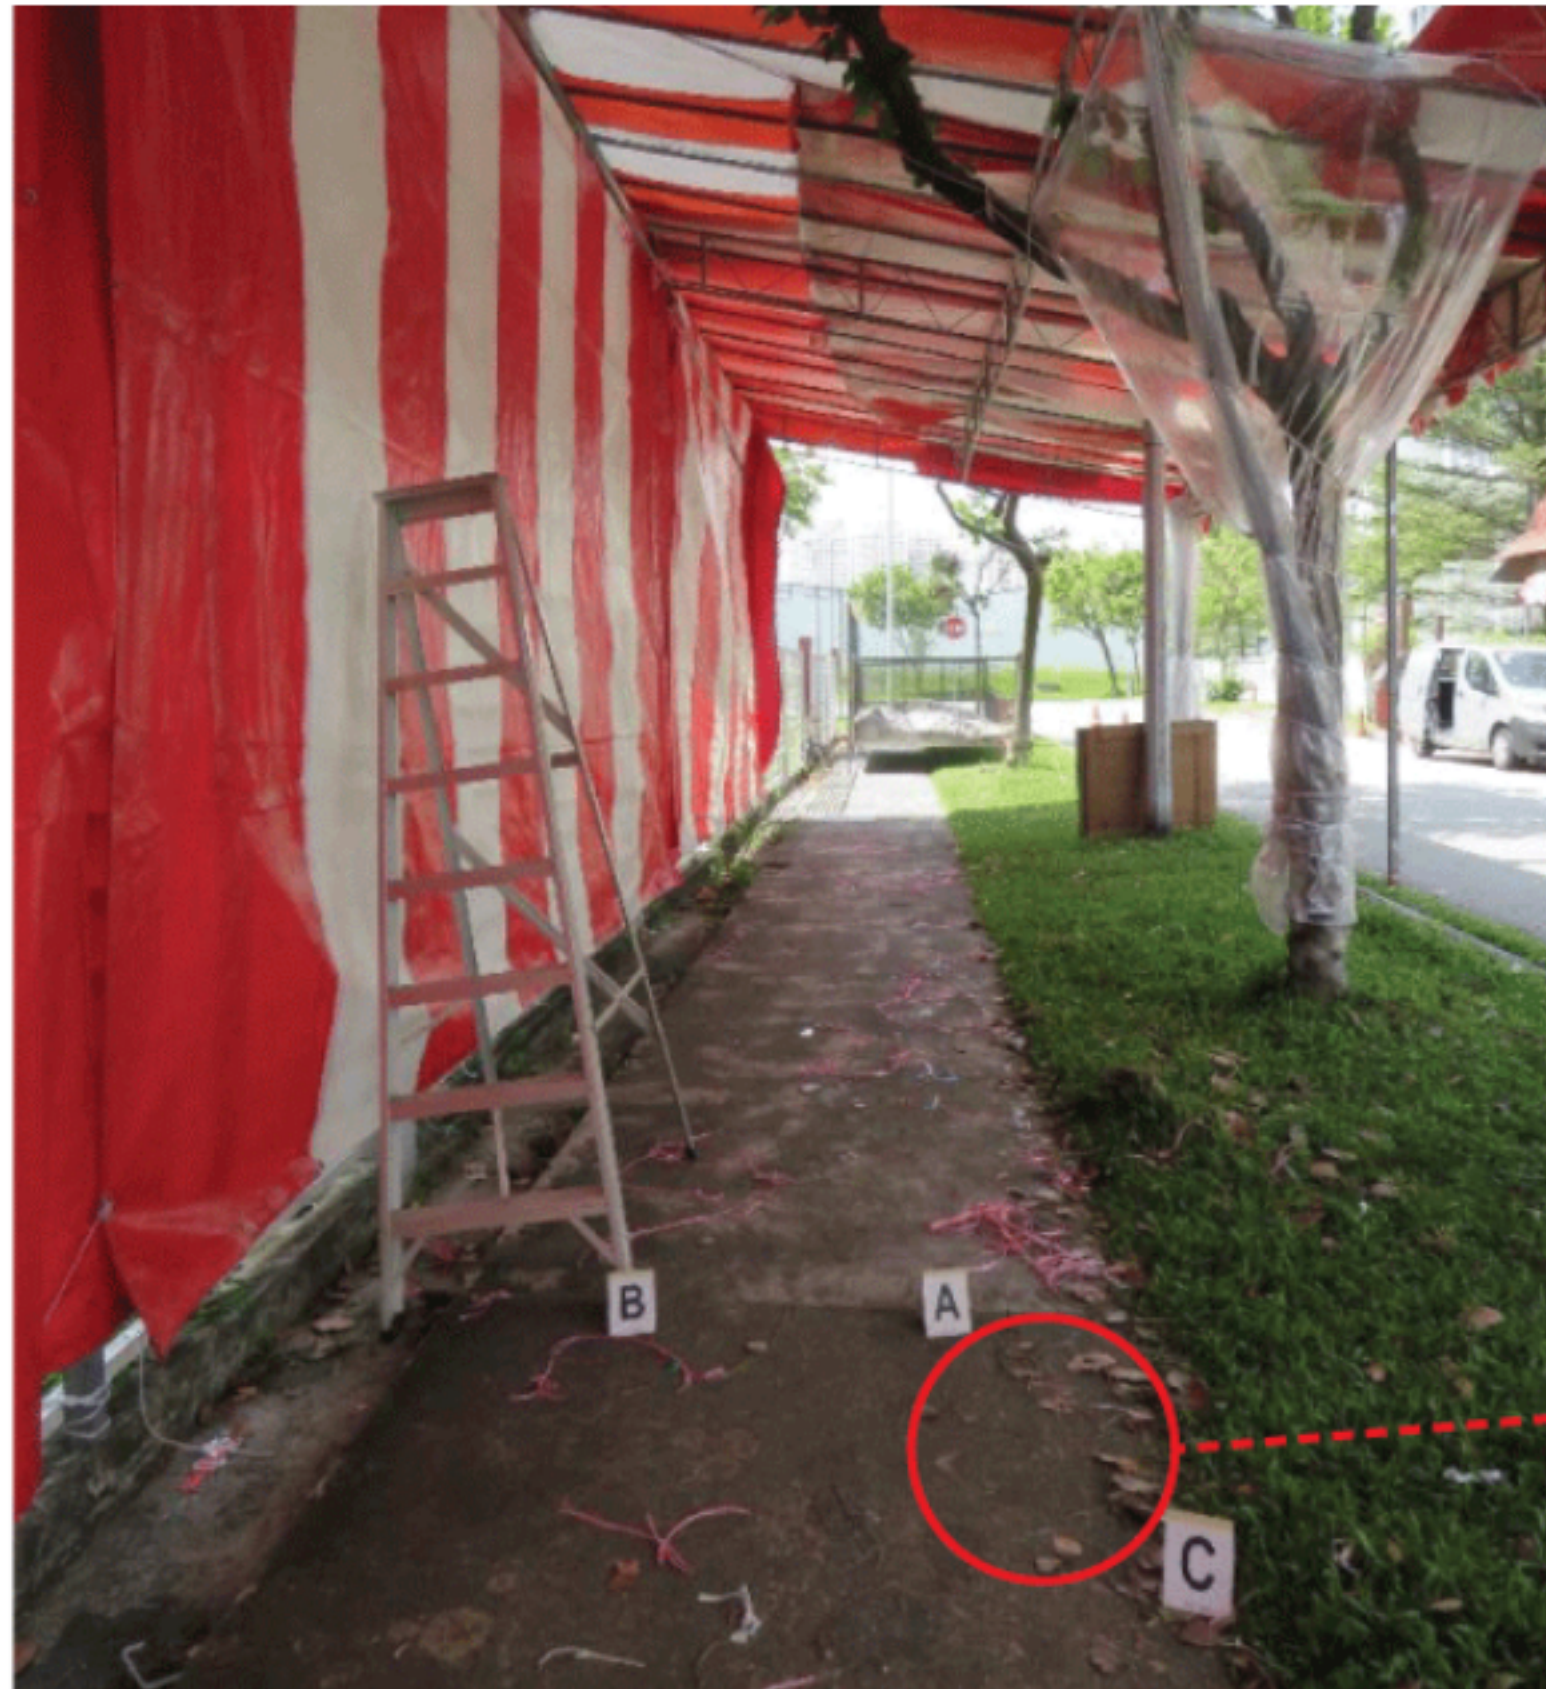
On 21 April 2022, a worker suffered head injuries after falling about 1.2m from an A-frame ladder while trying to hang items to the top of a tentage. He passed away two days later.

The worker was wearing slippers when using the ladder, and the floor was wet from rain.

Location where worker was found.

Scene of the accident.

- **Select a good ladder:** Confirm the ladder is in good condition and of the correct height for the task. Do not use ladders that are damaged or contain loose or missing parts. The use of ladders certified to SS EN 131: 2019 is strongly recommended.

- **Safe ladder location:** Place the ladder on stable and flat ground.
- **Worker health:** Check that workers are fit for the task before starting work. Do not allow workers who are feeling unwell to get onto a ladder.

- **Safe ladder use:** Lock the spreaders before using an A-frame ladder. Maintain three points of contact when climbing up or down the ladder. Do not carry materials or tools as you climb. Never step on the top rung of the ladder.

- **No overreaching:** Overreaching can cause the ladder to become unstable. Instruct workers to keep their weight centred between the ladder's side rails at all times. Shift the ladder as necessary to avoid overreaching.

- **Personal protection:** Provide workers with anti-slip footwear. Equip workers with a safety helmet to protect against head injuries.

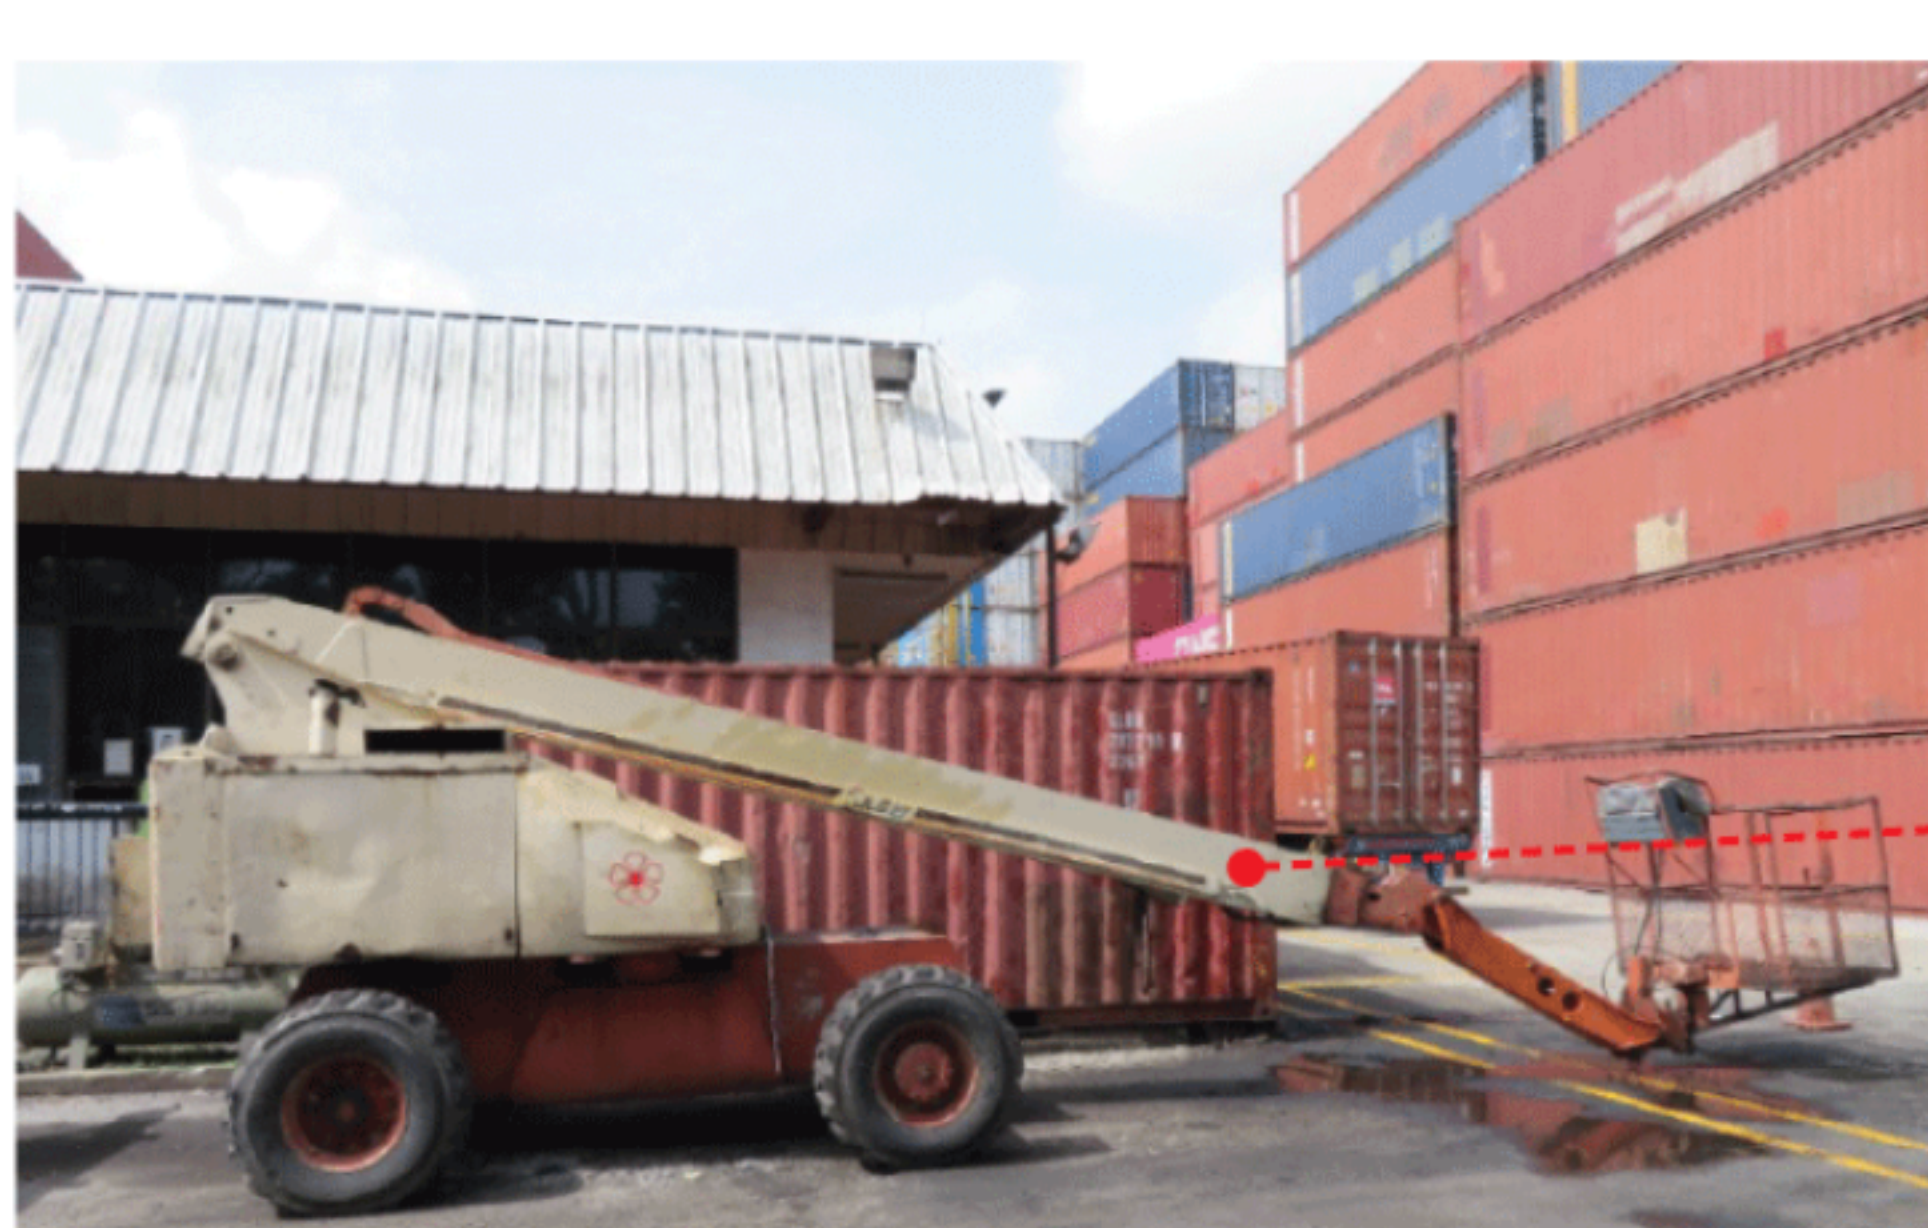
Figure 2: Boom lift involved in the accident.

Investigations revealed that the mechanism in the final telescopic section of the boom was broken.

Telescopic section of the boom lift

- **Mandatory examination and testing:** Ensure MEWPs are inspected by an Authorised Examiner as per statutory requirements (at least once every six months for lifting platforms used to carry workers). Never allow MEWPs to be used if its lifting platform certificate has expired.
- **Regular maintenance:** Implement a preventive maintenance programme for MEWPs according to the manufacturer's recommendations. Ensure that maintenance is carried out by competent personnel.
- **Authorised operator:** Ensure only authorised operators are allowed to operate the MEWP. Authorised operators must complete brand and model-specific familiarisation training before operating the MEWP.
- **Pre-use check:** Confirm that MEWPs are in good working condition and free of visible defects before starting work.

In addition, workers in boom lifts should wear harnesses secured to designated anchorage points.
