09 May 2022

FATAL ACCIDENT

Renovation company owner fell through ceiling board

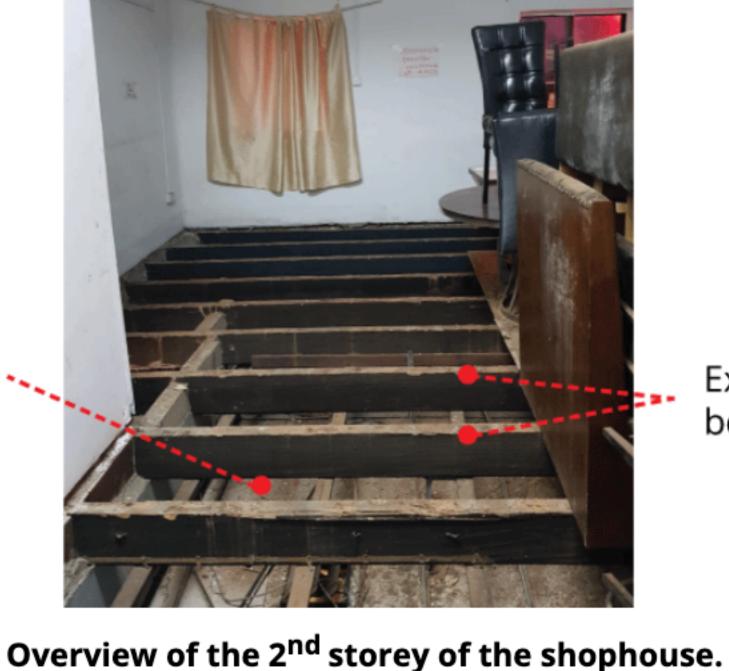
On 2 May 2022, the sole proprietor of a renovation company was surveying the 2nd floor of a shophouse, where the wooden flooring had been removed, exposing the floor beams and the false ceiling board of the 1st floor. He fell between the exposed floor beams, through the false ceiling board and landed about four metres below. He was sent to the hospital where he passed away.

No fall prevention or protection measures were implemented.

False ceiling board under the exposed floor beams

beams

Exposed floor

Ceiling boards are fragile surfaces not designed to bear a person's weight and may give way once stepped on. There was a recent similar accident on 8 April 2022 where an engineer fell through a false ceiling while carrying out maintenance inspections. To prevent similar accidents, consider the following measures:

- Safe work method: Establish and implement a safe method of work for carrying out floor removal and survey works. Ideally, floor removal and surveying works should be done in stages so that the exposure to fragile surfaces can be minimised.
- Identification of fragile surfaces: Any fragile surface revealed upon floor removal must be identified and clearly marked. Instruct workers never to step directly on fragile surfaces.
- Safe workplace: Provide a safe way to access the work area at all stages of the work. Using secured crawl boards is one way to work safely around exposed floor beams and fragile surfaces.

• Fall Prevention Plan (FPP): Implement a FPP and a Permit-To-Work system for work activities

where a worker could fall more than three metres. Along with staged floor removal, consider implementing a travel-restraint system to prevent falls or use a self-retracting lifeline to protect against falls in cases where there is not enough clearance for a shock-absorbing lanyard. For more information, please refer to WSH (Work at Heights) Regulations 2013, WSH Council's

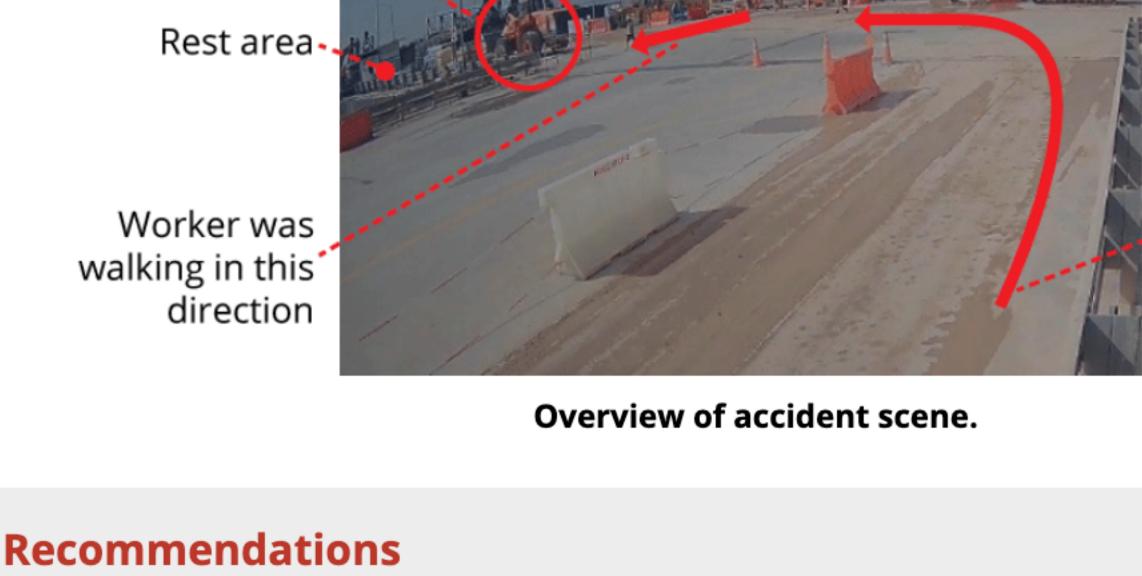
On 22 April 2022, a worker was walking towards a rest area at a worksite when he was run over by a wheel loader. He was sent to the hospital where he passed away on 5 May.

There was no barricaded pedestrian walkway at the accident location.

Wheel loader and accident location

Wheel loader 's

direction of

travel

• Traffic Management Plan (TMP): Establish and implement a workplace TMP. The TMP should consider the provision of barricaded pedestrian walkways, blind spot mirrors, road humps and traffic signs.

• Safe traffic layout: Plan the traffic layout based on the risk assessment for movement of

pedestrians and vehicles. High hazard locations (e.g. traffic junctions) must be identified so that risk controls (e.g. traffic lights, zebra crossing) can be put in place. • Safe area for resting: Locate rest areas where there is minimal vehicular movement.

• Safe driving: Instruct vehicle operators to keep within the site speed limit and to look out for

- pedestrians when driving. Blind spots must be checked especially before turning or reversing. In high-risk areas, move the vehicle only under the direction of a trained ground guide.
- Use of technology: Where possible, use technology to ensure safe movement of vehicles. Examples include blind spot cameras, obstacle and personnel collision detector, and an interlock system that can stop the vehicle upon detection of upcoming collision.
