16  
March  
2022

# WSH ALERT

## FATAL ACCIDENT

### Worker fell off open side of landed residence

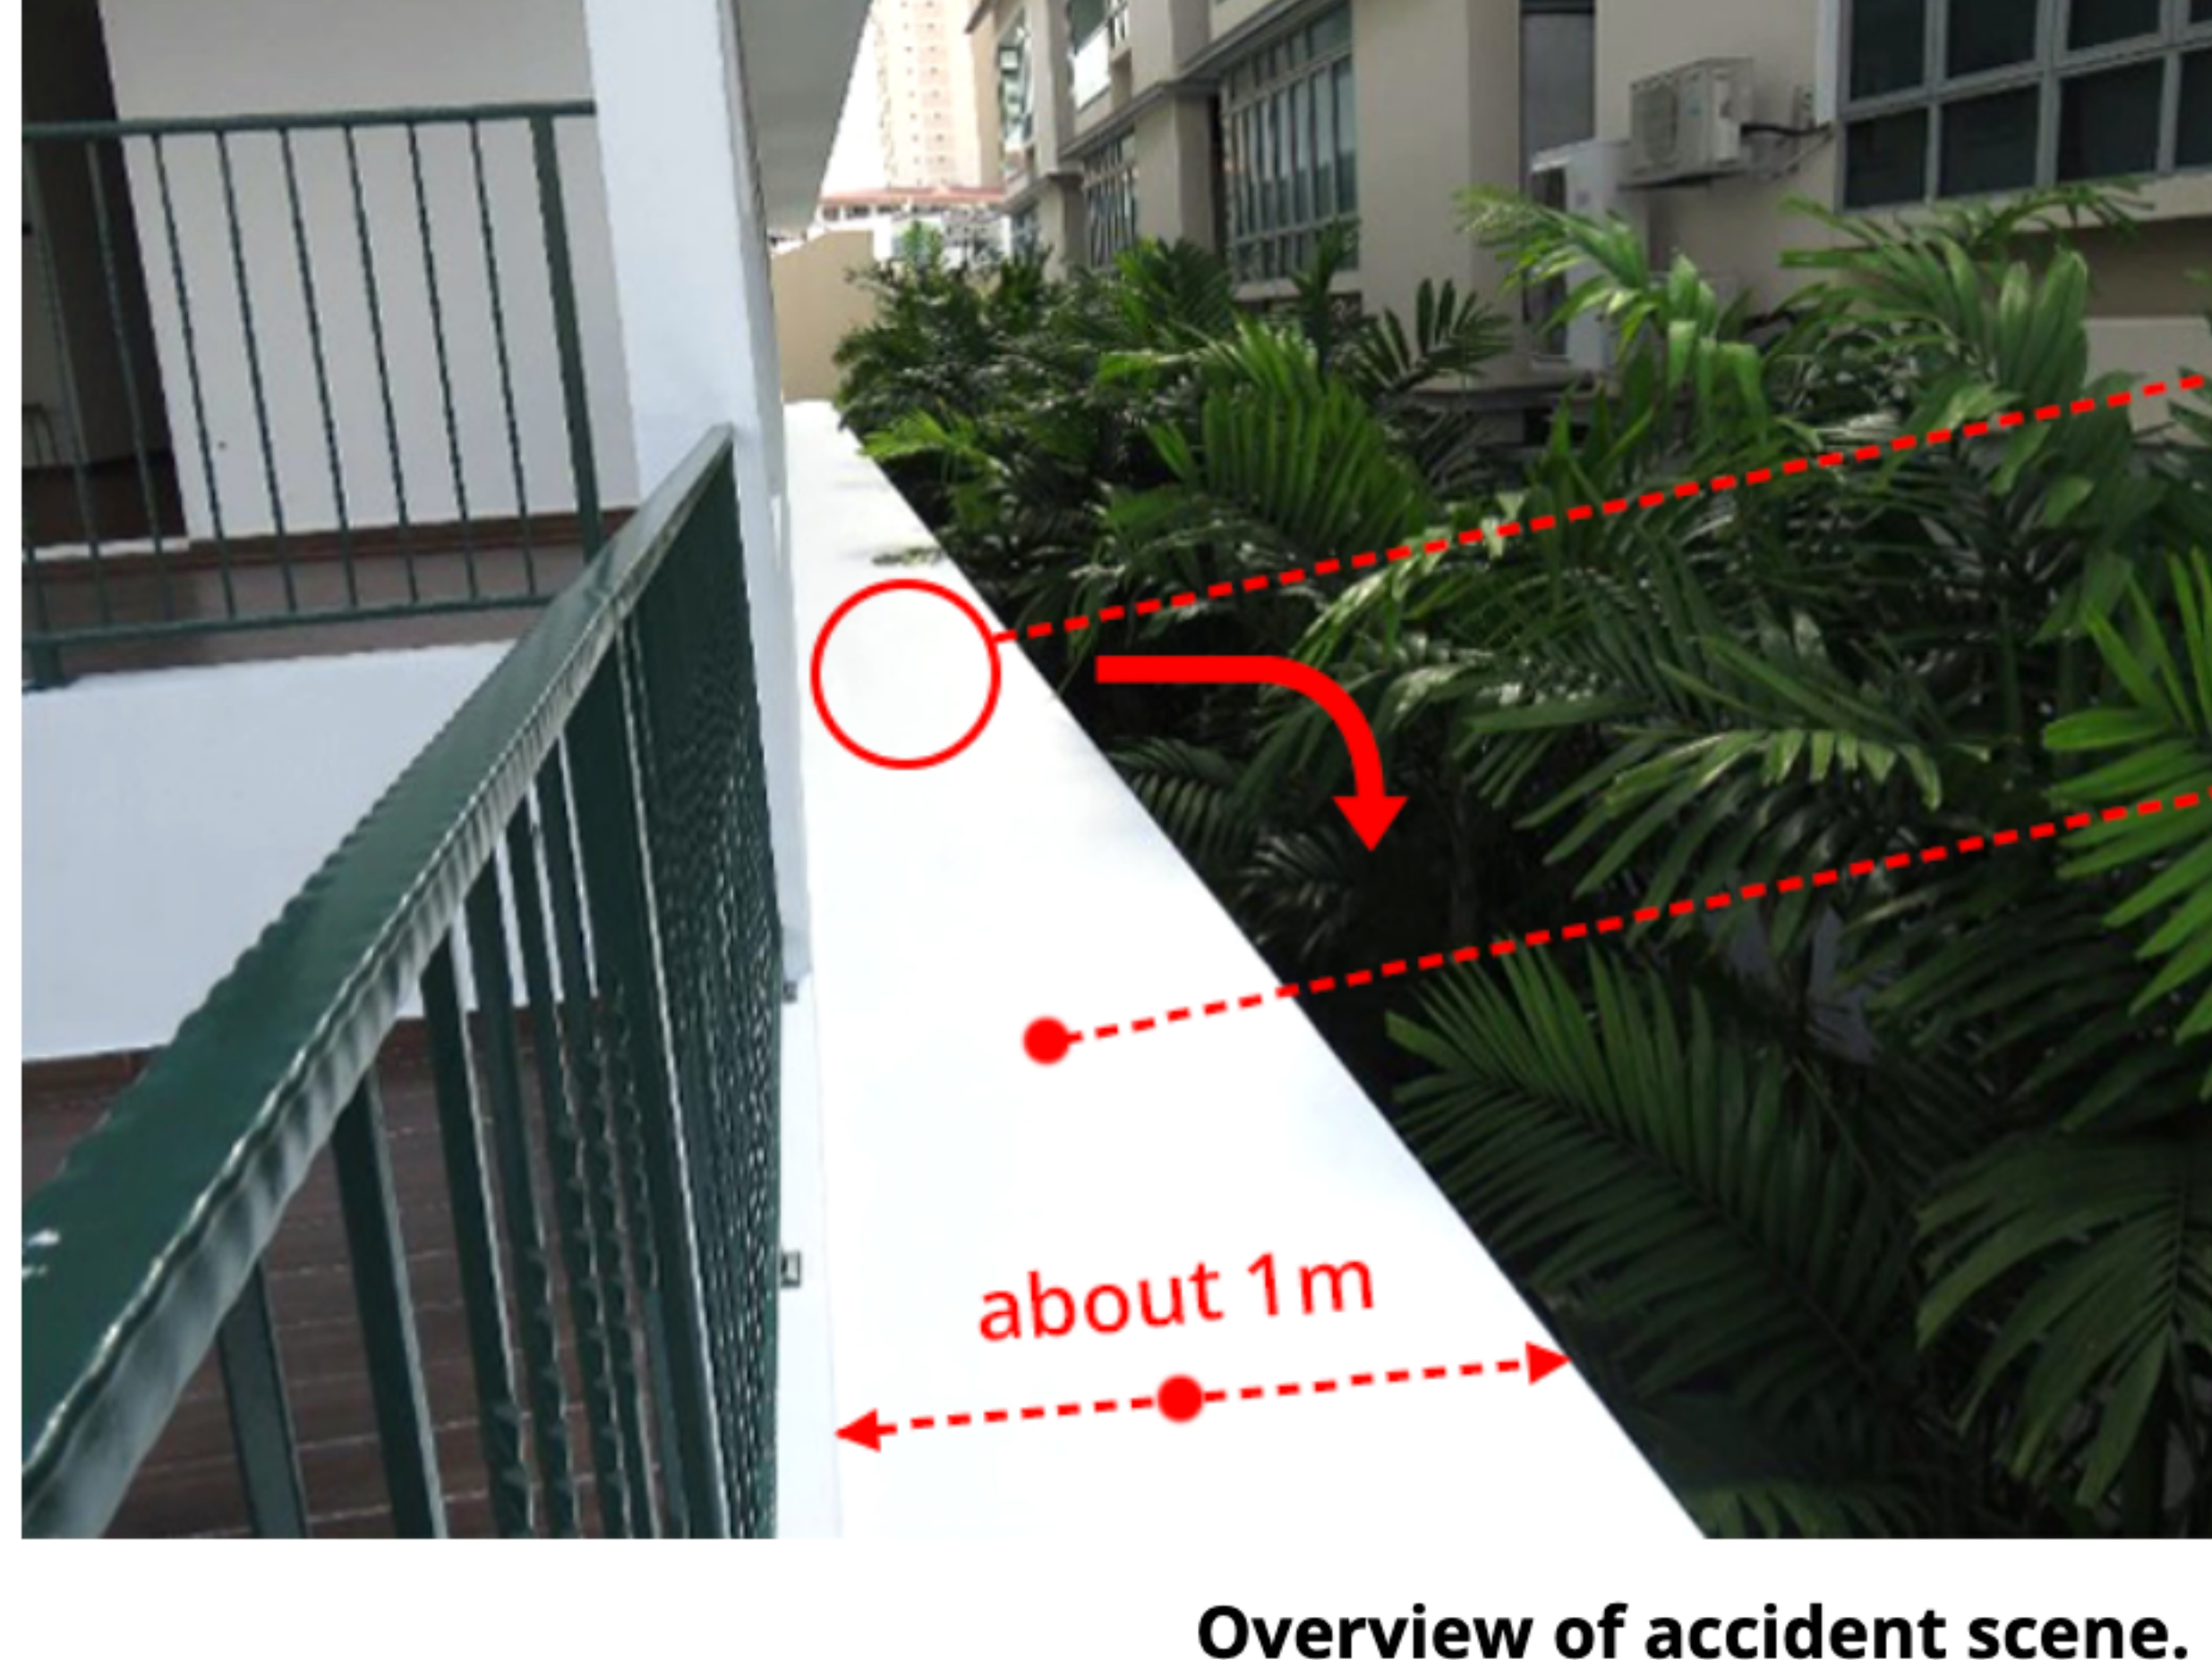
On 2 March 2022, a worker was doing inspection and painting works at a newly constructed three-storey house when he fell off an open side. The worker was likely on the second storey ledge when he fell. He was wearing a pair of slippers and not equipped with personal fall prevention equipment. The worker was sent to the hospital where he passed away.

Overview of accident scene.

Likely location of the worker before he fell

Second storey ledge with open side

about 1m

- **Safe work platform:** Use a proper work platform (e.g. scaffold, mobile elevated work platform) for workers to work safely at height.
- **Fall prevention:** If it is not possible to use a work platform, use a travel restraint system to prevent workers from working too close to open sides.
- **Fall protection:** If work near an open side must be done, provide each worker with a personal fall arrest system with a secure anchor point.
- **Safe Work Procedure (SWP):** Develop a SWP for the task and provide supervision to ensure workers are following the SWP.
- **Permit-to-Work (PTW):** Implement a PTW system for any work where a person could fall more than 3 metres.
- **Proper footwear:** Provide and ensure workers put on the correct footwear (e.g. safety shoes with non-slip soles).

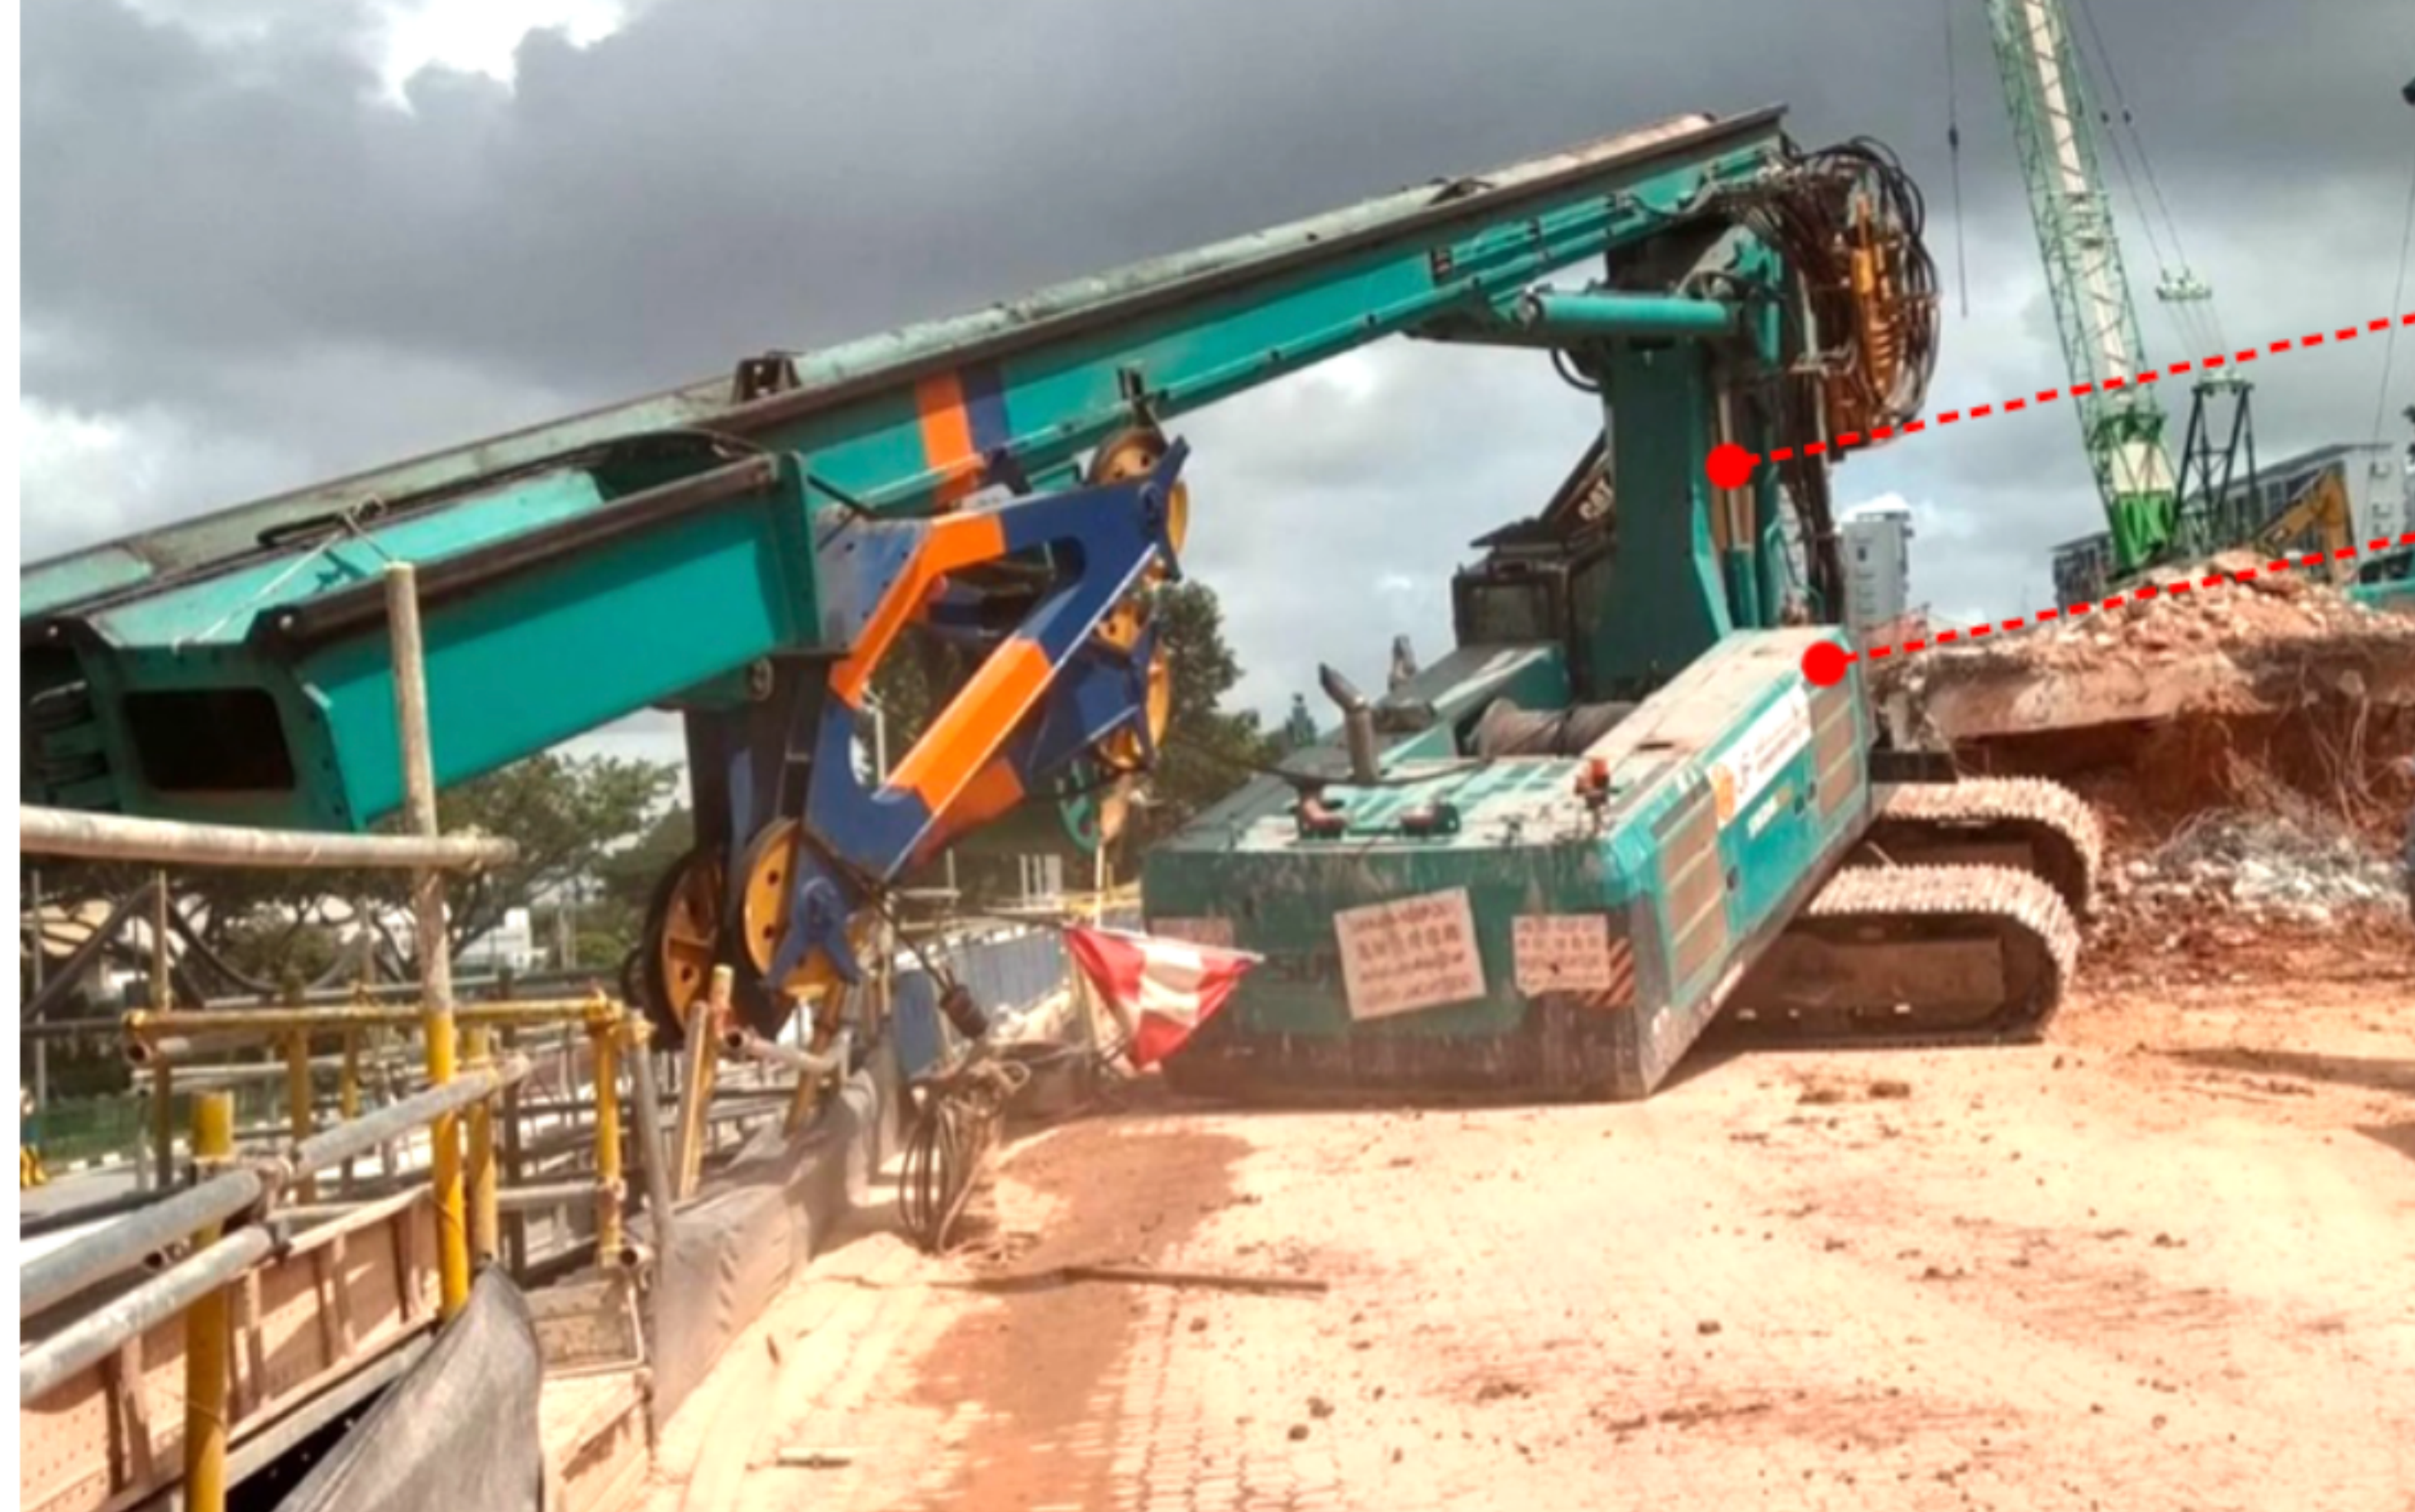
An operator was moving a bore piling machine. As the operator was turning the chassis, the machine toppled sideways. Investigation revealed that the machine's crawlers were not extended before it was moved, reducing its stability.

Overview of accident scene.

Bore piling machine

Chassis of the machine

- **Pre-use check:** Confirm that the machines are in good working condition and free of defects before starting work.
- **Fully extend crawlers:** Most machines require their crawlers to be fully extended before operations. Crawlers are designed to be retracted for the transportation of the machines on vehicles. Ensure the Safe Work Procedure (SWP) includes the need to fully extend the machine's crawlers before operation.

- **Use of technology:** Consider working with manufacturers to install a safety interlock to ensure the machine can be operated only if its crawlers are fully extended.
