CASE STUDIES

WORKING IN AND
AROUND WATER

WSHCOUNCIL

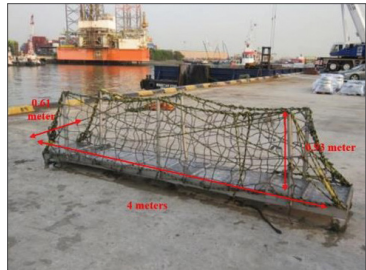
Photograph showing the gangway which was involved in the accident.

- Unsafe method to board and disembark from the vessel before the gangway was secured.

Risk assessment	<ul style="list-style-type: none"> • Conduct a thorough RA before any work commences. RA should identify falling into the sea as a hazard.
Safe work procedures	<ul style="list-style-type: none"> • Establish safe work procedures; they should include the following (non-exhaustive): <ul style="list-style-type: none"> - Secure the gangway properly at both ends, i.e. vessel and wharf side. - Maintain and check the gangway at regular intervals according to the maintenance regime to ensure it is in proper condition for use. - Ensure all moving parts are in good working conditions and are well greased. - There should also be at least one crew member (often referred to as the gangway watch) on board the vessel tending the gangway and observing passenger movement. The gangway watch would be able to initiate emergency response should an accident occur.
Work planning	<ul style="list-style-type: none"> • Do a thorough work planning before works start (e.g. gangway is secured). The owner, agent, master, or person-in-charge of a vessel must ensure that all railings and fencing of hatchways, accommodation ladders and gangways are of substantial construction, constantly maintained and kept in position during use.

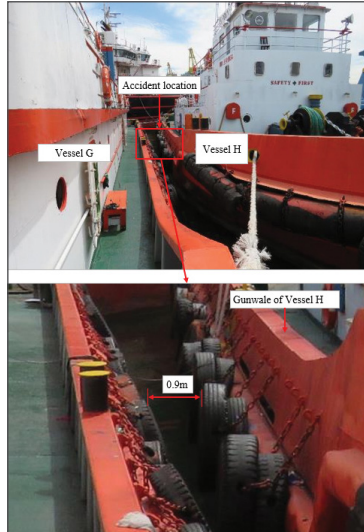
- The mooring and tide conditions could have caused the vessels to move away from each other.

Photographs show the accident location between the 2 berthed vessels.

- Ensure that there is a safe means for access and egress when driving or walking from shore-to-vessel or vessel-to-shore, and while on the vessel.
- As part of workplace housekeeping, check all access routes on a regular basis to confirm that the gangway and walkways are in good condition and safe for use. Remove any visible substance (e.g. oil, mud) as soon as possible as these can lead to slip and fall incidents. This is particularly dangerous if the fall occurs near a water body.

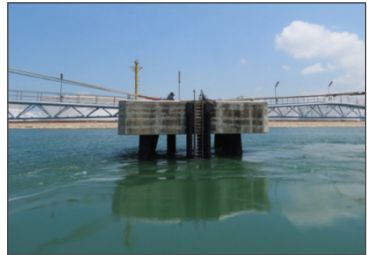
Photograph showing the mooring dolphin.
