CASE STUDIES

LOGISTICS AND TRANSPORT INDUSTRY

WSHCOUNCIL

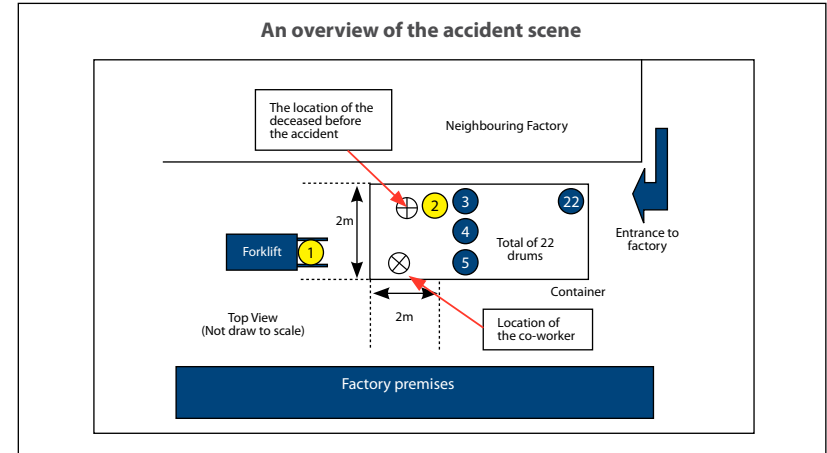
1. Normal usage of drum mover

Evaluation of loss	• One worker killed.
Type of contact	• Fall from height.
Immediate cause(s)	• Slipping while using drum mover.
Basic cause(s)	• Inappropriate handling of drum mover.
Failure of SMS	• Hazard analysis and risk assessment; WSH practices and procedures.

Disseminate information on hazards of such operations to workers.

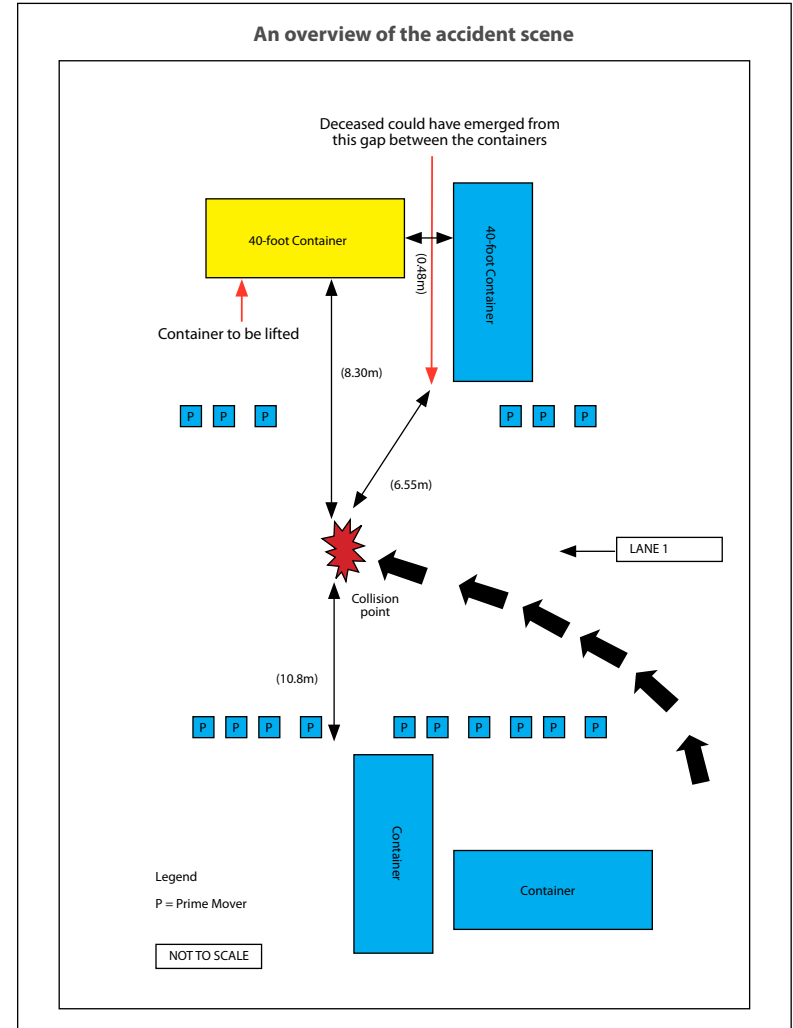
1. Deceased could have emerged from this gap between the containers
2. Driveway and container storage areas not demarcated

Evaluation of loss	<ul style="list-style-type: none">• One worker killed.
Type of contact	<ul style="list-style-type: none">• Struck by moving vehicle.
Immediate cause(s)	<ul style="list-style-type: none">• Unsafe driving of side loader; high visibility vest not used; no proper demarcation of storage area, passage way and driveway
Basic cause(s)	<ul style="list-style-type: none">• Lack of traffic control management programme.
Failure of SMS	<ul style="list-style-type: none">• Hazard analysis and risk assessment; WSH practices and procedures.

Develop and implement a workplace traffic management programme to separate the paths of pedestrians and vehicles.

Conduct regular safety inspections and enforcement to ensure workers comply with safe work procedures and safety rules such as using the designated pedestrian walkways and wearing luminous vests.
