# CASE STUDIES

METALWORKING INDUSTRY

WSHCOUNCIL

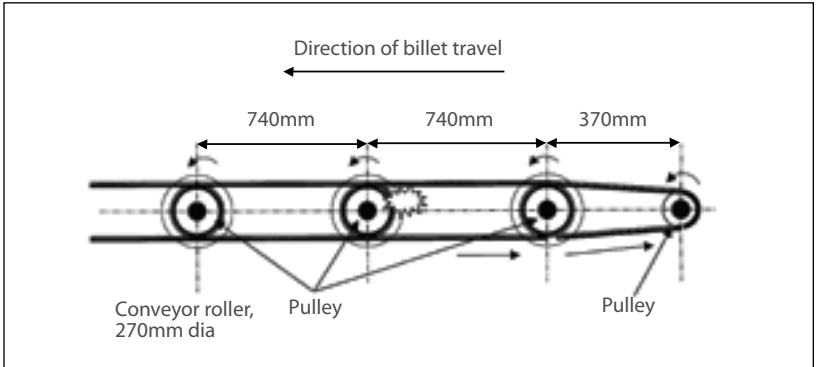
- There was inadequate fencing provided on the belts and pulleys system driven by the motor.
- The worker was walking along the inner walk platform that was about 450mm wide with cable tray

carrying cables running along the inner walk platform at about 400mm high. After taking into account the space used by the cables and cable tray, the effective space for walking along the inner walk platform was about 250mm.

Risk Assessment	<ul style="list-style-type: none"><li>• Risk assessments must be carried out prior to work operations.</li></ul>
Safe Work Procedure	<ul style="list-style-type: none"><li>• Safe work procedures must be developed and implemented.</li><li>• Lockout/Tagout procedures should be implemented before any inspection, adjustment or repair is carried out.</li></ul>
Work Planning	<ul style="list-style-type: none"><li>• Present cable tray location is a hindrance to conveyor adjustment and repair works and should be relocated.</li></ul>
Equipment and Tools	<ul style="list-style-type: none"><li>• All exposed moving parts should be adequately covered.</li></ul>

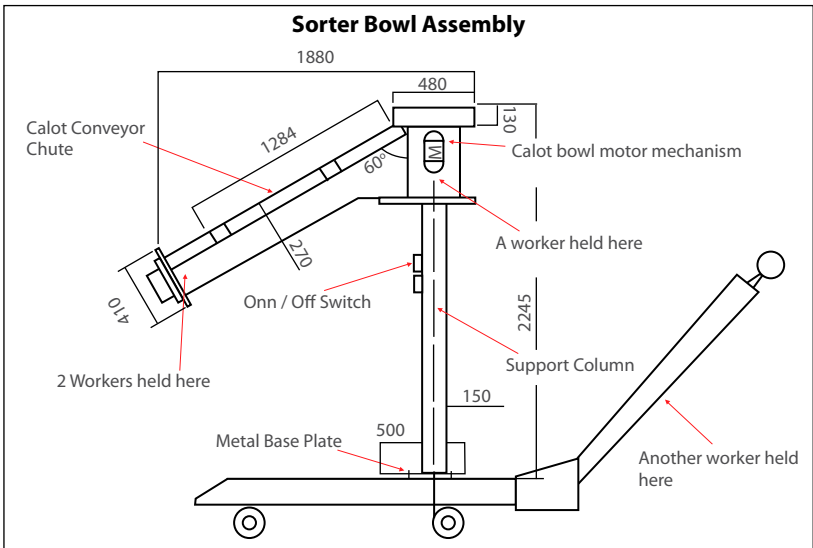
The team stopped to assess the situation. The supervisor instructed that the sorter bowl assembly be placed on the production floor. The team began to tilt and lower the sorter bowl assembly. During the process, the sorter bowl assembly suddenly fell onto the chest of one of the workers. The worker died in the hospital the same day.

- The sorter bowl assembly was about 267cm in height, 50cm in diameter and weighed 250kg.
- The supervisor had attended the Lifting Supervisor Course and had more than 8 years of working experience on manual handling of articles and machinery. One of the workers had attended the Rigger and Signaling Course and had more than 15 years of working experience on manual handling of articles and machinery. The worker had attended the Safety Orientation Course and had more than 10 years of work experience in moving heavy machinery.

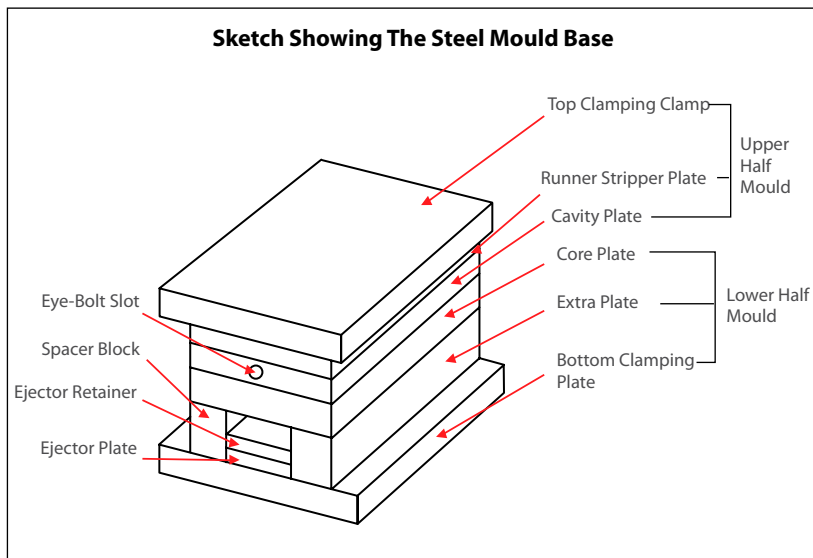
1. Overhead crane
2. Lifting belt
3. Working table

- The worker said that when the upper half mould base was lifted up to a height of about 150mm above the working table, the mould suddenly slipped and hit his right ring finger.
- The probable cause of the accident may be due to the imbalance of the mould when it was being lifted, which caused the mould to slip and hit the worker's finger.

Risk Assessment	<ul style="list-style-type: none"><li>• Risk assessments must be carried out prior to work operations.</li></ul>
Safe Work Procedure	<ul style="list-style-type: none"><li>• Safe work procedures must be developed and implemented.</li></ul>
Equipment and Tools	<ul style="list-style-type: none"><li>• Loads should be properly balanced and securely rigged before lifting.</li></ul>
Training and Awareness	<ul style="list-style-type: none"><li>• Crane operators should be trained on the correct rigging methods.</li></ul>

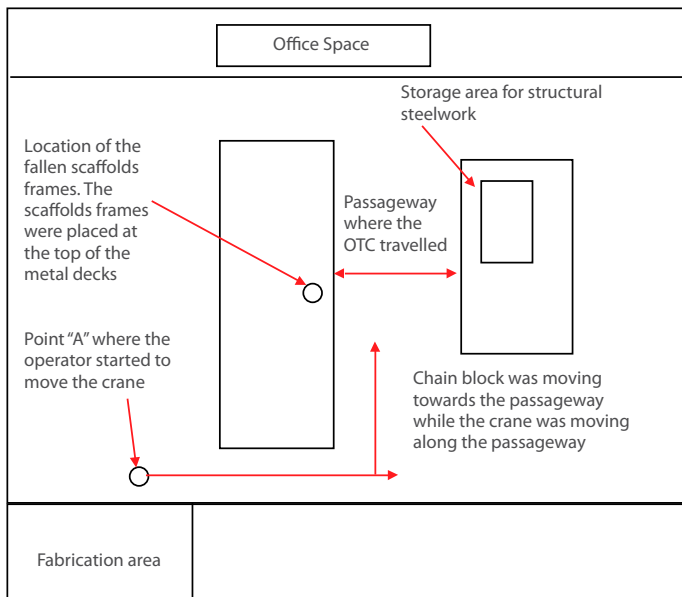
### Sketch Showing the Layout of the Place of Accident

- Investigations revealed that prior to the accident, the bundle of scaffold frames placed on top of the metal platform were not securely tied to the metal platform. The height of the metal platform was about 3.5m and the height of the bundle of scaffold frames was about 1.2m. The bundle of scaffold frames weighed about 0.7tons.

Risk Assessment	<ul style="list-style-type: none"><li>• Risk assessments must be carried out prior to work operations.</li></ul>
Safe Work Procedure	<ul style="list-style-type: none"><li>• Safe work procedures must be developed and implemented.</li></ul>
Work Planning	<ul style="list-style-type: none"><li>• Proper planning of the route of the lifting operations must be carried out to ensure that there is no structure or other objects that could be hit or entangled by the suspended load.</li><li>• The work environment must be checked to ensure that no personnel are in the path or within close proximity of the suspended load when it is being transferred.</li></ul>
Equipment and Tools	<ul style="list-style-type: none"><li>• Equipment or materials, especially those that are stored at height, should be properly secured to ensure that they do not fall easily.</li></ul>
Training and Awareness	<ul style="list-style-type: none"><li>• All personnel executing the lifting operation (e.g. lifting supervisor, crane operator, signaller, etc.) must be appropriately trained.</li><li>• The lifting operation must be made known to those that may be affected by it and/or may be working in the vicinity.</li></ul>

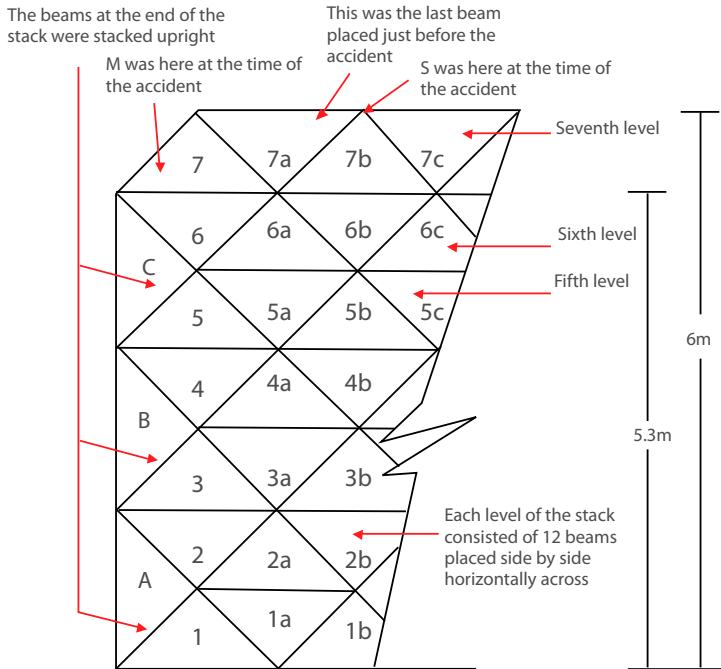
### Sketch Shows the Front View (Partially) of the Stack of Beams which was Stacked to 7 Levels High at the Time of the Accident

- On the day of the accident, the occupier did not appoint a qualified lifting supervisor to supervise the lifting of the beams for stacking.
- There was no supporting structure to ensure the stability of the stack.
- Some of the beams might not be sufficiently and securely bound together with galvanized wires.
- Prior to the accident, the company did not have a safe work procedure for the stacking of beams.

Risk Assessment	<ul style="list-style-type: none"><li>• Risk assessments must be carried out prior to work operations.</li></ul>
Safe Work Procedure	<ul style="list-style-type: none"><li>• Safe work procedures must be developed and implemented e.g. working at height and stacking of materials.</li></ul>
Equipment and Tools	<ul style="list-style-type: none"><li>• Binding materials and supporting structures used should be adequately strong to hold the stacks of beams in a stable manner.</li></ul>
Training and Awareness	<ul style="list-style-type: none"><li>• A qualified lifting supervisor should be appointed for all lifting operations.</li></ul>
Coordination and Communication	<ul style="list-style-type: none"><li>• Lifting processes must be supervised by a qualified Lifting Supervisor, or in his absence, must adhere to a set of lifting procedures established by him and be communicated to all affected personnel.</li></ul>

Personal Protective Equipment	<ul style="list-style-type: none"><li>• Fall arrest devices such as safety harnesses with proper anchorage points should be provided for personnel that are working at height.</li></ul>

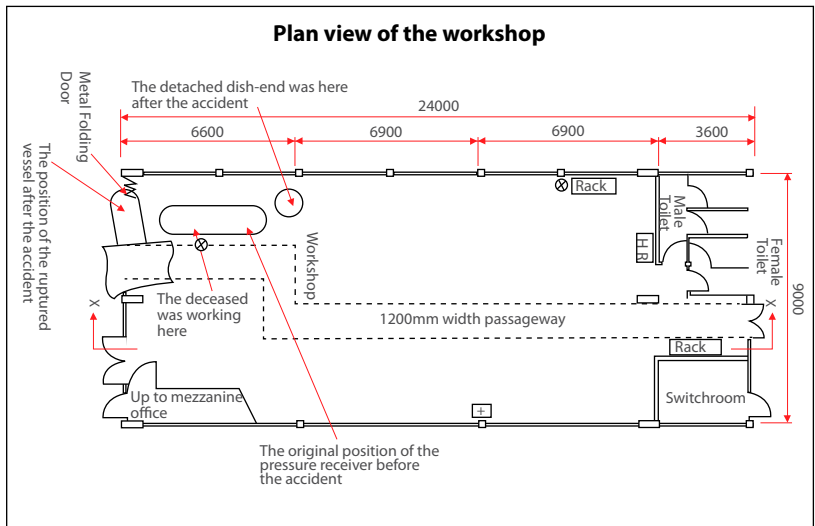
- The workers had not undertaken any welding competency test.
  - There was no non-destructive test or examination conducted on the pressure receiver to check on the quality and the integrity of the weldments before the pressure test was carried out.

- There were no safety precautions or measures taken in conducting the pneumatic pressure test.

Risk Assessment	<ul style="list-style-type: none"><li>• Risk assessments must be carried out prior to work operations.</li></ul>
Safe Work Procedure	<ul style="list-style-type: none"><li>• Safe work procedures must be developed and implemented.</li></ul>
Equipment and Tools	<ul style="list-style-type: none"><li>• The pressure receiver should have been designed and fabricated by qualified and competent persons and examined and approved by an Authorised Examiner.</li></ul>
Training and Awareness	<ul style="list-style-type: none"><li>• “Skilled workmen” such as welders must undergo the relevant training and certifications.</li></ul>
Others (Process design, etc.)	<ul style="list-style-type: none"><li>• Hazardous tasks, like pressure testing, should be carried out by trained personnel, in accordance with specified standards and safe work methods and within proper test cells.</li></ul>

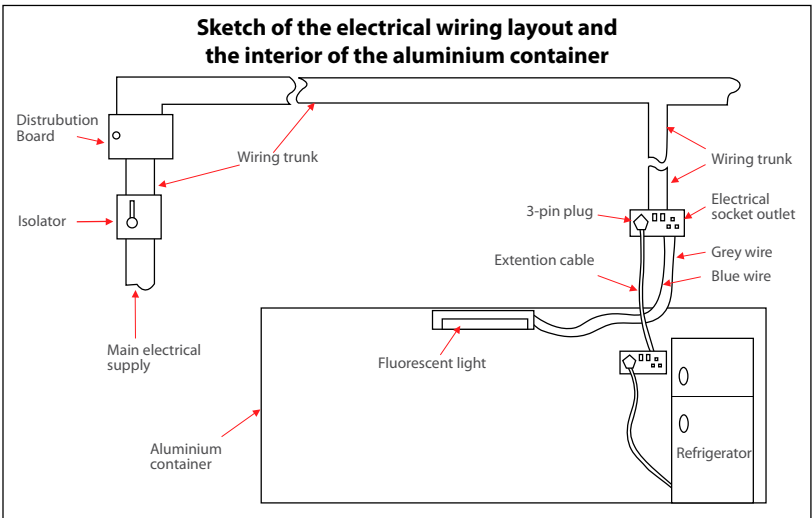
- Investigations revealed that the grey wire of the fluorescent light was disconnected from the electrical socket outlet and the blue wire was still connected directly to the electrical socket outlet of 230 volts. The insulation of the blue wire was damaged and the wire inside it was exposed.
- It is probable that the worker who was electrocuted was trying to pull out the wires and hence damaged the wires. He then accidentally came into contact with the exposed wire and received an electric shock.

Risk Assessment	<ul style="list-style-type: none"><li>• Risk assessments must be carried out prior to work operations.</li></ul>
Safe Work Procedure	<ul style="list-style-type: none"><li>• Safe work procedures must be developed and implemented.</li></ul>
Equipment and Tools	<ul style="list-style-type: none"><li>• Electrical equipment should be fitted with earth leakage circuit breakers.</li></ul>
Training and Awareness	<ul style="list-style-type: none"><li>• Electrical installations should only be undertaken by a trained and qualified electrician or a licensed electrical worker.</li></ul>
Others (Process design, etc)	<ul style="list-style-type: none"><li>• Electrical fittings and connections should be inspected for damage or defects before use.</li></ul>
