JIVZ Forum #7: Process Safety Local Case Studies + Learning Points

Er. Nicholas Yip

Major Hazards Department
Occupational Safety and Health Division

Local Case Studies & Learning Points

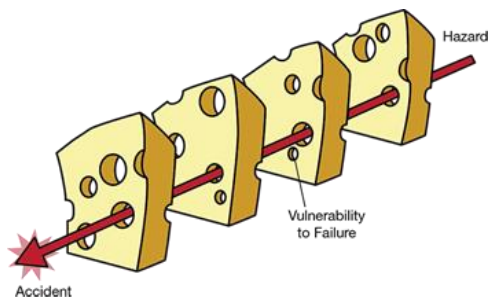
- **Electrostatic ignition** of flammable vapours occurred when flammable liquid was discharged into **plastic IBC** from a product tank.
- Investigation revealed that the main factor was due to **inappropriate use of plastic IBC** for handling flammable liquid.
- Operator failed to **ground the metal cage** of plastic IBC and failed to immediately **clean up flammable liquid spills** which has earlier overflowed from product tank.
- **Poor operating practices** contributed to presence of flammable atmosphere around work area (e.g. operator allowed discharge of product onto the floor to drain off water first. The draining stopped only when flammable liquid was observed to be evaporating off the floor)

- **Semi-conductive IBCs** or **metal IBCs** should be used to store flammable liquid. Plastic IBCs must never be used for storing flammable liquids.
- A thorough **risk assessment** must be carried out to consider the possibility of a flammable vapour or aerosol mist being produced from the liquid while taking into account the flashpoint and process parameters such as temperature and pressure. **Hazard of electrostatic discharges** must be considered as well.

- **Grounding clamps** and **conductive hoses** used must be checked for its electrical continuity at regular intervals by competent personnel.
 - Splash filling should be avoided by **bottom filling** via an earthed conductive fill pipe or via grounded dip pipe. At the start of the discharging process, the linear velocity of the system should be no greater than 1 m/s until the inlet pipe is fully submerged.

- Operators should be equipped with **personal gas detectors** when working in potentially flammable atmosphere for early detection.

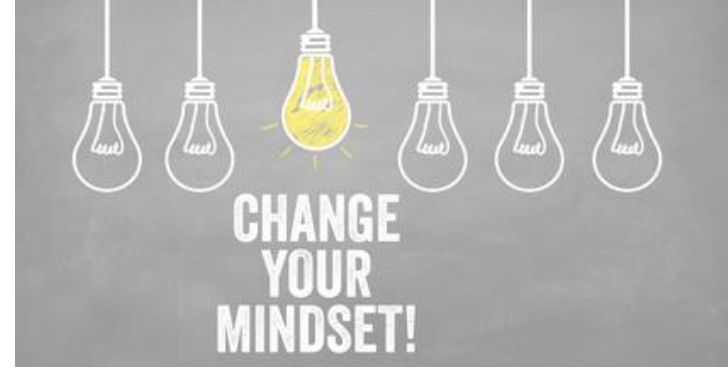
- Three employees and one contractor were **exposed to highly toxic gas** during leak check of a reactor sight glass. The check was conducted following replacement of a sight glass that turned opaque with use.
- Investigation revealed that reactor was **not completely gas-free** due to a **passing valve**. **Toxic gas backflow** from downstream vessel into reactor. The passing valve issue was known but the **risk assessment** failed to include **safety impacts** on maintenance activity.
- Other findings include:
 - Lack of positive isolation between reactor and downstream vessel
 - Permit failed to cover the leak test job (only up to replacement job)
 - Lack of SWP developed for leak test job
 - No alarm raised by workers when personal toxic gas detector sounded
 - Alarms were raised by several fixed toxic gas detectors to the DCS but no actions were taken by those in control room

- Repair or replace leaky isolation valve promptly.

- Explore mechanical solutions to achieve positive isolation of reactor from downstream system due to large piping (i.e. >30”).

- Train all involved on importance of conducting RA to cover all risks and communicating risks, prior to starting job.
- Develop leak test procedure to minimise toxic gas presence in downstream system.
- Verify gas-free status within work scope.

- Display fixed detector alarms more prominently in the control room.

- Re-train to inculcate right behaviour and response following detection by personal toxic gas detector.

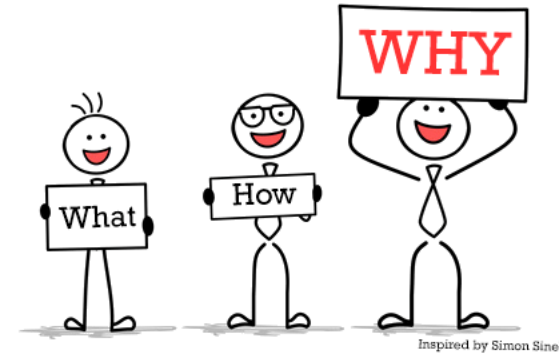
- A group of workers was carrying out hot work when a **flash fire** broke out. Two workers suffered burns and were conveyed to the hospital.
- Investigation revealed that there was a leak at the **strainer** beneath one of the waste tanks. This resulted in the **accumulation of flammable gas** in the area, which was ignited during hot work.
- Prior to incident, there was a **previous near-miss** where the strainer leaked as the solvent in the waste tank corroded the **O-ring** in the strainer cover. The O-ring was replaced, but the **valve handle seal**, which could also be corroded by the solvent, was not identified and replaced, resulting in the new leak that occurred.

Near Miss (NM) Reporting	Management of Change (MOC)	Hot Work Permit	Gas Detectors	Training	Personal Protection
<ul style="list-style-type: none">• Identify root cause and put in measures that address root cause of all NM incident reports.• Identify materials or components of tank strainer could be corroded by the solvent in the tank.	<ul style="list-style-type: none">• Measures identified through NM reporting need to be managed.• MOC assessment includes assessing the scope for change.• This includes systemically identifying and replacing incompatible seals used plantwide.	<ul style="list-style-type: none">• Conduct gas checks and implement other control measures• Prevent fires and explosions, before issuing any hot work permit.	<ul style="list-style-type: none">• Install fixed gas detectors at strategic locations near hot work.• Equip at least one worker carrying out hot work with a portable gas detector.	<ul style="list-style-type: none">• Ensure workers are familiar with the SWP before starting work.• Otherwise, provide the workers with refresher training.	<ul style="list-style-type: none">• Provide suitable PPE, such as fire-retardant clothing to all workers performing works involving flammable substances.
