# Crane Safety – A Collaborative Effort

Bernard Kwok Ministry of Manpower

14 Oct 2021

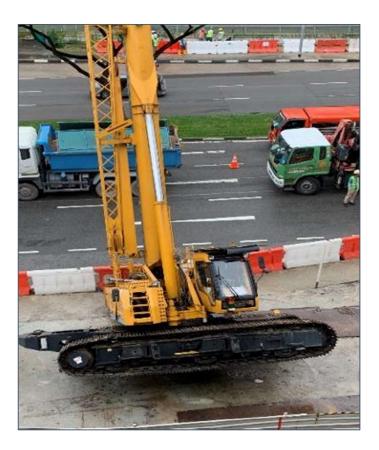
### **Overturning of Crawler Crane**

- Crawler crane was slewing when it overturned to its side.
- Crane's tracks were retracted.

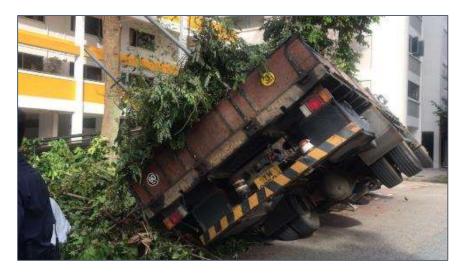
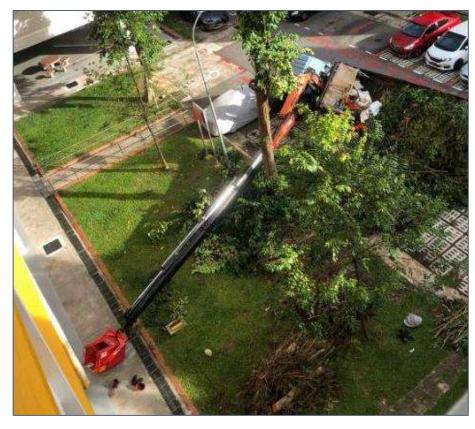
# **Overturning of Lorry Crane**

- Lorry crane overturned to its side as the workman basket with worker in it was being lowered.
- Outriggers were not fully extended.

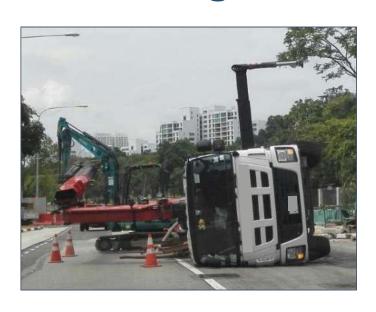
#### **Overturning of Lorry Crane**

- Many similar incidents over the years.
- Lorry crane was lifting an excavator onto its lorry bed when it overturned.
- Outriggers were not fully extended.

Operator slewed the boom when the outriggers had been retracted, resulting in the overturning of the crane.
