6 March 2019, Ref: 1819090

Accident Advisory: Worker found dead in lift car

Ref: 1819083 WSH Alert Accident Notification dated 1 February 2019

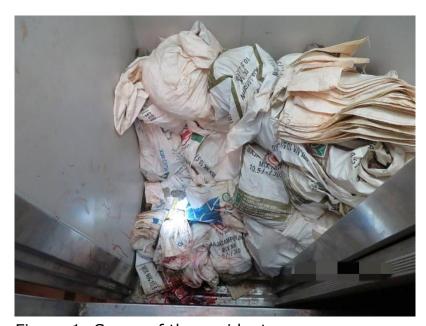
On 14 January 2019, a worker was using a lift to transport demolition debris down from the 8th floor when the lift started descending at a high speed and landed into the lift pit. The worker was pronounced dead at the scene. He was part of a team carrying out lift upgrading works at the residential building.

Figure 1: Scene of the accident

• Ensure all lift car safety devices (e.g. brake system, safety gear, overload detector, buffer) are in good working order and properly maintained to ensure their continued operability and effectiveness.

- To prevent unintended car movements, lift owners are advised to consider upgrading the lift braking system with built-in redundancy and self-monitoring features, such as a rope gripper. The rope gripper can be designed to automatically stop the lift once unintended lift car movement is detected.
- Workers using the lift car are not to by-pass or remove such safety devices installed or fitted to the car.

Building materials or debris to be transported in the lift car must be within the safe working load of the lift car, and properly stacked or securely fastened to prevent undesirable movement or accidental toppling.
