UNSAFE AND SAFE PRACTICES WHEN WORKING AT HEIGHT

Working at height is a high-risk activity, with falls from height accounting for more than 20% of all fatal injuries in 2021. The Ministry of Manpower put up [a Facebook post on 4 August 2022](#), calling out unsafe work at height practices which it found during inspections.

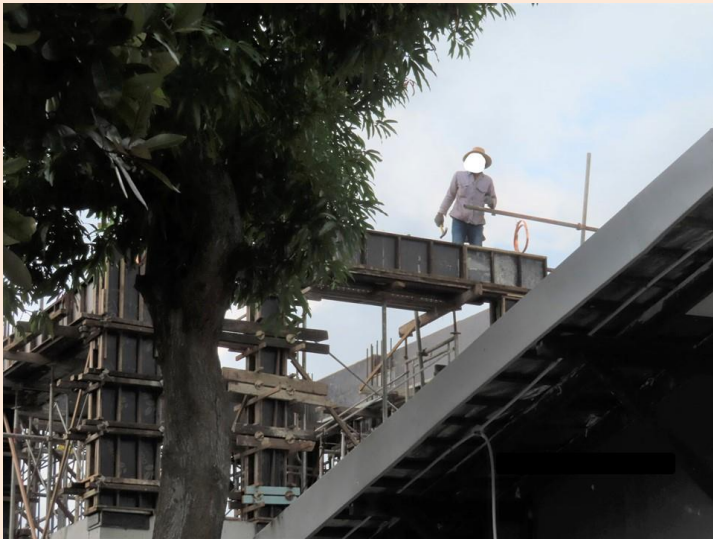
Unsafe

- ✗ Inadequate work platform
- ✗ Open sides
- ✗ No fall arrest equipment

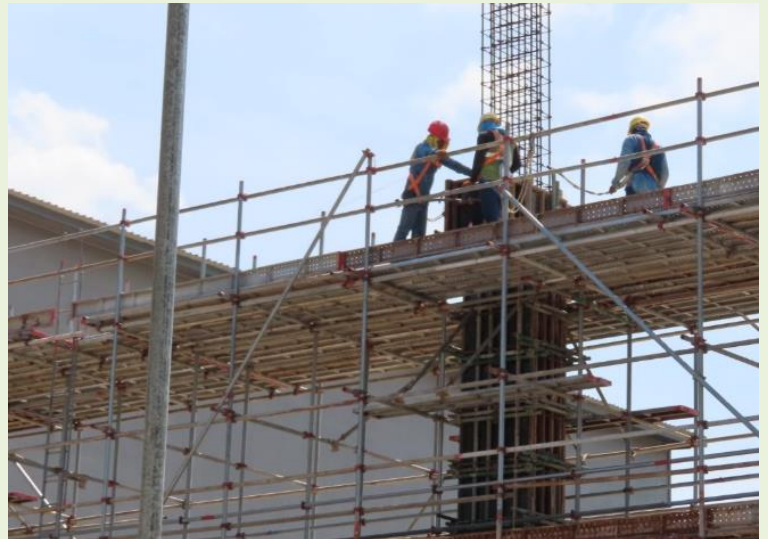
Safe

- ✓ Fully boarded work platform
- ✓ Guard rails and toe-boards in place
- ✓ Fall arrest equipment hooked onto secured anchor point if workers need to temporarily remove guard rails

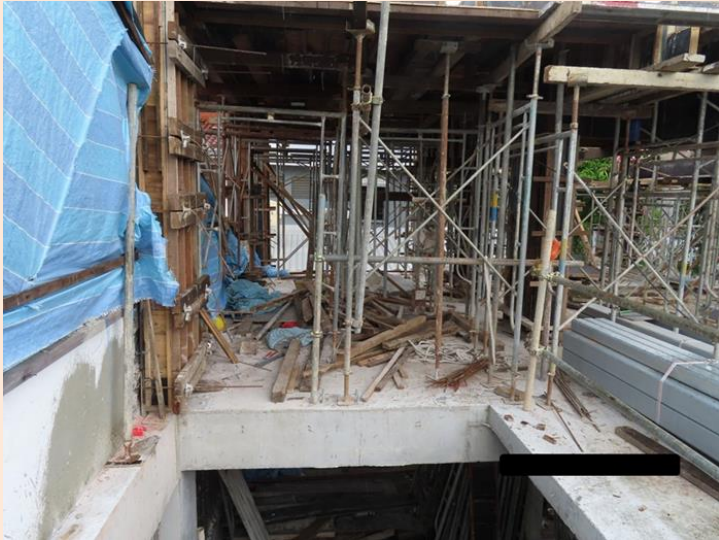
Unsafe

- ✗ Poor workplace housekeeping
- ✗ Unguarded floor opening
- ✗ Stored materials can fall over the edge, injuring workers below.

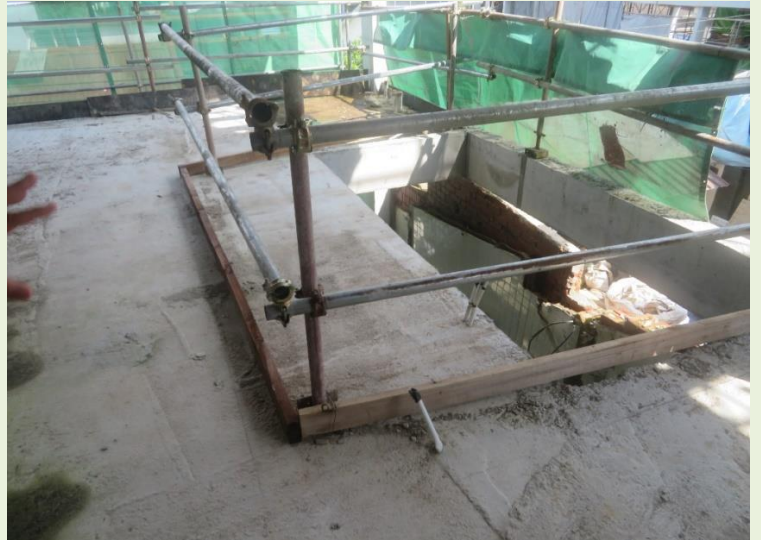
Safe

- ✓ Good workplace housekeeping
- ✓ Fully guarded work area with no floor openings
- ✓ Materials safely stored away from openings
- ✓ Toe-boards and netting help to prevent loose materials from falling off

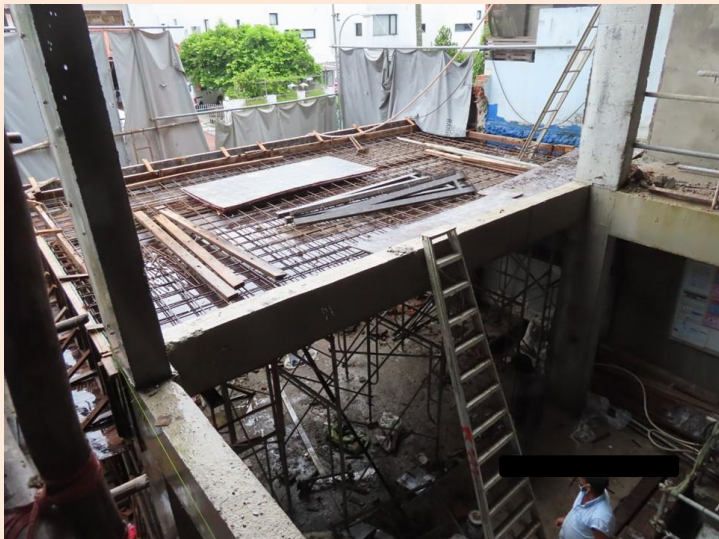
Unsafe

- ✗ Work at height location with open sides
- ✗ Improper access: A-frame ladder used as leaning ladder
- ✗ Disorganised workplace creates trip hazards

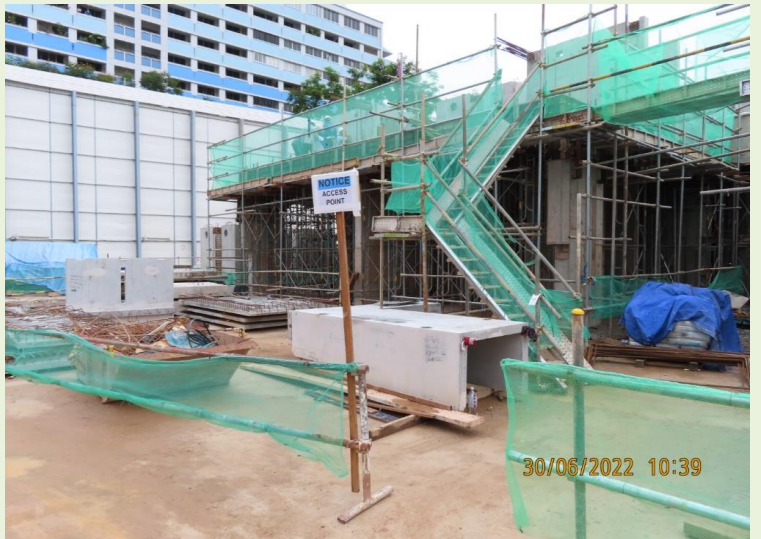
Safe

- ✓ Work at height location with fully guarded perimeter railing
- ✓ Designated access point via stairway access
- ✓ Organised storage for a safer workplace

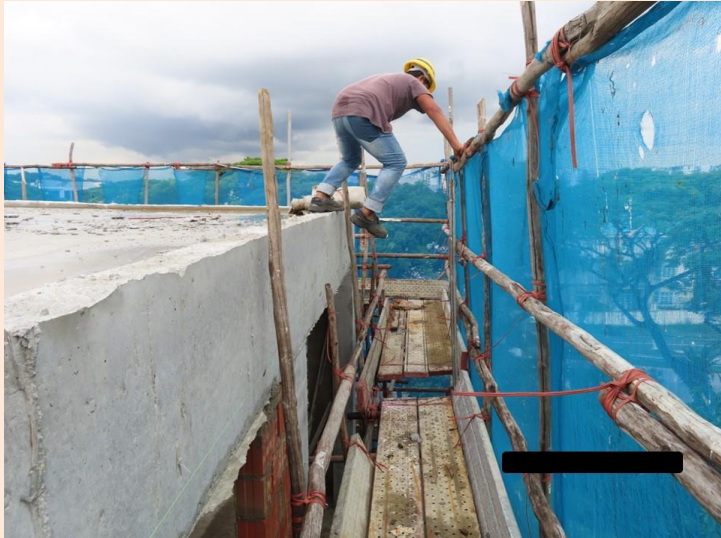
Unsafe

- ✗ Worker jumping off the roof to get onto the platform
- ✗ Gap in platform decking
- ✗ No fall arrest equipment

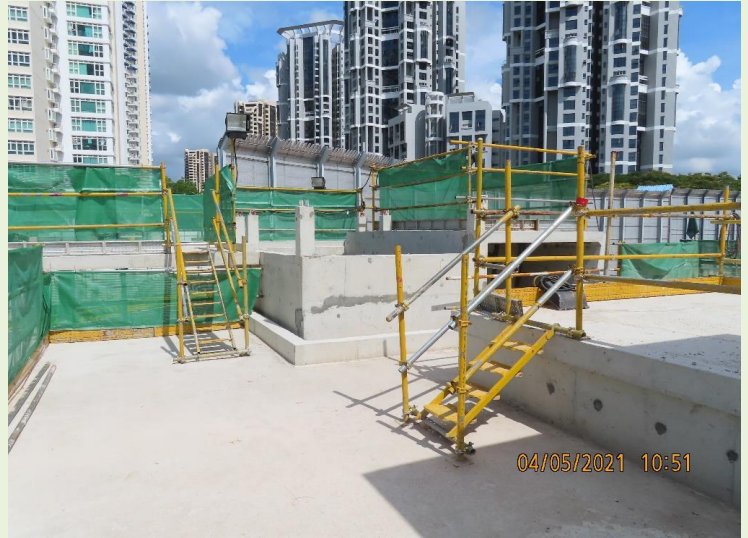
- ✓ Safe stairway access to work areas
- ✓ Platform decking flushed along their lengths and secured
- ✓ Work areas with open sides properly guarded
- ✓ Fall arrest equipment not needed in above work area

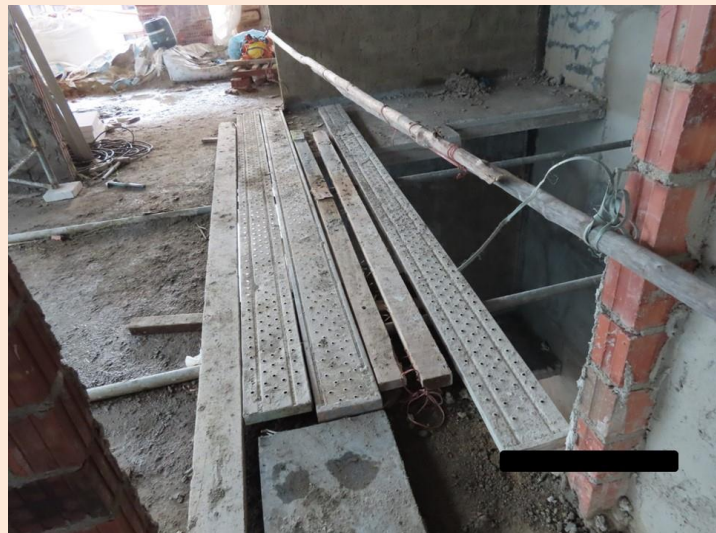
Unsafe

- ✗ Unsecured decking placed on unsecured pipes over void area
- ✗ Makeshift platform could collapse or flip on its side
- ✗ Makeshift guard rail with no toe-board

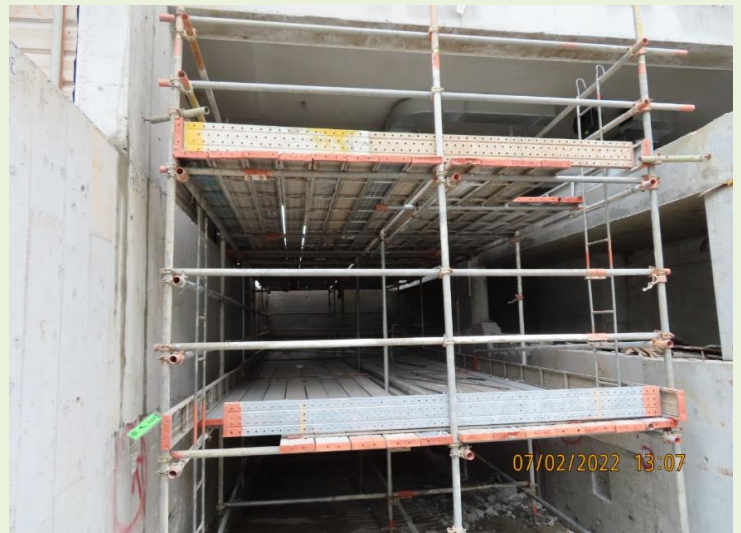
Safe

- ✓ Bird-cage scaffold erected in void areas to prevent falls through openings
- ✓ Fully boarded work platform with ladder access
- ✓ Properly secured guard rails with toe-boards

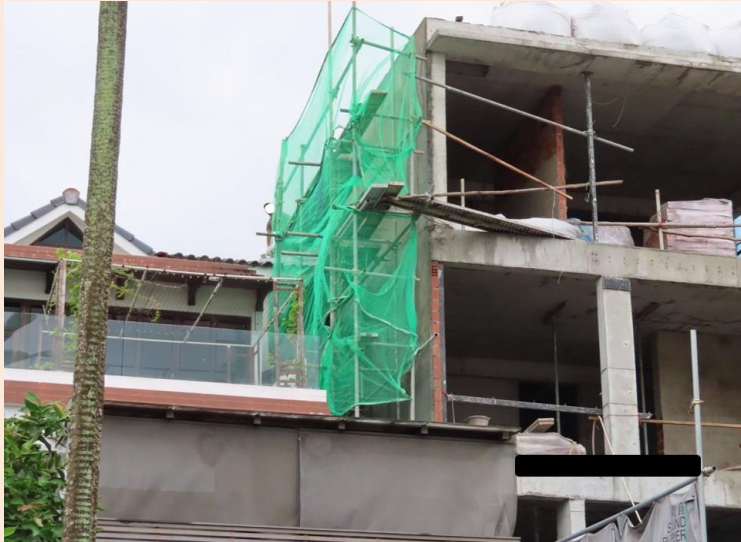
- ✗ Makeshift scaffold erected by untrained workers
- ✗ Scaffold placed on adjacent roof which may give way
- ✗ Unsafe access onto the scaffold via decking extended from building edge

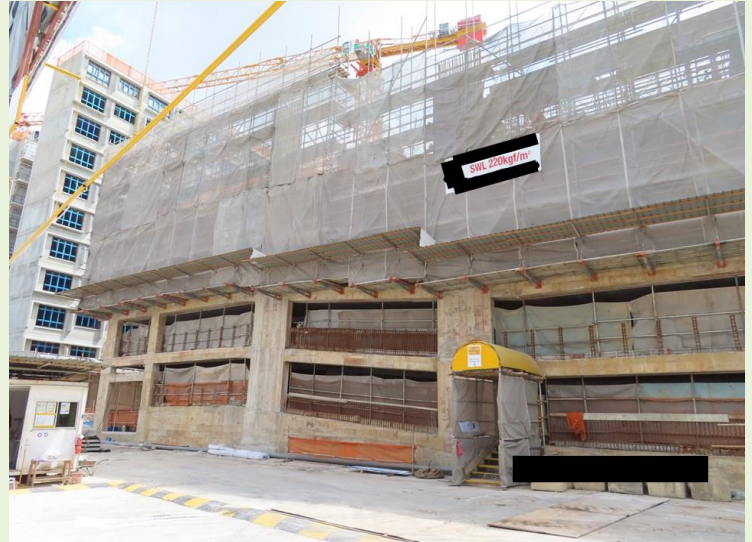
- ✓ Scaffold erected by approved scaffold contractor
- ✓ Scaffold constructed on solid foundation or on cantilever brackets with PE design and calculation
- ✓ Safe access onto the scaffold and safe access within the scaffold to get to different lifts

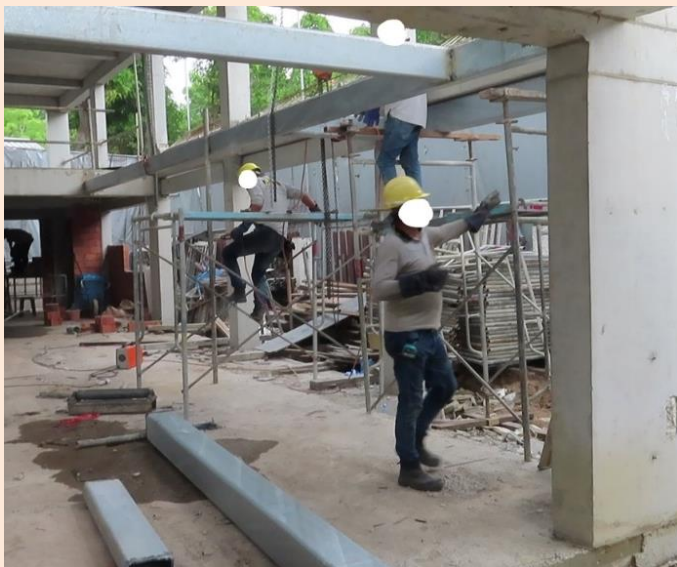
- ✗ Unsafe work platforms with unsecured decking, missing guard rails and toe-boards, and no sole plates.
- ✗ Unsafe access to the work platforms

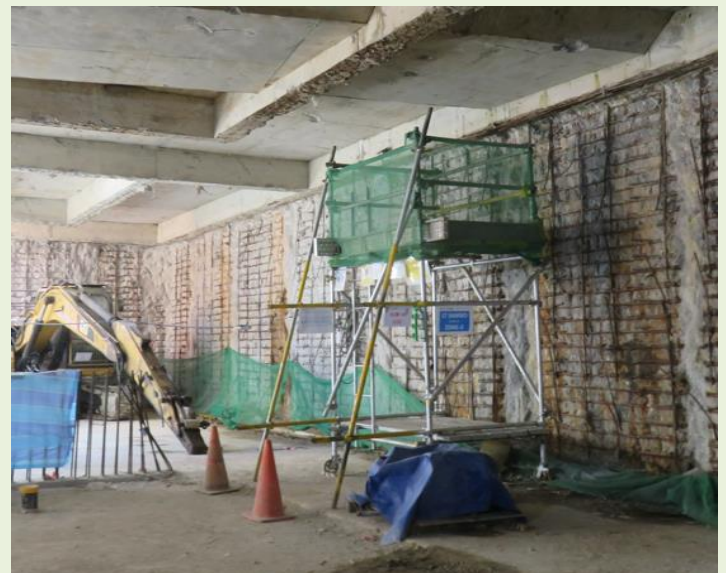
- ✓ Proper work platforms with secured decking, guard rails and toe-boards
- ✓ Safe ladder access to work platform
- ✓ Adequate foundation to prevent toppling
- ✓ Scaffold inspected by scaffold supervisor upon erection
